Chapter 4: Conservation Approaches, Applications, Case Studies

THE DIFFICULT CHOICE OF MATERIALS FOR THE RECONSTRUCTION OF THE CATHEDRAL OF NOTO

Luigia Binda, Giuliana Cardani, Claudia Tiraboschi

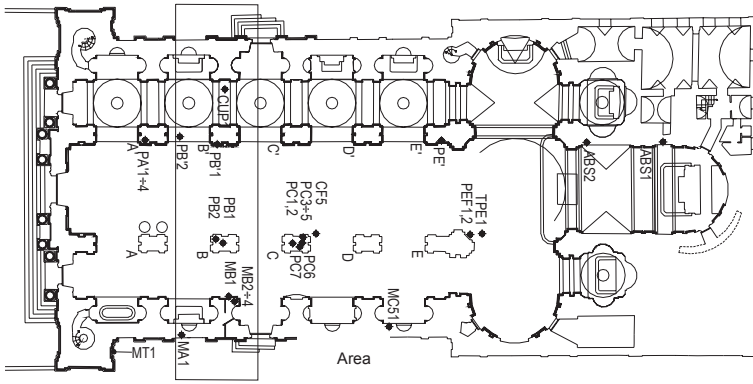
The losses caused by the collapse were the following: 4 pillars of the right part of the central nave and one of the 4 pillars supporting the main dome and the transept, the complete roof and vault of the central nave, three quarters of the drum and dome with the lantern, the roof and vault of the

right part of the transept and part of the small domes of the right nave (Figures 1, 2). The right pillars were named A, B, C, D, E; the left ones were named A', B', C', D', E' starting from the internal part of the façade (Figure 1).

Figure 1. The Noto Cathedral: plan of the remaining parts and samples locations.

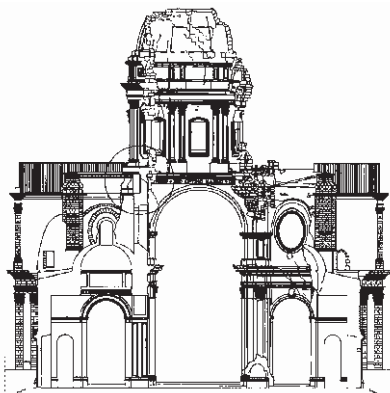
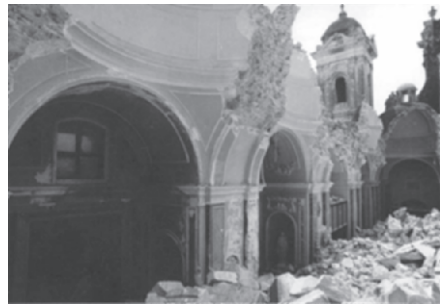
Figure 2. (a) The transversal section and (b) the collapsed Noto Cathedral.

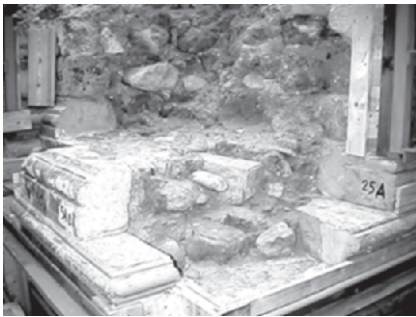
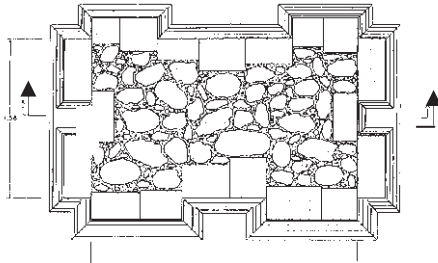
compared to the pillar dimensions, varies from 25 to 30 cm. No effective connection was realized between this external leaf and the core (Figures 3, 4). The external part of the base is made with regular blocks of limestone (calcarenite) which have a greater thickness and a better strength than the travertine (see next sections).

Figure 3. Detail and horizontal reconstruction of a pier section.

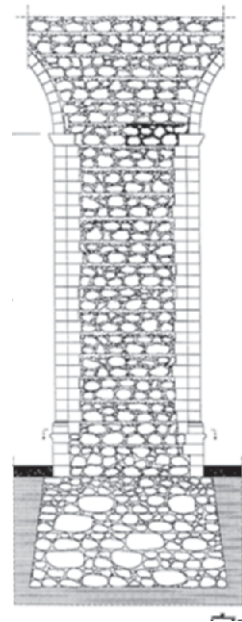
Figure 4. Reconstruction of a vertical section.

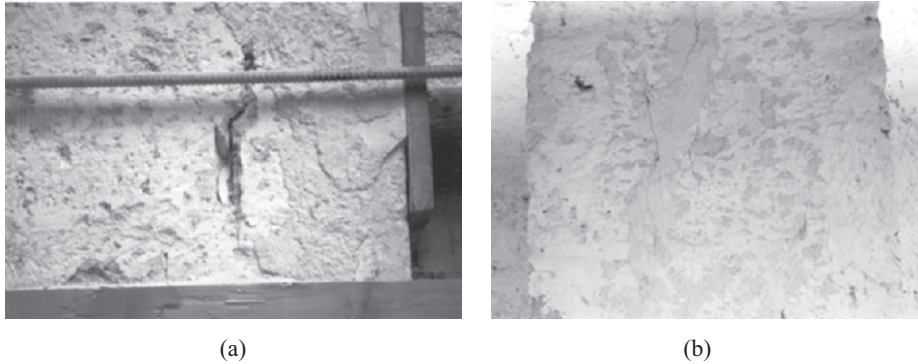
The left pillars, still covered with a thick plaster, showed vertical cracks at the bottom (Figure 5a), but the concern that the damage could be inside and perhaps even present before the 1990 earthquake, suggested that the plaster made in the fifties should be removed and a series of large vertical cracks were found, some of which were filled with the gypsum mortar used for the

Figure 5. a) Large crack found in a pillar and b) Example of a crack filled with gypsum mortar in the sixties

plaster (Figure 5b). This finding was the proof that the damage was already present before the last earthquake. The pre-existing crack pattern showed clearly damage from compressive stresses, indicating long term damage dating probably even before the rendering. This damage would have probably progressed even without the earthquake, which only accelerated the collapse¹.

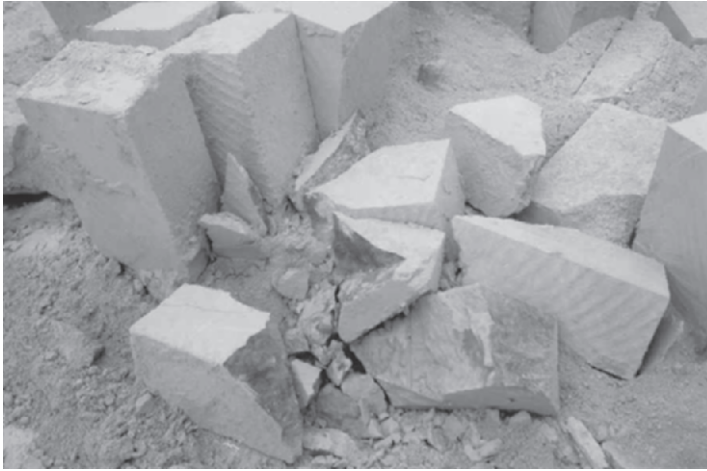
Figure 13. Creaked blocks in quarry.
