Chapter 14

Modal Testing of a Repaired Building After 2010 Chile Earthquake

Manuel Archila, Ruben Boroschek, Carlos E. Ventura, and Sheri Molnar

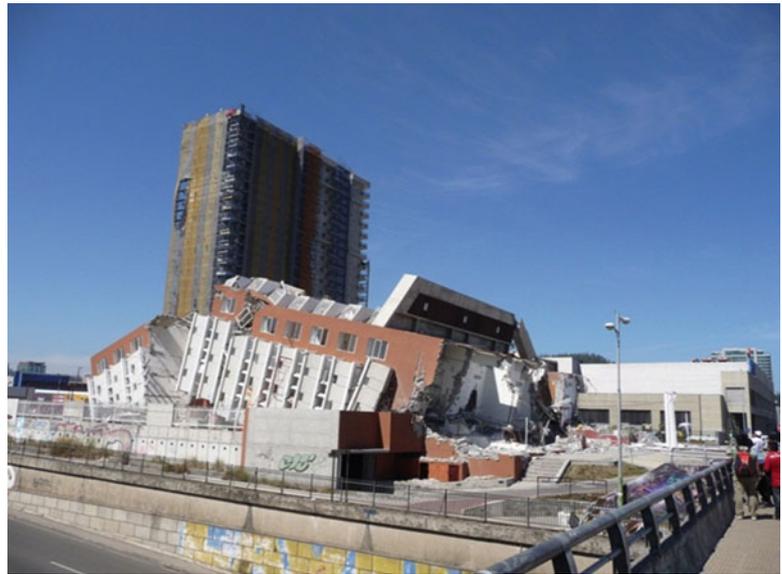
Fig. 14.1 Photo of a 15 storey reinforced concrete building in Concepcion city that collapsed during 2010 Chile earthquake (Photo courtesy of Perry Adebar)

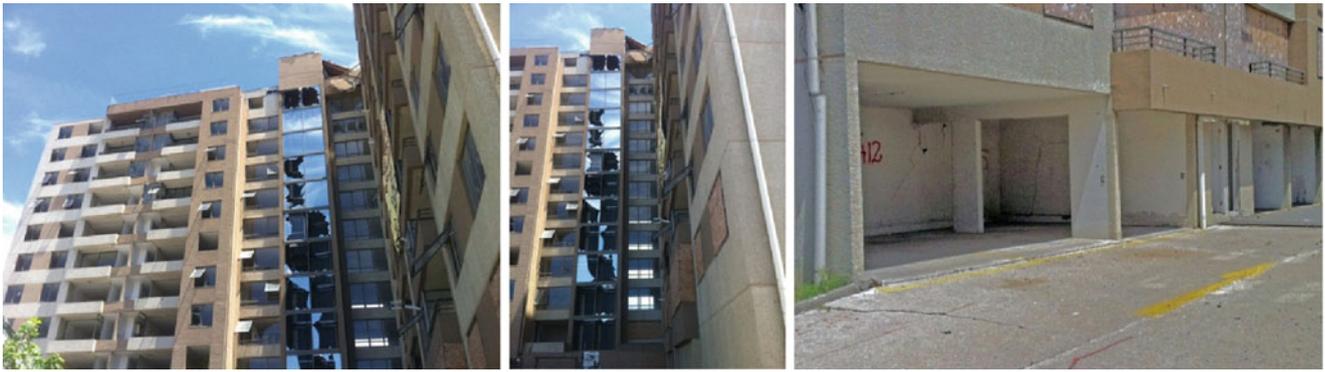
Fig. 14.4 Damage observed in 12-storey reinforced concrete building

The pictures in Fig. 14.4 show that the windows of the panoramic elevator suffered extensive damage. Partial collapse of the roof structure above the elevator was observed. The base of the walls above ground showed extensive cracking in horizontal and diagonal patterns. This building was considered inhabitable after the earthquake and has been slated for demolition. No access was allowed to this building; however the fundamental frequency of a shear wall building can be estimated using a rule of thumb described in equation 1.

where N is equal to the number of storey above ground level. Comparing the fundamental frequency of site 1 of 1.16 Hz and the estimated fundamental frequency of this building, it is clear that seismic amplification of motion could take place due to resonance. This correlation confirms that ground conditions played an important role on the seismic damage caused by the earthquake which rendered the building inhabitable.

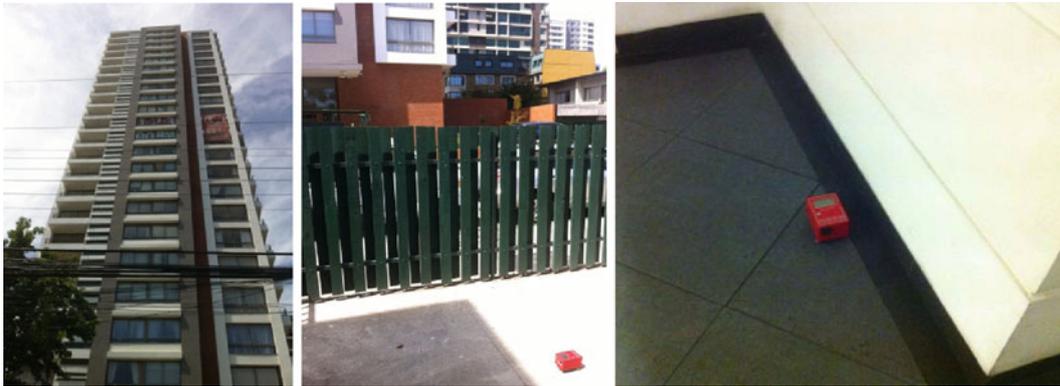
Fig. 14.5 Elevation of 24 Storey Building and ambient vibration measurements

A 24 storey repaired reinforced concrete building for residential occupancy was subject to modal testing. The building has 23 stories above ground level and one basement storey. The approximate plan layout dimensions are 40 m by 15 m. The structural system to withstand earthquake and gravity loading is comprised of slender reinforced concrete walls. Figure 14.5 shows pictures from the building and the ambient vibration tests performed on the ground (site 2) and the building.

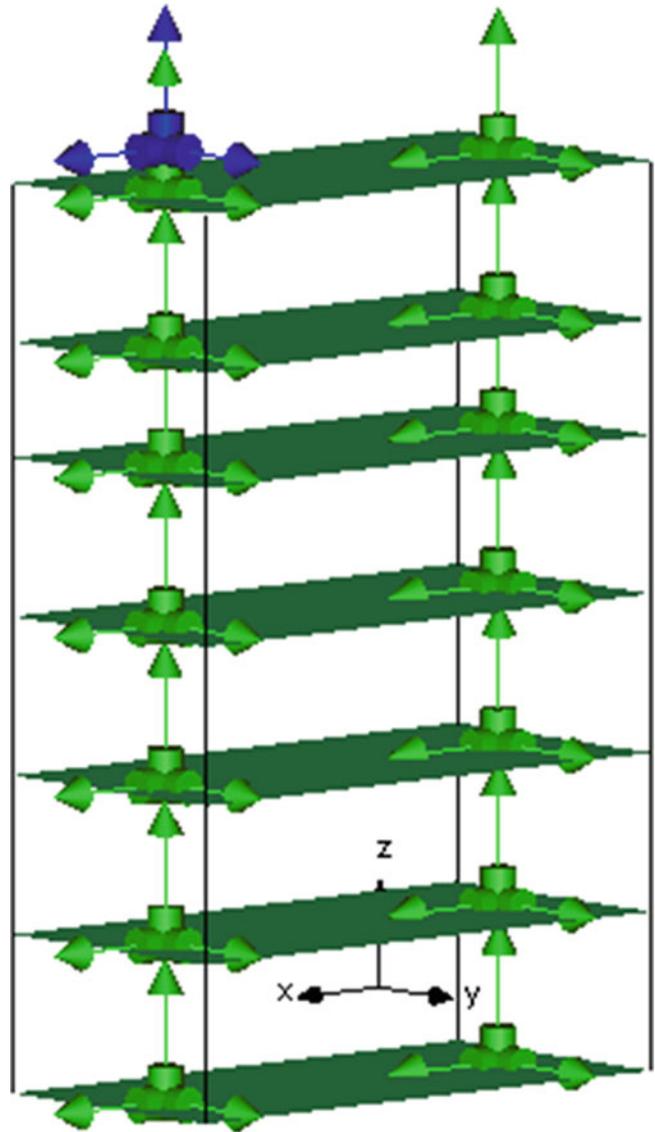
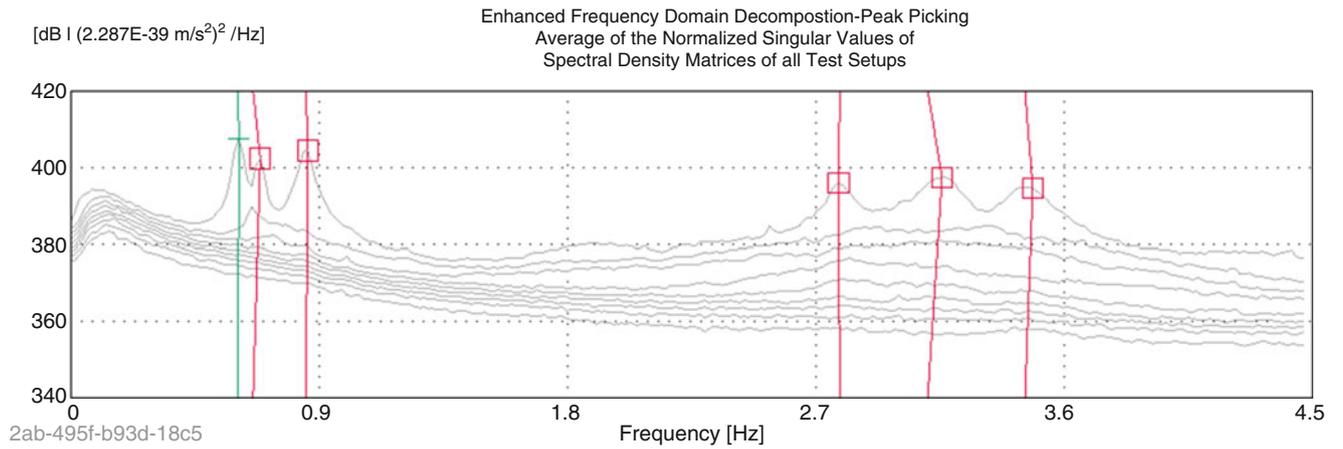
Fig. 14.6 Location of sensors over building height

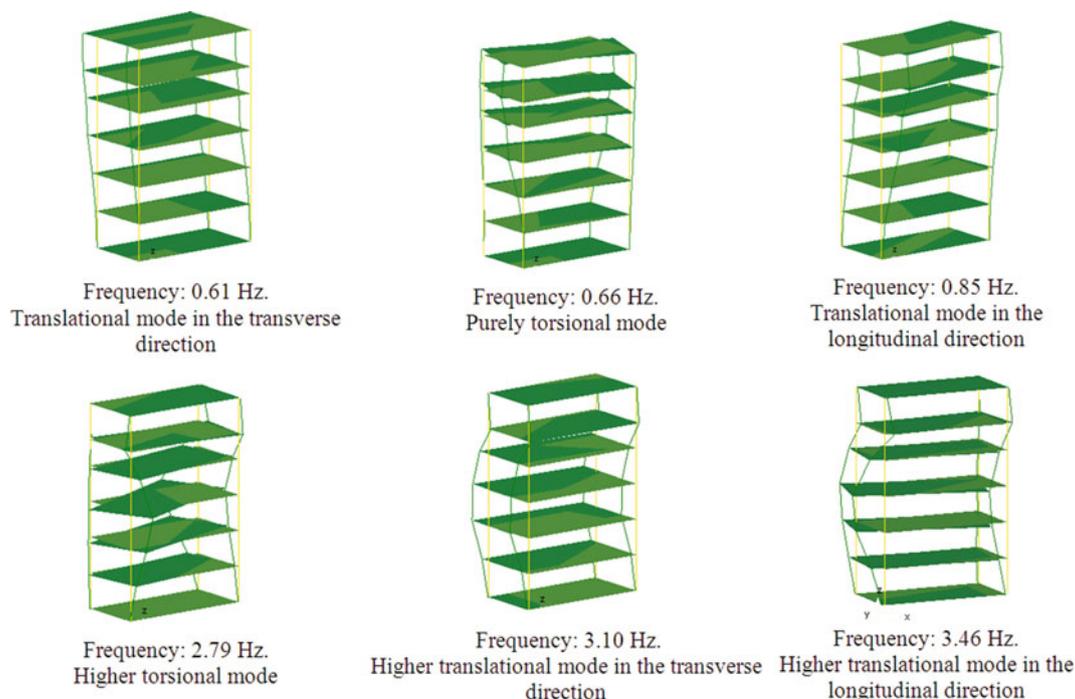
The model was developed using the seven different setups depicted in Fig. 14.6. The peak picking method was used to select frequencies from the singular value decomposition plot shown in Fig. 14.7. Six modal frequencies were identified. The summary of the modal properties obtained are listed in Table 14.1. The fundamental frequencies of the translational modes are 0.61 and 0.85 Hz in the transverse and longitudinal directions, respectively. The damping ratios range between 1.5% and 2.0% which is expected at the ambient vibration level. The corresponding modal shapes are presented in Fig. 14.8, only floors where measurements were taken are shown for clarity.

The fundamental frequency of the soil profile at site 2 where the building is located was determined to be 0.97 Hz (Fig. 14.2), and the dominant frequencies of vibration of the repaired building range between 0.61 Hz to 0.85 Hz. The frequencies are comparable and confirm that ground conditions also played an important role on seismic amplification of demands on the building that led to the severe earthquake damage observed.

Fig. 14.7 Plot of Singular Value Decomposition of the average of all measurements
