Renovating the Housing Stock Built Before 1945: Exploring the Relations Between Energy Efficiency, Embodied Energy and Heritage Values

Abstract Swedish multi-family buildings constructed before 1945 constitute an important part of the national built heritage. However, the majority does not have a formal heritage protection. Part of this building stock has already been renovated, notably through earlier energy saving programmes where additional exterior insulation, new façades and windows were frequently installed with little consideration for the original architecture. Now, 40 years later, these buildings face new renovations. This provides opportunities to improve the energy efficiency, indoor climate and user comfort. At the same time, the original architectural and historical characters lost in previous renovations could be recreated. In this paper, an inter-disciplinary research team illustrates the challenges met in practice to reach a sustainable renovation based on three cases. The case buildings are so-called “Landshövdingehus”, constructed in the 1930s and owned by a public housing company. The relations between building physics, energy efficiency, embodied energy, and th

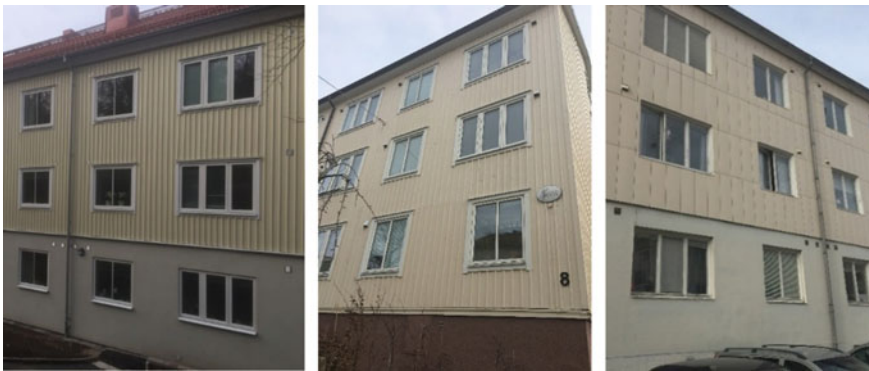
In 1970, the façades of case Case A and C (Fig. 2) were covered in asbestos boards to reduce maintenance costs. No insulation was added. In the 2010s, renovations of Case A and B were initiated due to high energy use. In Case A, exterior insulation was added to the façades and the windows were replaced. Initially the housing company wanted to replace the asbestos façade with a new board material. After negotiations with the city planning office, a wooden façade was chosen instead, with the goal to reconstruct the appearance of the original façade. For the roof, a solution with exterior insulation was chosen. One advantage with this solution is that the tenants do not have to empty their attic storage during the renovation process.

Fig. 2 Façade of Case A after the reconstruction of the wooden façade (left), Case B with unchanged façade (middle), and façade of Case C with the asbestos boards from 1970s (right)

The details in the original panel were more in proportion and thought through than the details on the new façades. The original panel is equipped with both window ledge and a decorative transition from panel to ground floor, while Case C only has window ledge. Almost all windows in the three buildings have been replaced and it is no longer possible to find original window settings and boards.

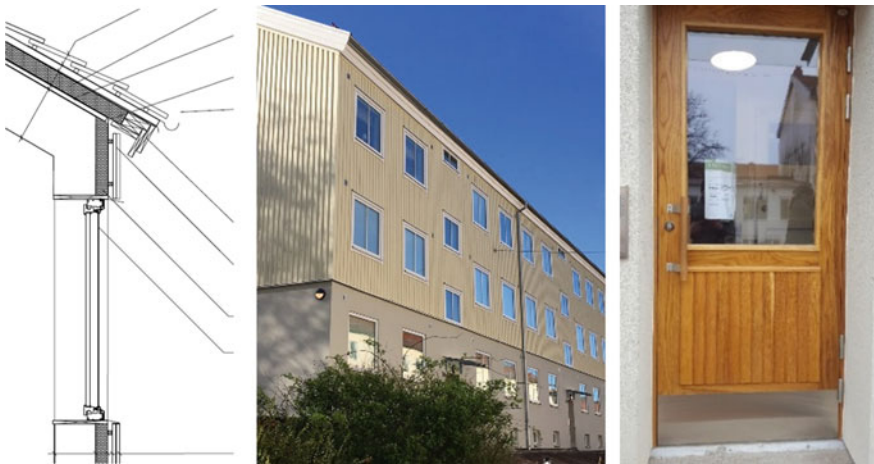
The largest renovation was made in Case A where the attic was insulated from the outside with 100 mm insulation (vapour open phenolic foam, $\lambda = 0.020$ W/(m K), system Clima Comfort, Monier) with an outer ventilated air gap under brick tiles, see Fig. 3. Walls were insulated with 70 mm mineral wool on the exterior.

The new windows are pivot windows with a U-value of 1.1 W/m²K. The windows were, with respect to the original façade from the 1930s, placed in line with the outer wooden panel except for the ones in the basement (masonry walls). They were left in their original position because of the storage rooms in the basement and that moving the tenants' belongings for this operation was considered too complicated and costly. The new placement of the windows in the wooden walls proved to be difficult as it left an uninsulated air gap around the window causing problems with both conductive and convective heat losses. It is essential for energy, thermal comfort and moisture protection to have a good air barrier when renovating.

Fig. 3 Detail of the roof to wall connection and the wall design (left, building permit, 2015-04-09), Case A with recessed windows in the basement floor (middle) and new doors (right)

In Case A, one part of the building had an air barrier (wind barrier on the exterior) and one part lacked air barrier. In order to investigate how this affected the airtightness, one apartment of each type was tested (airtightness and air leakage search). The apartments had similar measured airtightness rates and penetrations were a large cause of air leakage (for example air inlets that were not properly connected). There were draught and cold surfaces around the windows (in total 8 examined windows). All windows except one had been changed and the original window was the only one without leakages. The fitting of new windows during renovation has often been proved problematic with respect to airtightness. Since there were leakages around several windows, the sealing was redone and extra sealing was applied using expanded polyurethane on the exterior and extra joint sealants on the inside.

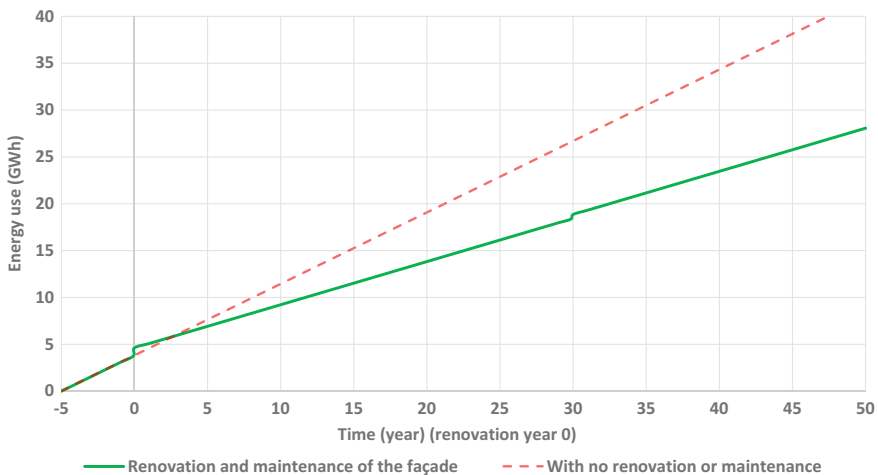
The payback time (with respect to embodied and operational energy) of the studied renovation is estimated to 1–2 years using four different databases. Results from the Ökobilanzdaten im Baubereich database are shown in Fig. 4 (payback time 2 years).

Fig. 4 Primary energy use for Case A over a 50-year scenario estimated with the Ökobilanzdaten im Baubereich database
