Vulnerability of Architectural Heritage in Seismic Areas: Constructive Aspects and Effect of Interventions

Maria Rosa Valluzzi and Luca Sbrogiò

Abstract In this chapter, the effects of past interventions applied to historical city centers struck by a series of earthquakes over time are analyzed in terms of local and overall damage. Three villages in central Italy, Castelluccio di Norcia, Campi Alto di Norcia and Castelsantangelo sul Nera, containing overall about 150 buildings, are examined here. Classification of damage was based on the European Macroseismic Scale. The study provided vulnerability maps detailing the influence of interventions on buildings in historical city centers, which may contribute to better evaluation of damage scenario and maintenance plans.

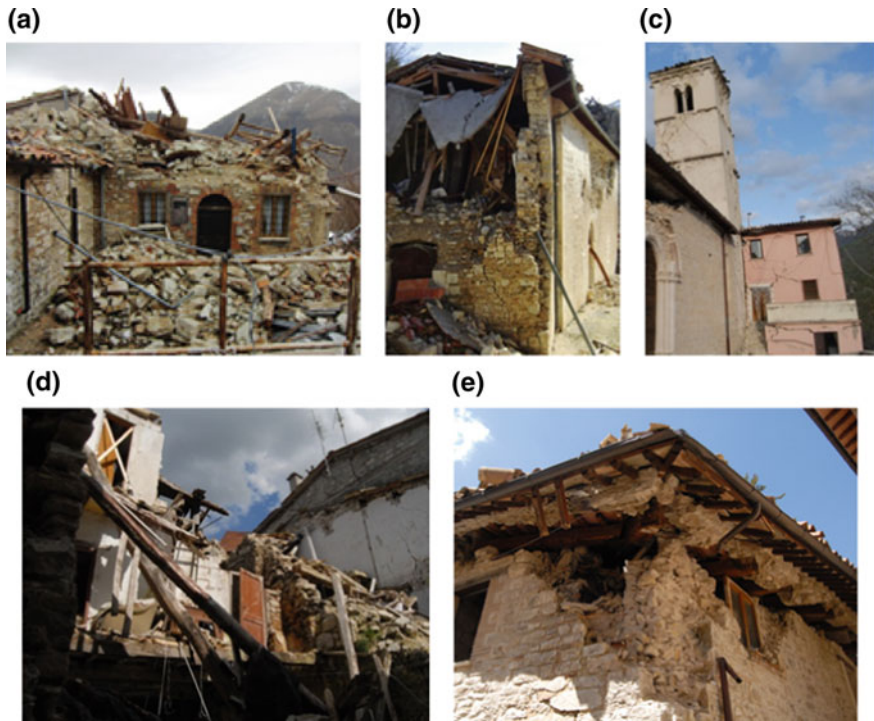
Unfortunately, 'mode 0' failure is a major problem. The supply of building materials near it greatly influences the quality of masonry, which ranges from including very poor sand and clay mortar with almost spherical sandstone rocks (Fig. 2b) to better-dressed limestone with pure lime mortar (Fig. 2a).

Fig. 2 Unfavorable behavior of masonry structures under seismic actions. Out-of-plane collapse (modes 0 and 1) due to poor-quality construction: **a** collapse due to poor-quality masonry (Gualdo, near Castelsantangelo sul Nera); **b** local collapse due to lack of connections in multi-layer masonry at corners (Castelsantangelo sul Nera); **c** pounding due to irregular interaction between house and contiguous bell-tower (Castelsantangelo sul Nera); **d** facade overturning in terraced house with original timber floors parallel to façade (Castelsantangelo sul Nera); **e** effect of thrusting roof resting on two-leaf masonry wall (Castelsantangelo sul Nera)

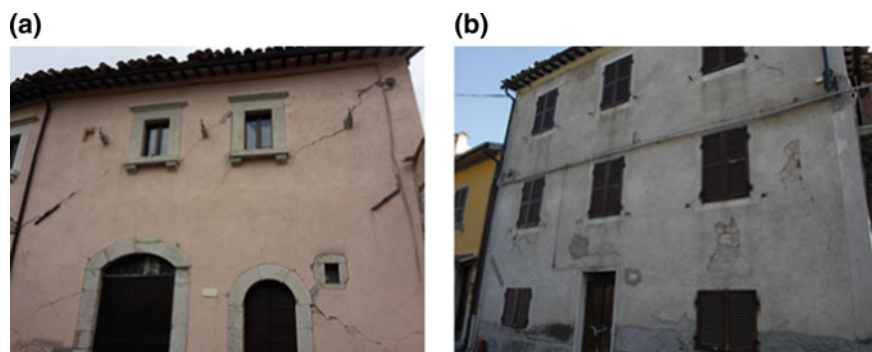
Fig. 3 Favorable behavior of masonry structures under seismic actions. In-plane damage limited to repairable elements without collapse (mode 2): shear failure mainly extensive in masonry piers **a** (Castelsantangelo sul Nera) and, more favorably, on lintels **b** (Pieve Torina, MC)

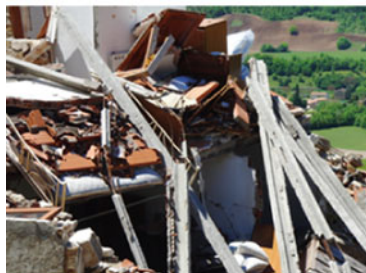
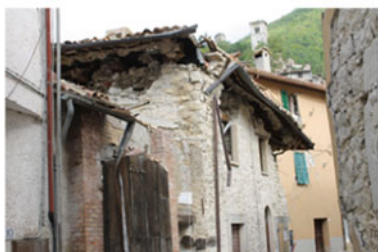
◀**Fig. 5** Damage caused by unfavorable interaction of existing masonry structures with retrofitting techniques: **a** corner overturning due to r.c. ring beams (Campi Alto di Norcia); **b** damage at interface between r.c. beams and masonry (Castelsantangelo sul Nera); **c** disaggregation of ancient masonry together with new masonry (Gualdo, near Castelsantangelo sul Nera); **d** unreinforced first-floor overturning under reinforced upper storeys (Campi Alto di Norcia); **e** collapse of jacketed multilayer masonry (Nocelleto, near Castelsantangelo sul Nera); **f** failure due to irregular distribution of r.c. jacketing (Castelluccio di Norcia); **g** shear failure in precast r.c. beams and consequent overall collapse due to lack of horizontal floor diaphragms (Campi Alto di Norcia); **h** partial collapse due to poor-quality masonry under heavy r.c. floors (Pretare, near Arquata del Tronto, AP); **i** overall (Castelluccio di Norcia) and **j** partial (Castelsantangelo sul Nera) collapse under heavy r.c. floors and roofs; **k** V-shaped overturning under r.c. ring beam, even in presence of anchoring rebars (Castelsantangelo sul Nera)

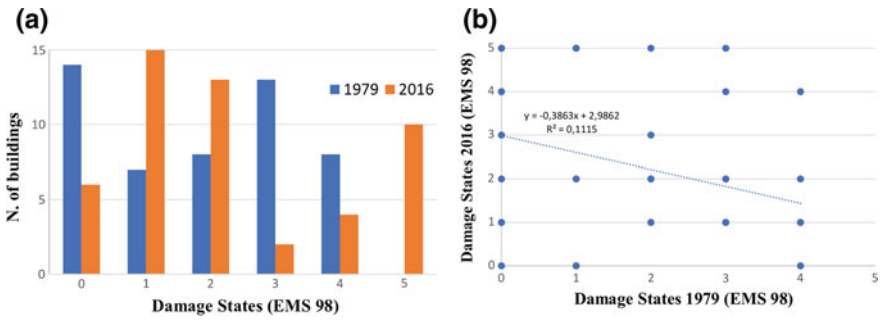
In particular, comparisons between the conditions and the damage scenarios surveyed after the 1979 and 2016 seismic events provide significant results in terms of evaluation of intervention effects. Figure 8 shows a considerable shift towards higher damage states in Campi Alto di Norcia: no cases of collapses can be found in 1979 and ‘medium’ damage (i.e., D3 category, according to EMS 98) involves much of the building stock. In 2016, damage state surveys show the opposite

Fig. 8 Campi Alto di Norcia, distribution of EMS 98 damage states in 1979 and 2016: **a** absolute frequencies; **b** correlation between them

behavior, as most buildings are listed either in EMS 98 classes D1-D2 (low or almost no damage) or D5 (collapse).

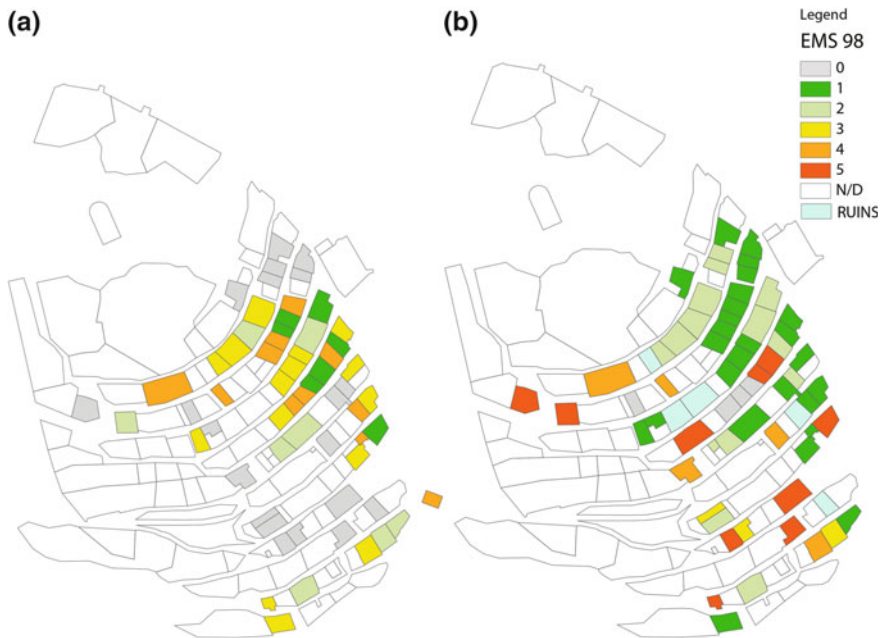
GIS mapping clearly shows that, for instance (Fig. 9), the buildings severely damaged in Campi Alto di Norcia in 1979 are now not damaged, and vice versa. On one hand, this means that retrofit interventions have been effective, whereas buildings with generic structural updating became more vulnerable than the previous states. On the other hand, effective interventions imply the complete transformation of the original architectural qualities of a building, because all components (wall, floors, roof) are involved in the strengthening process.

Fig. 9 Campi Alto di Norcia, comparison between EMS 98 damage level distributions after 1979 **a** [19] and 2016 **b** earthquakes in retrofitted buildings

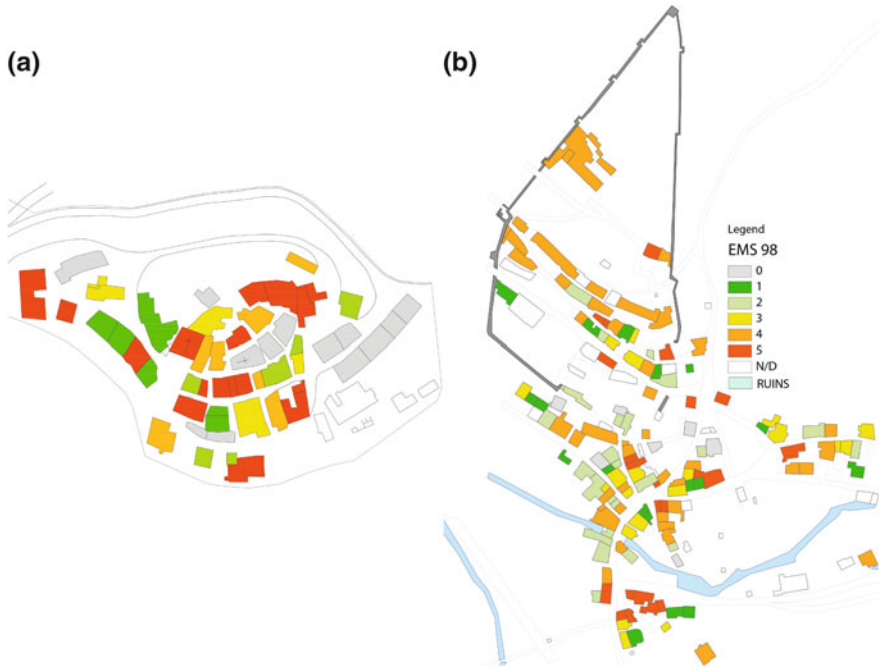
Fig. 10 EMS 98 damage level distributions in **a** Castelluccio di Norcia and **b** Castelsantangelo sul Nera after 2016 earthquakes

Also in Castelluccio di Norcia and Castelsantangelo sul Nera, for which no information about damage states after previous earthquakes is available, a certain shift towards higher EMS 98 damage states (D4-D5 compared to D2-D3) can be observed (Fig. 10). This trend may be an effect of the high number of partial ‘mode 1’ failures caused by interventions (mainly installations of r.c. ring beams and floors).
