The “Strange” Case of the Scorciavacche Failure

Abstract. Just after the completion of the upgrading works of the SS 121 national road connecting Palermo to Agrigento, in Sicily, the brand-new embankment linked to the northern abutment of the Scorciavacche viaduct suffered of two instabilities along the downhill side slope, causing the loss of two separate road segments of around 250 metres of total length. Early bird interpretation of the collapses ascribes the failures to a bearing capacity problem, consequence of the inadequacy of the embankment foundation. Surprisingly for the many actors on the scene, the subsequent forensic investigations have shown that the causes of the failure were different and not at all easily readable from the non-exhaustive observations of the initial scrutiny. Thorough geological and geotechnical investigations together with the monitoring of the site over a wide area made instead possible to discover clear signs of a quiescent instability which was bounded by a pre-existing failure surface that undoubtedly played a role in fixing the geometrical features of the collapses. The different picture of the scene that emerged after a careful geomorphologi

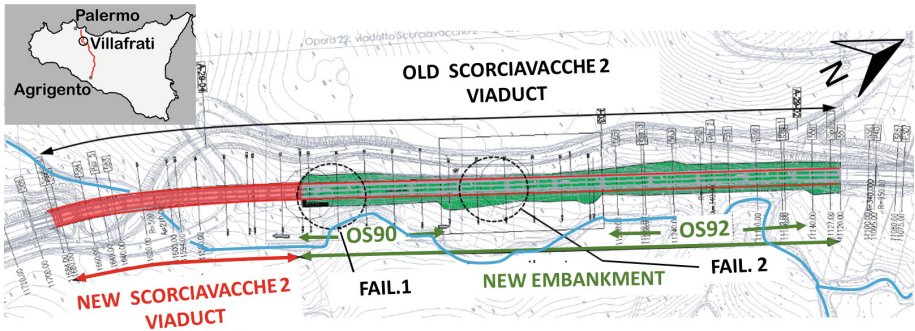
Fig. 1. Plan view of the embankment and positions of the two failure events

The construction works of the new road segment started in September 2014: the embankment was raised in stages, with layers of compacted crushed limestone; at the end of November 2014 the road pavement was completed. The road was opened to traffic on 23 December 2014. After six days, the first pavement sags were noticed in the area of OS90 and the damage worsened so rapidly that the following day, that is the 30 December, the road had to be closed. Three days later an evident scarp (about 1 m high) appeared on the pavement together with a bulge at the toe of the reinforced earth. The Failure 1 phenomenon, occurred where the reinforced earth reached its maximum height (about 9 m) and it was confined southward by the viaduct abutment.

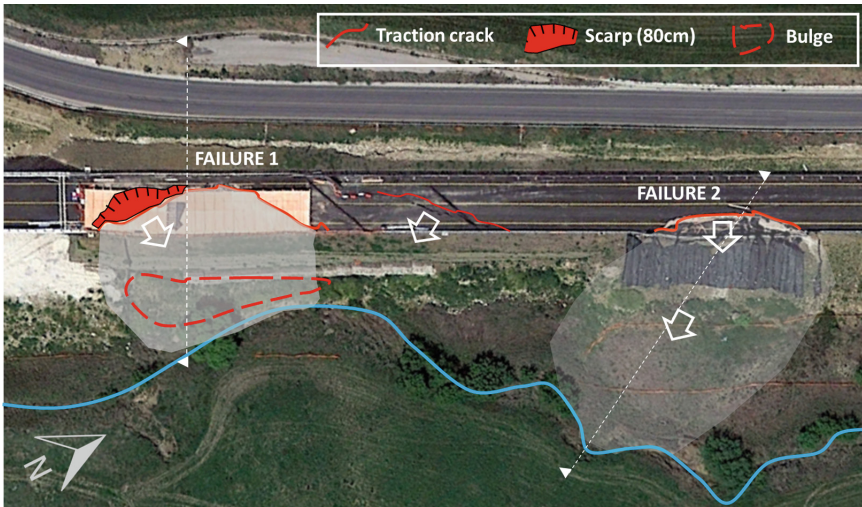
One month later, signs of a new failure phenomenon appeared on the pavement at chainage 110 m towards north; such new event fully developed in three days, so becoming the Failure 2. Figure 2 shows the main kinematic features of the two events on an aerial image of the area, that can be summarised as follows:

Failure 1:

- appearance of a scarp trench at the West side of the failure suggesting that the prevailing soil movements were towards East that is towards the stream at the toe of the embankment;
- planar rigid rotation of the reinforced earth close to the viaduct abutment;
- appearance of a traction fissure on the pavement, some tens of metres North side of the main failure, indicating a slight movement towards South-East of the embankment.

Failure 2:

- scarp at the crest of the mechanism very close to the upper limit of the embankment slope, thus suggesting that the failure surface is very shallow;

Fig. 2. Schematics of the instabilities drawn over the aerial image of the site.

- morphology of the ground, compatible with a movement towards South-East.

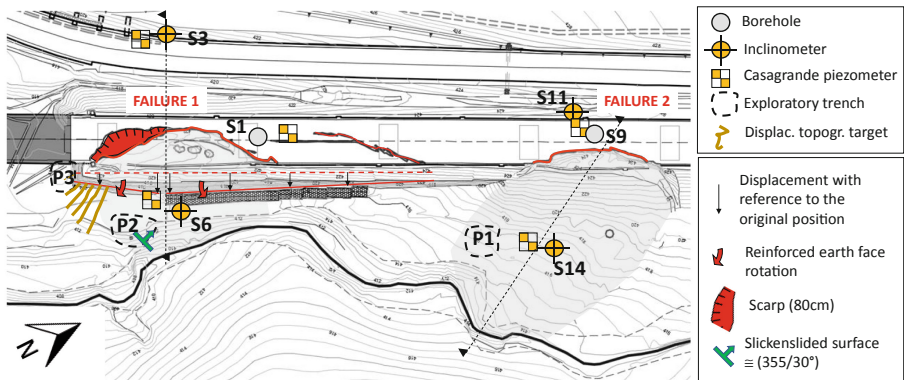
The geotechnical investigation plans consisted of several boreholes with undisturbed sampling, cone penetration tests (CPTu), exploratory trenches, plate load tests and geophysical surveys, as showed in Fig. 3. A monitoring of the site was also implemented with inclinometers, Casagrande piezometers and topographic benchmarks. Moreover, data from a series of topographic targets placed at the end of November 2014, soon after the embankment completion, on the reinforced earth close to the viaduct abutment were available during two time periods: one preceding and one following the first failure event (Fig. 3). As it will be clear in the following, the pre-failure topographic measurements resulted particularly significant to discover the key mechanism for Failure 1.

Fig. 3. Arrangement of the field investigation, displacement vectors and schematics of the two mechanisms

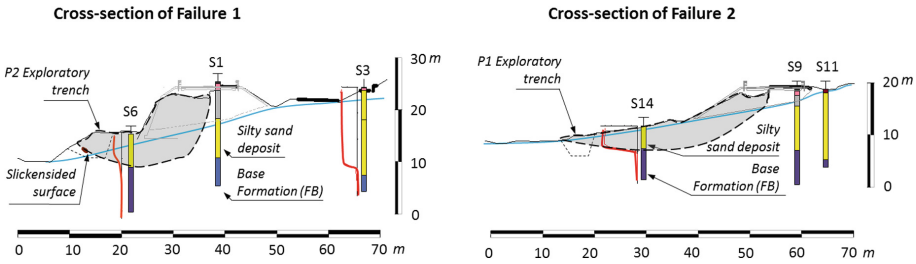
A schematic picture of the soil profile with groundwater heads from piezometers and deformation profiles from inclinometers are presented in Fig. 4 for the two failures. It is worth to note that the critical surface for both the collapses lies near the contact between the silty-sand deposit and the base formation.

Fig. 4. Cross section of Failure 1 (left) and Failure 2 (right).

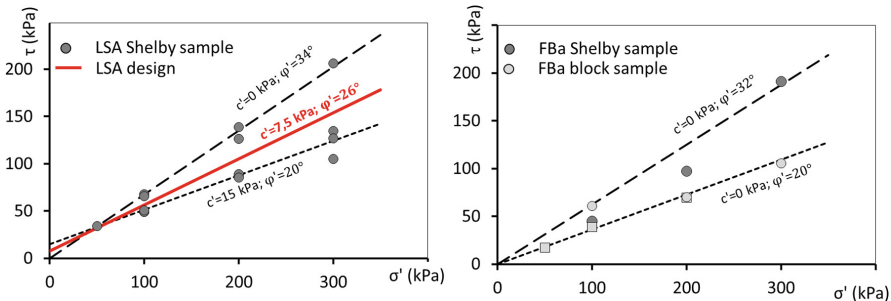
A band with higher natural water content was detected at the toe of the embankment across the contact between LSA and FBa where sliding is most probably localized. The fine fraction for both soils, LSA and FB, is of medium to low activity ($IA = 0.5-0.1$). To determine the effective strength parameters, direct shear and triaxial compression tests were carried out on undisturbed samples. Figure 5 shows the failure envelopes for the samples of LSA and FBa recovered during pre-trial investigation. The unit peak shear resistance shown by LSA samples appears sparse with samples from LSA-FB interface giving the lower values; it is however possible to draw upper and lower limit envelopes and observe that the design envelope falls in between those limits. The observed range of shear strength envelopes fit well with those obtained for design: the higher number of failure points close the lower envelope is justified because most of the samples were taken close to the slipping zone or to observed discontinuities.

Fig. 5. Effective strength envelopes for LSA and FBa samples recovered during pre-trial investigation

Only few samples from the Base Formation were available for direct shear testing, due to the limited interest for the investigated problem. Samples, belonging to FBa, gave ambiguous results: despite high stiffness and low void index resulting from the tests, shear strength parameters resulted closer to those expected for critical state or residual conditions, especially for samples recovered from the slickensided surface in P2. A plausible interpretation for this mechanical behaviour refers to the presence of pre-existing fissures in the samples: such planes may influence the strength according to their prevalent orientation, as documented in Calabresi e Manfredini (1973) for stiff jointed clays, in the same phenomenological framework of structurally complex formations.

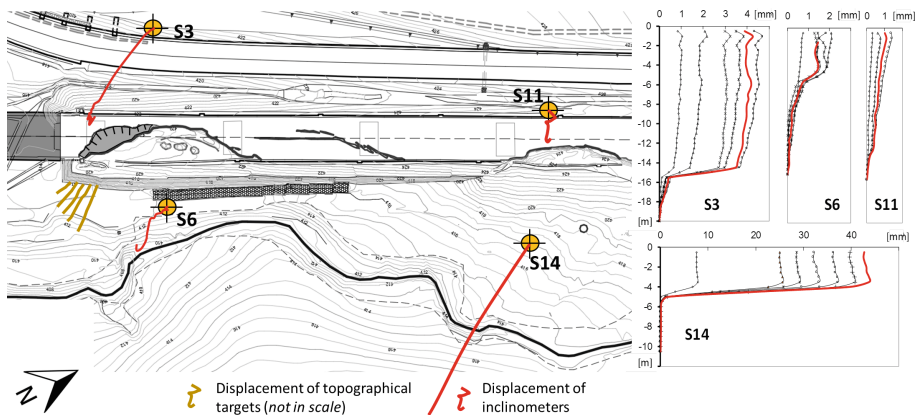
More interesting results were given by the monitoring activity. A map of the area with the polar representation of the magnified deformation measured by the inclinometers is shown in Fig. 6. Despite a relatively short monitoring period (4 to 5 months), which started ten months after the failure, three of the four inclinometers, S3, S6 and S14, gave a clear indication of the existence of a large movement, oriented in the direction 150–170°N, that included both the observed failures. Particularly meaningful were the readings of the inclinometer S3, located far away from the observed phenomena, showing clear signs of a sliding 16 m below the G.L. at the interface between LSA deposit and the base formation (FB).

Fig. 6. Monitoring of the displacements. Displacement vectors (left) and vertical profiles (right)

This finding greatly enlarged the scale of the problem and was interpreted as the indication of the presence of a specific weak layer, that is of a failure plane, along which a slide may have developed. From now on, the investigation perspectives were changed towards new interpretations of the observed mechanisms.

Results from the monitoring allowed to recognize the existence of a large mass movement with direction South-East in the site under investigation. This mass movement, possibly an old reactivated landslide, has at least interfered with, but very likely was the necessary precondition for the observed failure events. In fact this large movement easily explains the Failure 2 mechanism, whose kinematics is consistent with the geometrical features of the landslide. On the other hand, interpretation of Failure 1 is not straightforward, being the paroxysmal movement directed not accordingly to the landslide movement but orthogonally, towards the stream at the toe of the embankment, as it is demonstrated by the shape of the scarp at the top of the mechanism, that is close to the junction with the abutment. What makes awkward the interpretation of Failure 1, is the rotation of the azimuth of the displacement vector towards South-East which was observed after failure. Such direction of the displacements is coherent with the pattern of fissures appeared on the road pavement and above all with the displacements of the targets placed on the earth-reinforced wall that gave signs of an incipient failure accordingly to the kinematics features of the old landslide. All the above evidences suggest that Failure 1 was favoured by the pre-existence of a weak surface associated with the general hillside movement, but apparent movements were initially different, as they were conditioned by the local morphology, that is the presence of the stream at the toe of the embankment.
