Multidisciplinary Documentation Using Non-destructive Testing Techniques for the Diagnostic Study of an Ancient Temple

Abstract. In this work, an approach regarding the representation of a monument in combination with building material documentation information (deriving from non-destructive techniques) is presented. Through this approach, data incorporating architectural, surveying and building material documentation information are aggregated with the 3D documentation model, leading to valuable information regarding the preservation state of a monument. The illustration of the Pythian Apollo ancient temple, located in the Ancient Acropolis of Rhodes, Greece, aims to highlight the manner in which the fusion of multilayered information can contribute to the diagnostic study of a monument, ultimately leading to its sustainable protection through time. Information deriving from the three dimensional documentation of the monument is enriched with information deriving from non-destructive techniques (Ground Penetrating Radar, Infrared Thermography, Digital Microscopy) in combination with historical and architectural data and in-situ visual inspection observations. In addition, informa

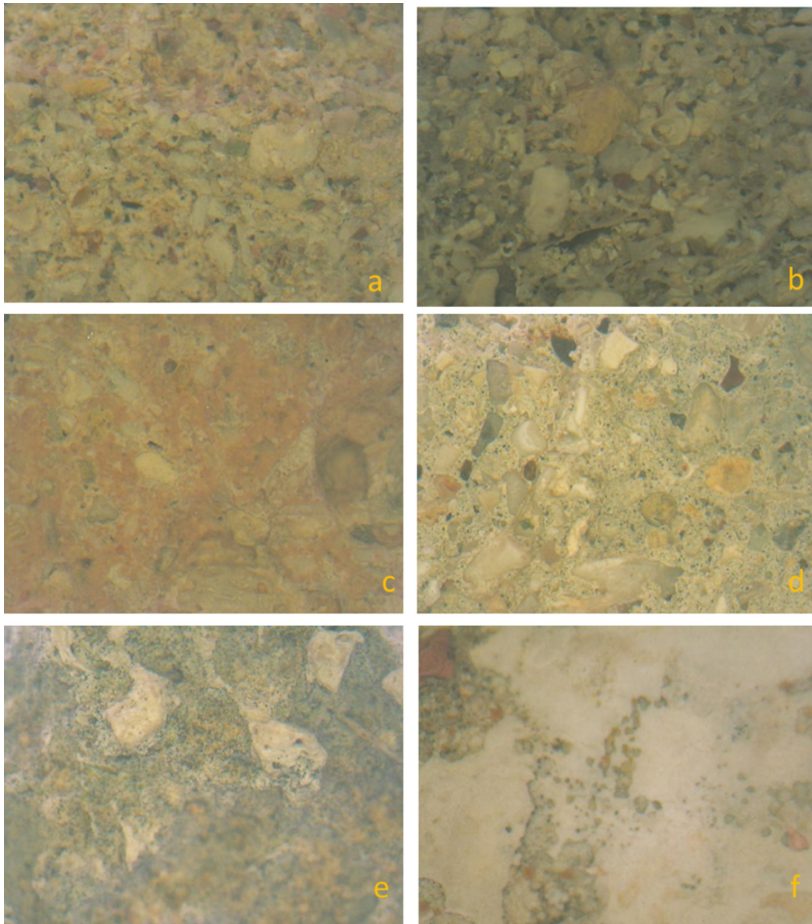
Fig. 9. Digital Microscopy images: (a) ancient stone (x30); (b) stone granular disintegration (x30); (c) plaster (x30); binding material (cement) (x30); dark grey area presenting biodeterioration (x30); white lichen decay (x30).

stone. The measurements were applied per column and per every 10 cm vertically. The most coherent surface of the shaft was selected for this investigation. During measurements the average ambient temperature was 26.3 °C, while the relative humidity was 58.3%. No specific conclusions could be drawn from the flow of moisture in the column body due to a great anisotropy resulting from the use of incompatible materials during the restoration process of the monument and the major and in-depth decay of its materials (Fig. 9).

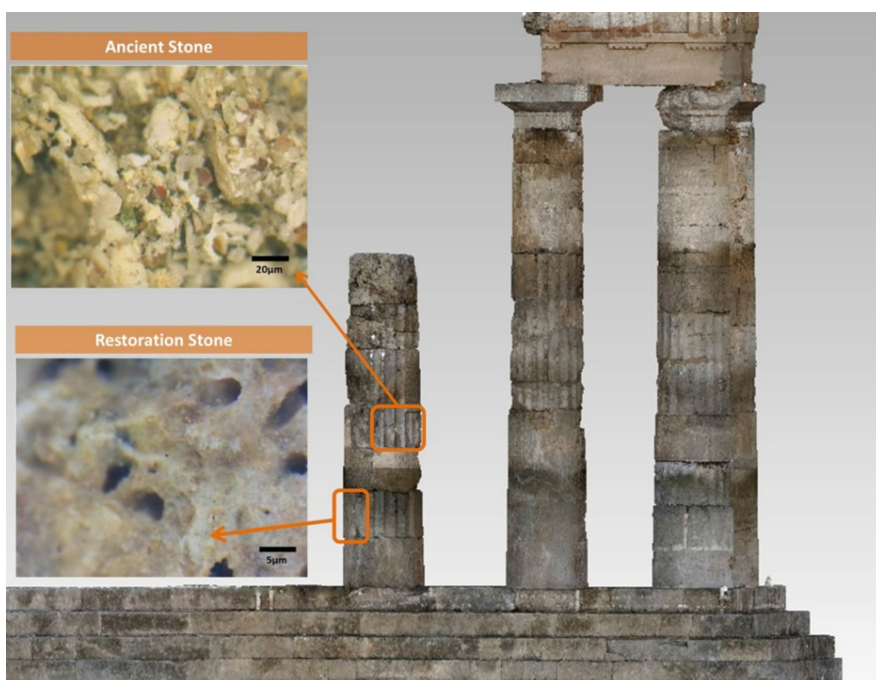
Fig. 10. Geolocation of the DM measurements; Up – Ancient dark orange color stone (30x); Down - Dark brown orange decay on biocalcarenite restoration stone (120x).

regarding their state of preservation. More specifically, concerning the ancient stone, the sample presented no consistency since it was disintegrated and fragile. Micro fissures and holes were observed. Green biodegradation prevailed in the sample. There were quite a few aggregates of different colors, shapes and sizes and agglomerated shells were observed on the body of the stone. As far as the restoration stone, located in the same area with the same orientation, presented different characteristics than the ancient stone. More specifically, the sample was compact and coherent. Externally showed a darker shade and black biodegradation prevailed. Malignances and holes were observed. From the resulting images of the DM technique, additional information regarding the restoration building materials and their state of preservation can be obtained. In Fig. 11, DM images from the K3 column, located in the west façade of the monument, presented restoration cement mortar, which was coherent and compact. The same applies for the plaster located in the same area, which presented coherence and decay patterns were not evident.

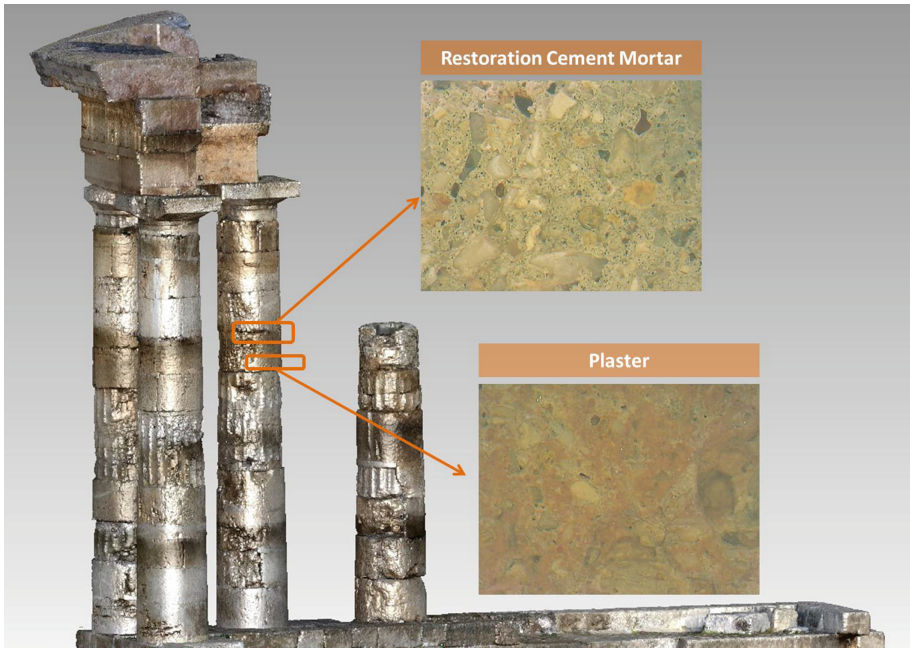
Fig. 11. Geolocation of the DM measurements in the K3 column. Up: Restoration Cement Mortar (30x); Down: Plaster (30x).

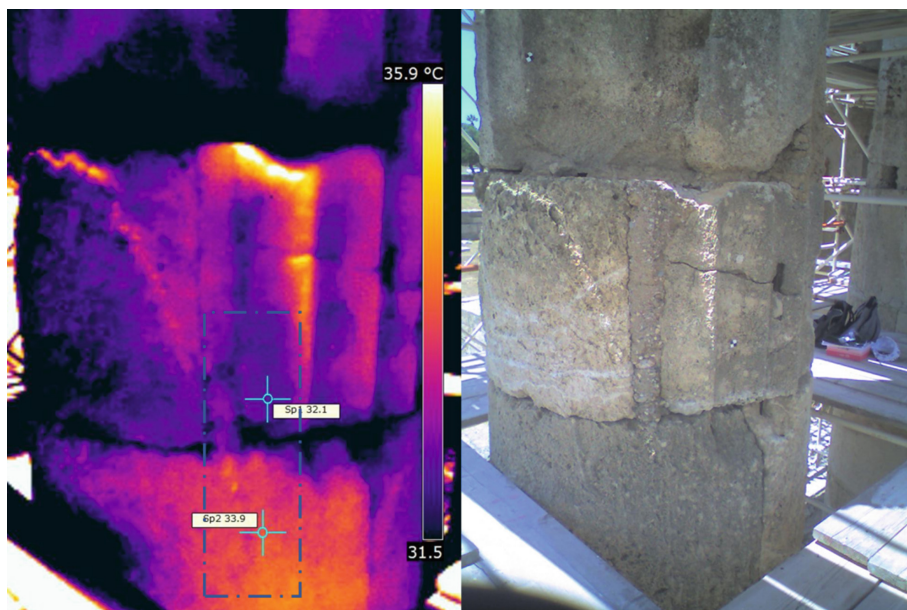
Fig. 12. Lower temperatures are indicative of the ancient stone.

evident. Specifically, the ancient stone presented lower values of temperature than the restoration stone, located in the same level of the column and having the same orientation in regards to other external environmental conditions (Fig. 12).

The breaches of the stones are noted with lower temperature at the thermal maps (Figs. 12 and 13) by contrast the edges of the shaft were noted to present higher surface temperatures than the rest of the round area of the shaft in the thermographs (Fig. 14).

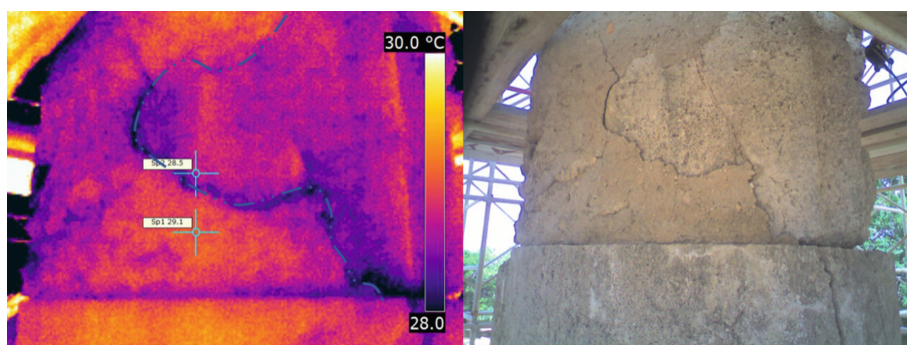
Fig. 13. Incompatibility due to different temperatures observed between restoration cement mortar and ancient stone.

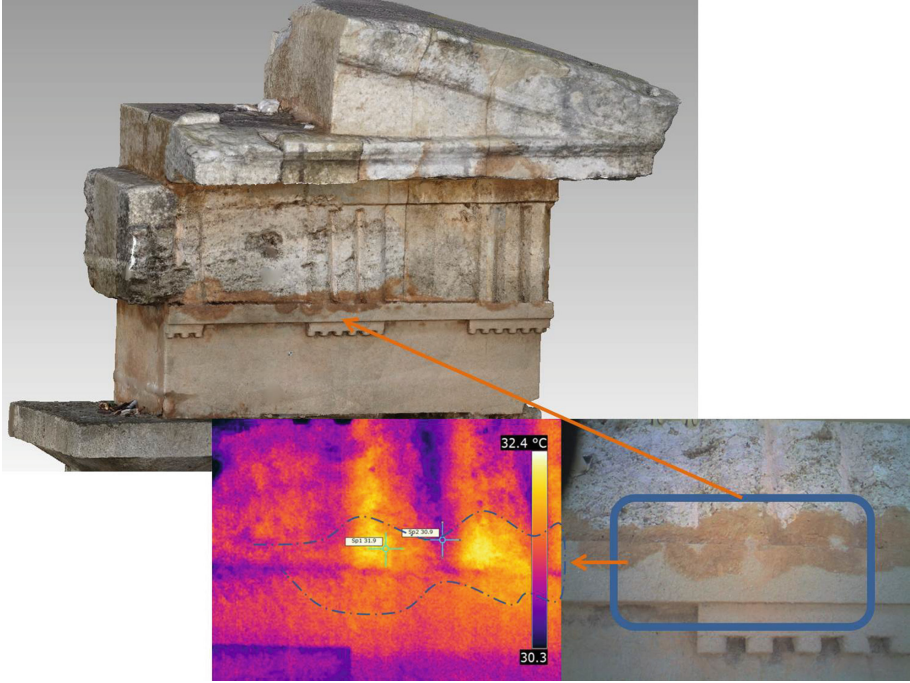
Fig. 14. Thermal incompatibility between restoration cement mortar and ancient plaster.

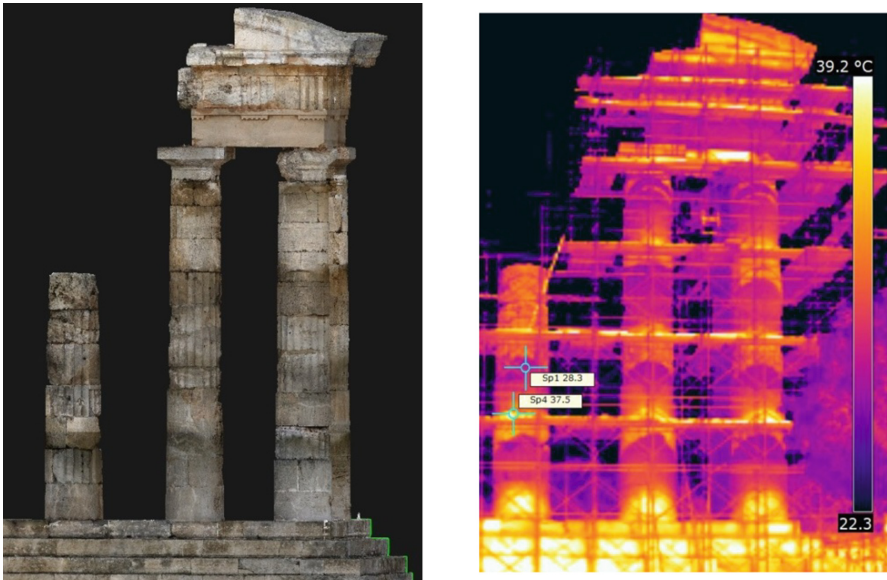
Fig. 15. Anisotropic heating is created by the scaffolding surrounding the monument.

Anisotropic heating is caused by the scaffolding surrounding the monument (Fig. 15) in addition to the physical and chemical incompatibility of the materials. In conclusion, a non-uniform mechanical stress distribution was created from the anisotropic heating and thermal allocations resulting in failure of the construction materials.

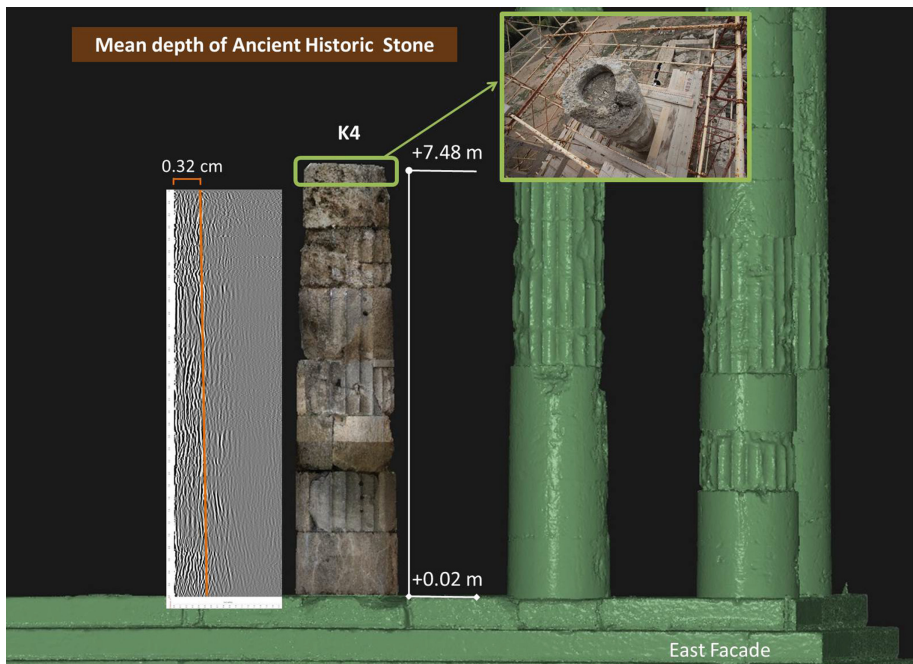
In addition, for all the columns, inspection of the structural formation of the Temple was performed through the use of the Ground Penetrating Radar. For column K4, the results deriving from the GPR interpretation, indicate that there is a mean depth for all the shafts, of the ancient/authentic stone of 0.32 cm. In total, seven vertical scans are deployed in the four columns and the outcome of the GPR interpretation indicates that the mean depth of all building materials that correspond as the exterior layer of the columns is 0.32 m (Fig. 16). This information from the scans was correlated with information from historical and architectural documentation and the results provide validation to the historical documentation regarding the restoration project by the Italian Archaeological Services. It is evident that, for the restoration project, the ancient stones were carved, so that a cement core could be embedded to the external stone structure.

Fig. 16. GPR scan of the column K4, indicating the depth of the Ancient Material as illustrated for all the shafts of the column.
