Pre-diagnosis Protocol for Large Residential Building Stock. The Case of Barcelona's Vulnerable Areas

C. Cornadó, S. Vima-Grau, and P. Garcia-Almirall

Keywords Refurbishment · Building assessment · Housing refurbishment · Pre-diagnosis protocol

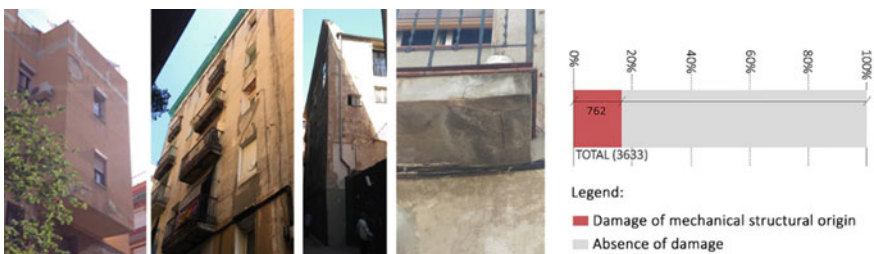
This type of damage (Fig. 12) was observed in 13% of the cases, with different levels of risk according to its impact on the overall structural system or to the severity of rather localized damage.

A considerable percentage of cracks in façade walls were horizontal or slightly inclined and were found at the point of contact between the roof slabs and the façade. Thus, they can be attributed to the fact that the roof slab has different hygrothermal behavior, and expands more during the summer, which causes considerable thrusts to the façade’s continuous wall. In cases in which façades are bearing walls subject to compressive stress, some vertical or 45° cracks were observed around window or door lintels. Another commonly observed type of damage was found in balcony slabs, where we observed cracks that could mostly be associated with corrosion of metal reinforcements. This very common damage, especially when it appears to be widespread in the building, was particularly severe in many cases. In only a very few cases, we could observe either a pattern of vertical continuous cracks in bearing façades subject to compression stress or a clear pattern of inclined cracks that can be associated with the wrong behavior of the foundations or the terrain causing differential settlements. In addition, the amount of observed buckling of façade bearing walls is very low, and in most cases some kind of repair had already taken place.

Fig. 12 Presence of damage of mechanical and structural origin and percentage within the total sample

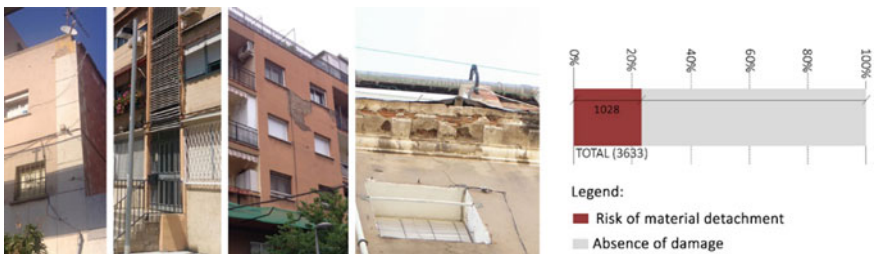
Finally, the risk of material detachment has been observed in many cases in cornice elements affected by other damage such as dampness, cracks or even plant growth (Fig. 13).

Fig. 13 Presence of unstable façade elements and risk of material detachment and percentage within the total sample

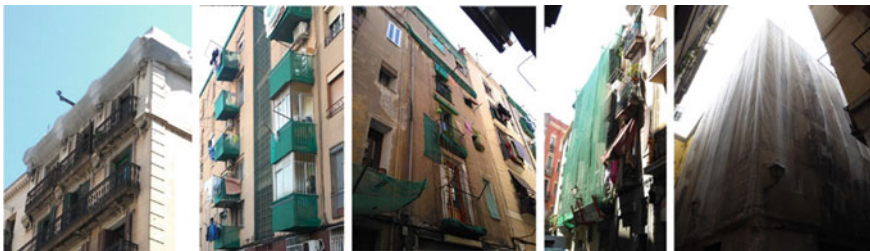
In contrast with the high percentage of damage of considerable severity, prevention measures (Fig. 14) were only found in 5% of cases. Sometimes, they were associated with localized damage (a balcony, a part of the façade or the cornice), sometimes they were widespread and affected many elements of the building skin or even the

Fig. 14 Buildings with prevention measures applied

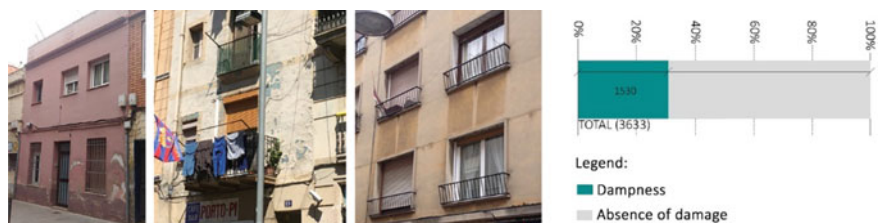
Fig. 15 Presence of dampness and percentage within the total sample

Dampness is the most common type of damage that affected 30% of the studied buildings (Fig. 15) and is usually linked to corrosion of metal elements, stains and dirt, or even risks of material detachment and cracks, which generally damage elements or parts of the building.

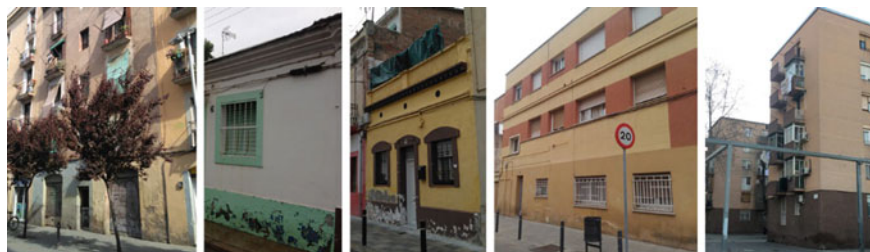
A first group of dampness damage was observed in the base of the façade and interior walls as rising damp due to capillarity (Fig. 16). Basement continuous claddings usually have dirt, stains or detachments because of rising damp, and discontinuous claddings tend to detach. Wall materials such as mud, stone masonry or brick masonry are usually affected with considerable intensity up to 1 m, with salt crystallization and dissolution of joint material such as lime mortar.

Fig. 16 Cases of rising damp due to capillarity

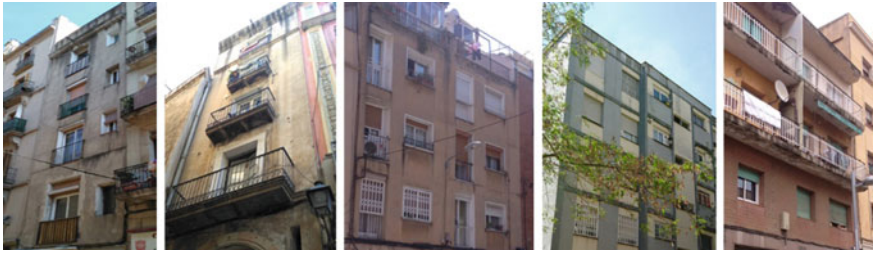
In addition, some dampness damage was observed in locations that are exposed to rainwater leaking, such as cornices, balconies and elements in contact with openings (especially the walls of interior courtyards) (Fig. 17). In the case of cornices, the presence of discontinuous cladding or irregularities in material such as decorative elements, material alterations or cracks contributes to a greater impact in the presence of water leaks. Humidity is very common on the lower side of balcony slabs, while its severity increases to the degree that it affects metal reinforcements.

Fig. 17 Buildings with cornices, balconies and sills in poor condition

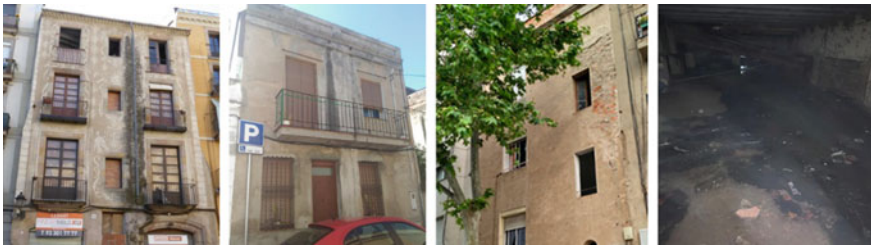
Fig. 18 Examples of water filtrations from interior services or water installations

Finally, some other types of dampness damage were observed at points of the façade in relation to possible water filtrations from interior services or water installations (rainwater or wastewater downspouts or water facilities) (Fig. 18).

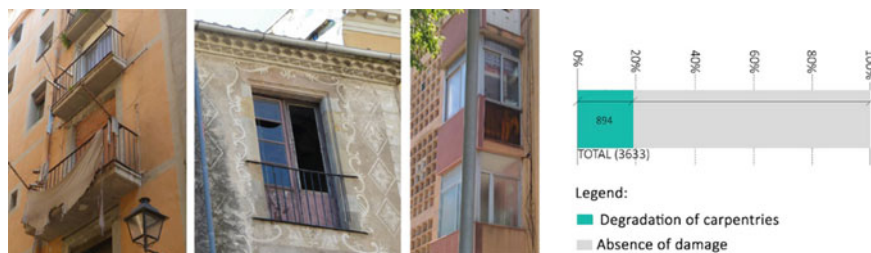
A considerable number of buildings have severe observable deficiencies in the openings (Fig. 19). In some cases, the corresponding dwellings are empty. This was the case of bricked-up or blocked openings, and windows without any kind of glass or carpentry enclosure. There were also some cases of dwellings with signs of occupancy and serious damage too, such as windows with some broken glass, without glass enclosures, or very degraded woodwork. Nevertheless, in most cases it could be seen that the carpentry had not been renovated, the woodwork was degraded and the glass was single pane.

Fig. 19 Examples of deficiencies in the openings and percentage within the total sample

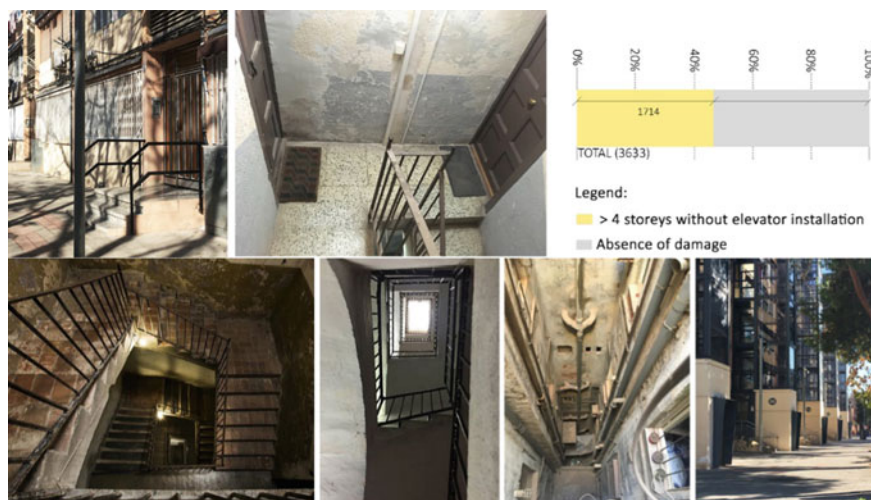
As explained in the previous section, several deficiencies in accessibility (CTE 2018) within floors and accesses were widespread among the studied buildings (Fig. 20). Corridors and accesses to the dwellings as well as vestibules and access doors are not big enough. In addition, generally there are one or two steps at the exterior entrance to the building. In some cases, there are over five steps.

These shortcomings are widespread and affect almost the entire sample. Figure 20 includes only cases of considerable height (buildings over four stories) in which a lack of vertical accessibility (no elevator installation) is combined with the rest of the accessibility deficiencies. With a percentage of over 45% of cases, the lack of an elevator when it is needed is by far the most common shortfall in the building stock. In some cases, when the inner dimensions of the staircase or the courtyards are big

Fig. 20 Deficiencies in accessibility and percentage of 4 or more story buildings without elevator within the total sample

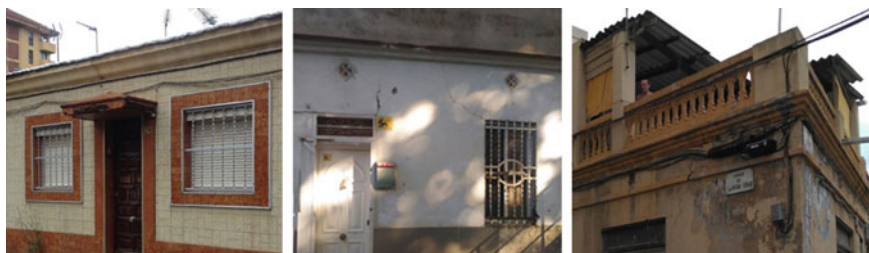
Fig. 24 Cracks in cornices and lintels in type 1 buildings

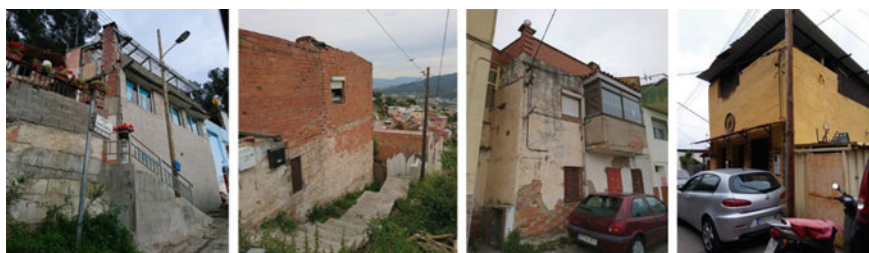
In the case of Torre Baró (Type 3), the observed deficiencies were much varied, and differed between considerable structural deficits in precarious self-constructions to other less relevant cracks in bearing walls around window or door lintels (Fig. 25). This combination of damage characterized, to a lesser extent, other areas with the same construction building types (Roquetes and Vallbona, Type 3).

Fig. 25 Damage in type 3 buildings

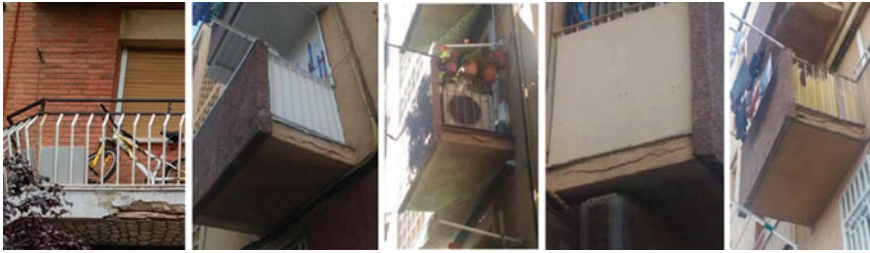
Cracks observed in high linear block buildings in El Besòs (Type 4) were associated with old, mostly repaired serious damage in bearing walls with insufficient foundations (Díaz 1954), and other currently ongoing problems associated with deterioration in balconies and other slab elements built with aluminous cement (Fig. 26). Even though El Besòs was very specific for this problem, similar concrete pathology and damage associated with the deterioration of balcony slabs were observed in both

Fig. 26 Damage in balcony slabs

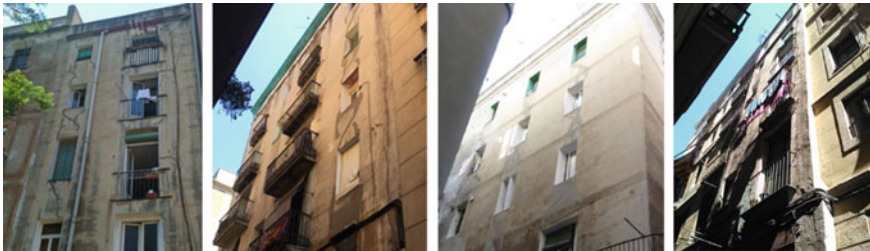
Finally, observed damage in El Barri Gòtic (Type 1) (Fig. 27) differed from processes of buckling of load bearing façade walls that had mostly been repaired, cracks around window and door lintels, cracks in balcony slabs due to the corrosion

Fig. 27 Cracks and damage in load bearing façades

of metal elements and, in occasional cases, widespread structural damage observable with cracks that affected the whole length of the façade. Similar damage was observed in El Raval and other construction buildings of Type 1, with the exception of façade buckling that was more specific to El Barri Gotic, where buildings are older.

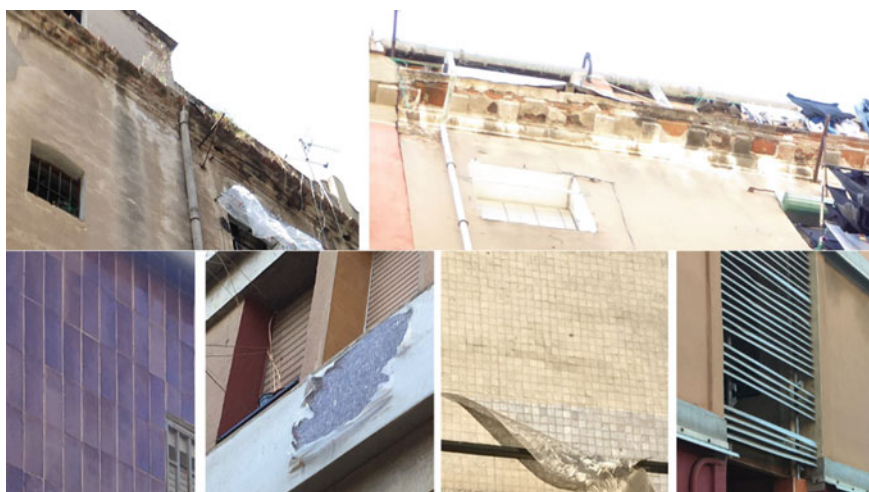
Secondly, unstable elements (Figs. 28 and 29) were observed in much more variable proportions among the neighborhoods (between 20 and 60%). Trinitat Nova was a distinctive case in which there was a very high percentage of buildings with unstable elements in the façade. This damage was greater in neighborhoods where Type 1 and Type 2 are predominant. In the first (Type 1), damage was mainly observed in balconies, cornices and continuous cladding, while in buildings from Type 2, these types of damage mostly appeared in façade plating and other elements besides balconies, and was similar to the observed damage in Trinitat Nova and linear blocks in El Besòs (Type 4). Curiously, in neighborhoods where Type 3 buildings are predominant, the amount of damage was considerably lower (Roquetes, Vallbona, and relatively low in Torre Baró).

Fig. 29 Material detachment in façades

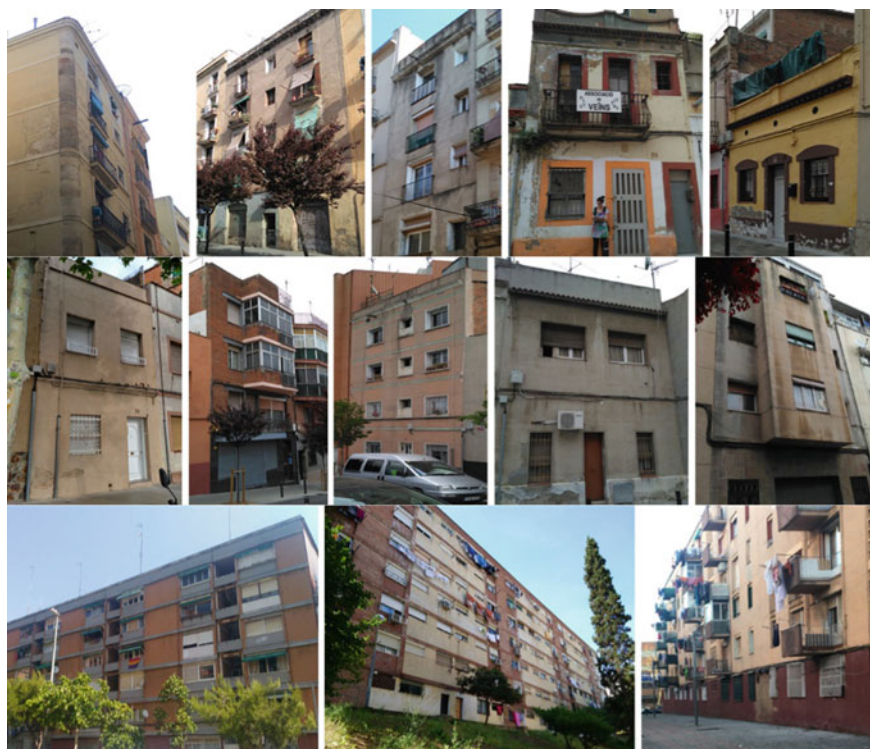
Other neighborhoods have significant percentages of damage, at around 40%, regardless of the building construction type (Types 1, 2 and 4) (Fig. 31). The concentration of damage in El Bon Pastor was, once again, specific to the ‘Cases Barates’ area.

Fig. 31 Damage due to dampness observed in façades. Buildings of Type 1, Type 2 and Type 4

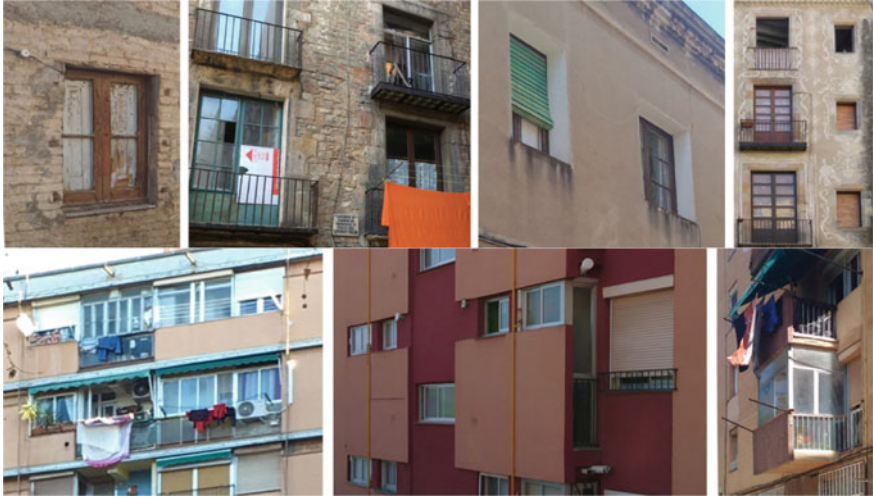
Regarding damage to carpentry and woodwork (Figs. 32 and 33), the percentages were considerably higher in Type 1 buildings (El Raval, El Barri Gòtic and La Marina de Port), mostly due to aging and deformation of woodwork. Percentages were also high in some neighborhoods characterized by Type 2 buildings (Trinitat Vella) and 4 (Ciutat Meridiana), where the carpentry is mostly old aluminum frames, sometimes with deteriorated sliding windows containing single-pane or non-transparent glass.

Fig. 33 Damage to carpentry and woodwork in buildings of Type 1 and Type 2 and 4

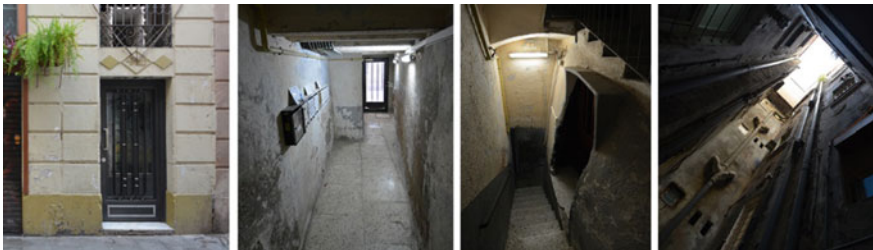
The highest percentages were observed in the historical neighborhoods of El Raval and El Gòtic, with Type 1 buildings in which the installation of elevators is extremely complex due to the small dimension of inner courtyards and staircases (Fig. 35), but the buildings are higher than 4 stories.

Fig. 35 Accessibility deficiencies in buildings of Type 1, in El Raval neighborhood

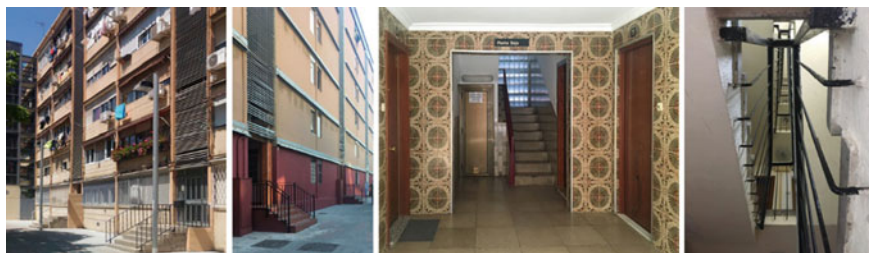
This problem is also common in large housing estates (Type 4), although in these cases it usually affects only linear block buildings, while tower blocks and other higher buildings usually have elevators installed at the time of construction. This explains the small percentage of deficiencies in El Besòs, where the coexistence of different typologies (higher blocks with elevators, lower blocks with no elevators and single family houses) distorts the relevance of the number of dwellings with no elevator access (a percentage that would be more similar to that of Ciutat Meridiana) (Fig. 36).

Fig. 36 Accessibility deficiencies in linear blocks of Type 4, in El Besòs neighborhood
