Remote Sensing and Integrated Geophysical Investigations of Unstable Sections of Ibadan-Iwo-Osogbo Highway, Southwestern Nigeria

Abstract High records of road accidents due to bad roads and failure of other engineering structures globally have necessitated this study. Geophysical investigation was carried out on six failed sections and two stable ones along the Ibadan-Iwo-Osogbo highway to examine the geological factors responsible for the highway failure in the area. A Landsat ETM⁺ (Enhanced Thematic Mapper Plus) imagery of the study area and its environs was acquired and processed for lineament analyses. Magnetic and Very Low Frequency Electromagnetic (VLF-EM) measurements were taken at a 5 m interval along each traverse established parallel to road pavements. The electrical resistivity method involving Schlumberger Vertical Electrical Sounding (VES) and 2-D imaging using the dipole–dipole array were utilized. Lineaments were identified across failed localities. Lateral magnetic variations in the near-surface, geologic materials characterized the study area. The generated 2-D VLF-EM models showed conductive zones corresponding to the fractured zones or conductive clay materials

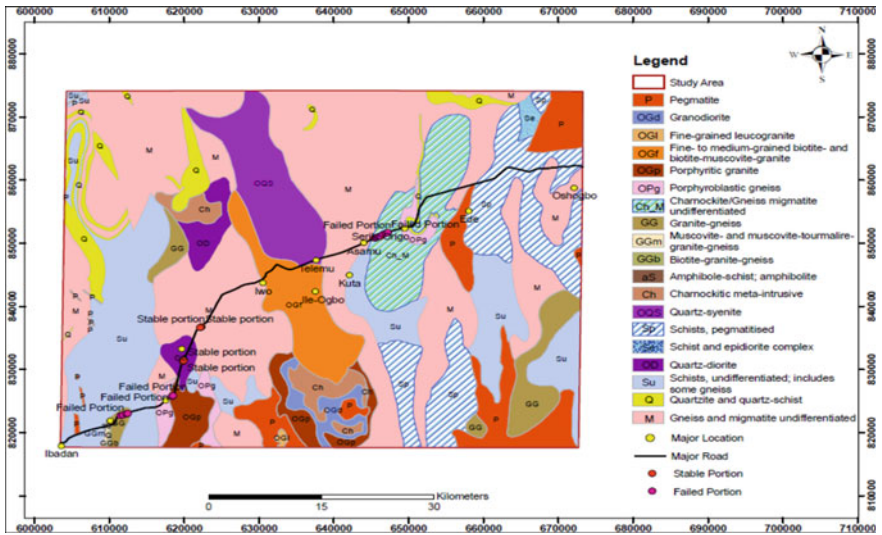
Fig. 1 Geological map of the area around the Ibadan-Iwo-Oshogbo Highway showing the failed and stable sections of the road

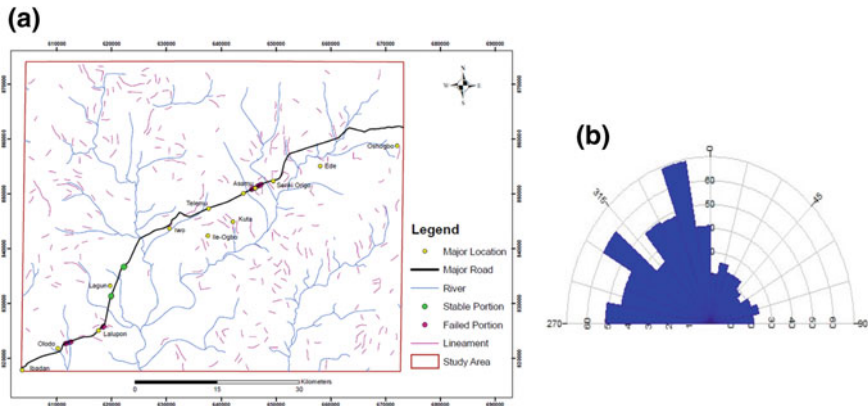
Fig. 2 a Lineament map of the study area, b rose diagram showing the lineament trends

Lineaments are assumed to reflect a subsurface phenomenon and can generally be equated with structural elements such as folds, fractures, faults, and joints [3]. Figure 2a shows the lineament map of the study area. Four major structural trends are represented in the area. One set of the lineament trends N–S direction, the second NNW–SSE, the third E–W, and the fourth NW–SE Fig. 2b. It is suspected that such linear features may be among the factors responsible for the continuous failure of the failed sections of the highway.

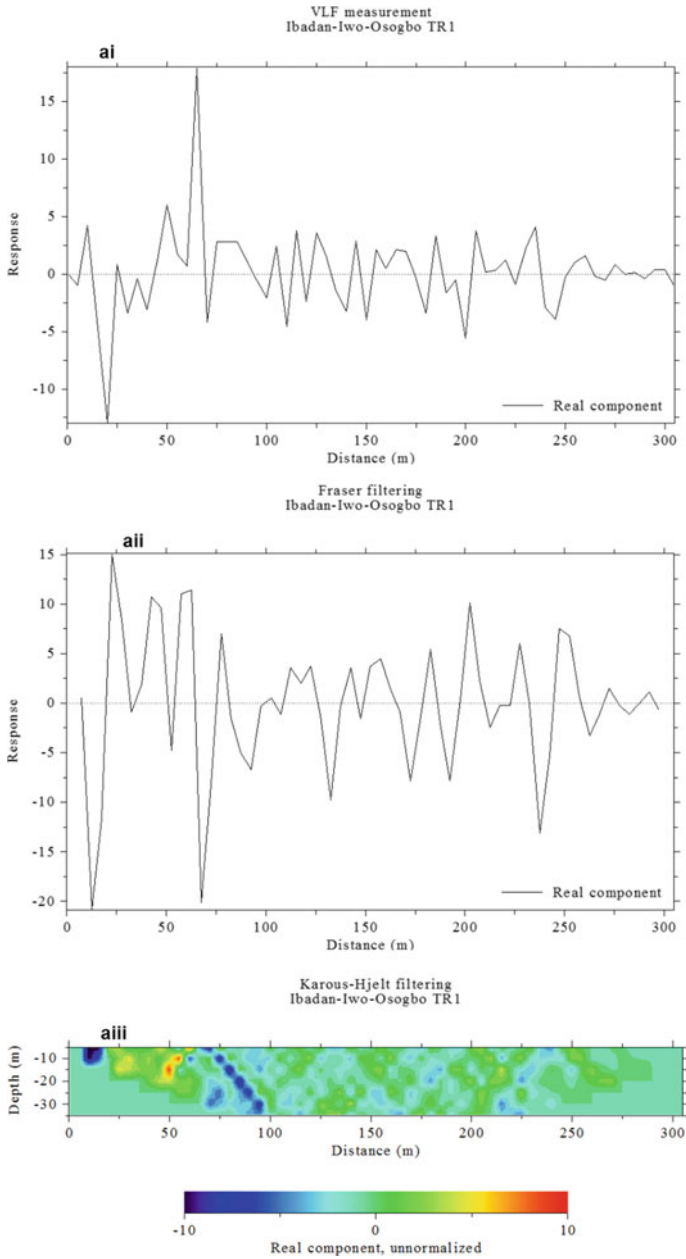
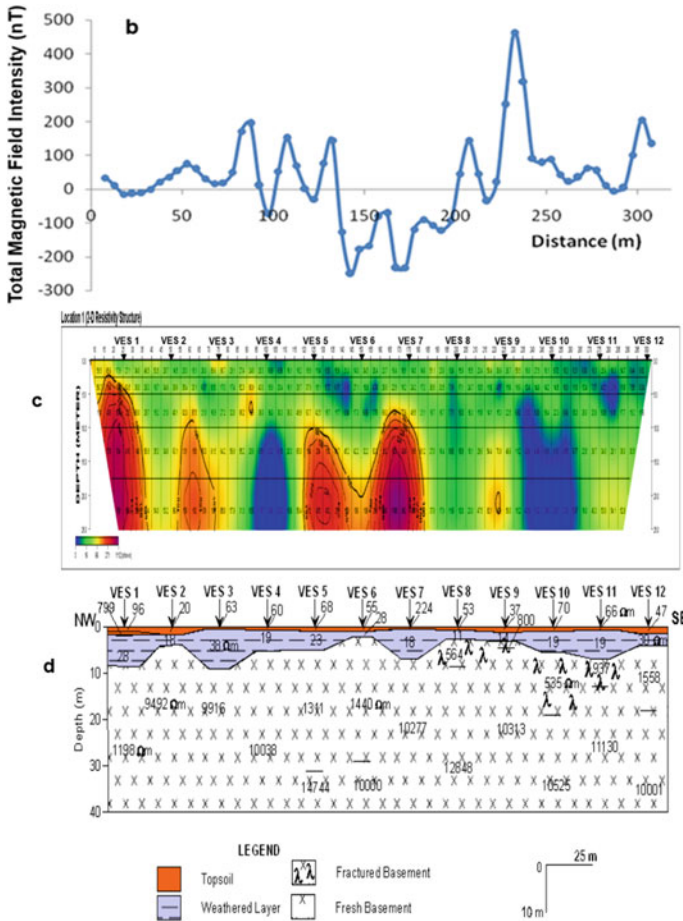
The failed sections show multiple peaks, positive filtered real anomalies that may have arisen from the inhomogeneous nature of the near-surface rock boulder used during previous rehabilitation works. The low amplitude (generally <15) filtered real anomalies on the 2-D model as patches of relatively poorly conductive features between 25 and 75 m; 175 and 225 m; and around 250 m Fig. 3a. The magnetic anomalies are located between 50 and 80 m, 160 and 200 m; and 250 and 300 m. The anomalies are generally typical of thick dykes (Fig. 3b). The causative bodies are generally of a significant width extent. These magnetic variations in the subsoil materials that underlie the study area have varying bearing capacities and thus may

Fig. 3 **a** Typical electromagnetic VLF-EM profiles beneath the failed sections of the Ibadan-Iwo-Osogbo highway (i) real component (ii) filtered real component (iii) model. **b** Typical total magnetic field intensity profile, **c** 2-D subsurface resistivity structure and **d** geoelectric section along a failed section

result in an unequal yielding capacity to the weight of structures that lie on it, hence, the failure that characterized the area. The magnetic anomaly zones correlate significantly with the EM-VLF anomalous zones along the failed section. The 2-D dipole-dipole resistivity structure shows that the overburden is generally thick (>5 m) in all places, except between the distance of 0 and 30 m. It, however, identifies near vertical/vertical low resistivity features having a depth extent of up to 20 m, typical of lineaments/fractures and buried channels with surface expressions at 35–50 m; 75–120 m; and 175–300 m from the Ibadan end of the section (Fig. 3c). The failed section is characterized by four geoelectric layers. These include the topsoil, the weathered layer, the fractured basement, and the crystalline basement rock. The weathered layer resistivity values range between 11 and 38 Ωm and the thickness ranges from 1.2 to

9.0 m (Fig. 3d). These low resistivity values observed beneath this unstable section are typical of clayey material.

A combined view of the results shows that the instability of the road pavement along the failed sections of the road is probably precipitated by the presence of low resistive weathered layer materials, subsurface geological structures, absence of a drainage network and of runoff, and poor construction practices.
