Building Pathology and Rehabilitation

J. M. P. Q. Delgado *Editor*

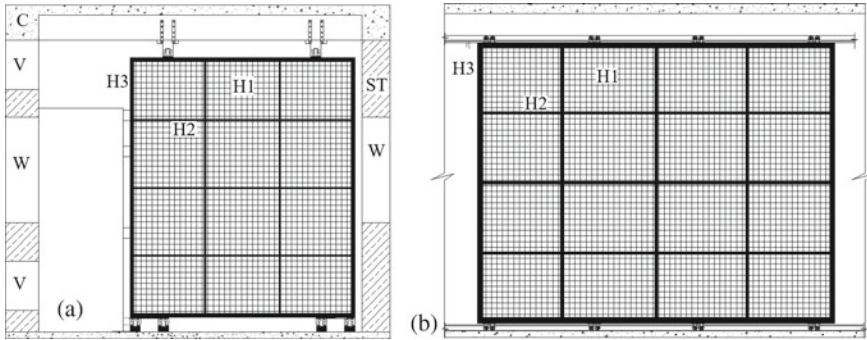
**Fig. 7** **a** Design of mobile art compactors painting shelving system and **b** design of sliding art shelving system (C-Concrete, V-Ventilator, W-Window, ST-Stone Masonry, H1-Mesh, H2-Internal Load Member and H3-Main Frame)

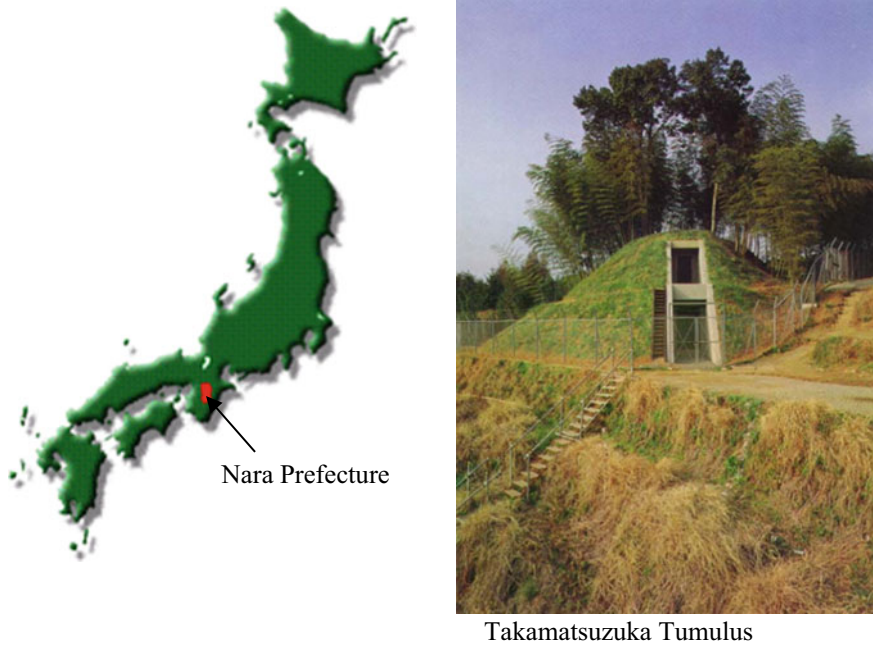
**Fig. 1** Position of Nara Prefecture and Takamatsuzuka Tumulus

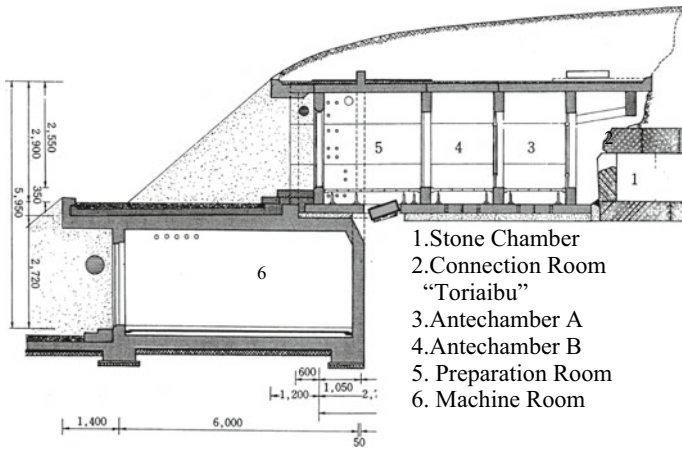
Fig. 2 Section of the conservation facility [1]

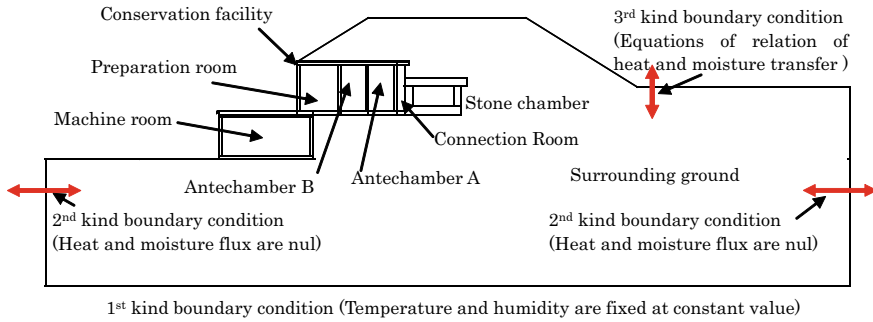
Fig. 4 Schematic diagram for analysis

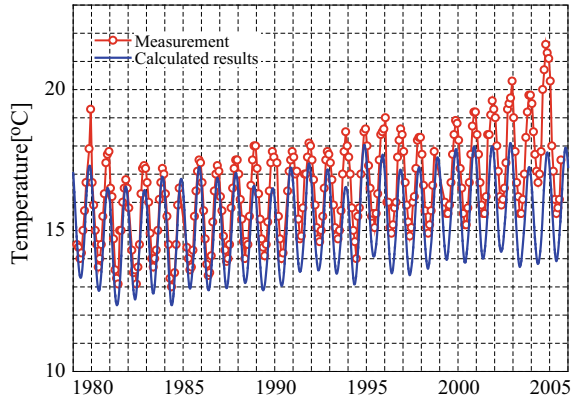
**5.1.2 Results and Discussions**

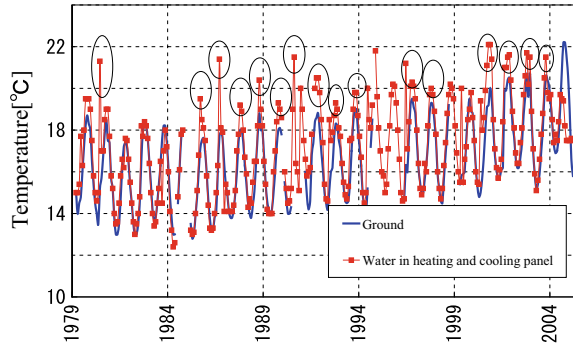
**Fig. 6** Measured temperature of the inlet water of the heating and cooling panel

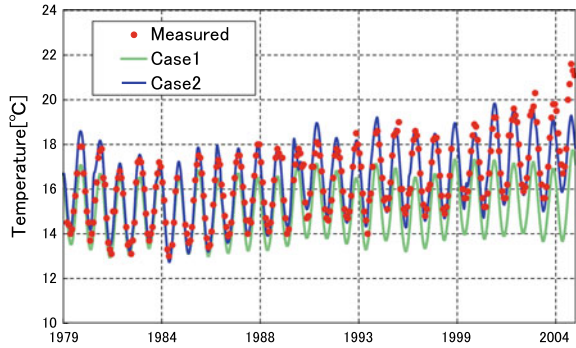
### 5.3 Effect of Heat and Moisture Generation Due to Work in the Stone Chamber [7, 9]

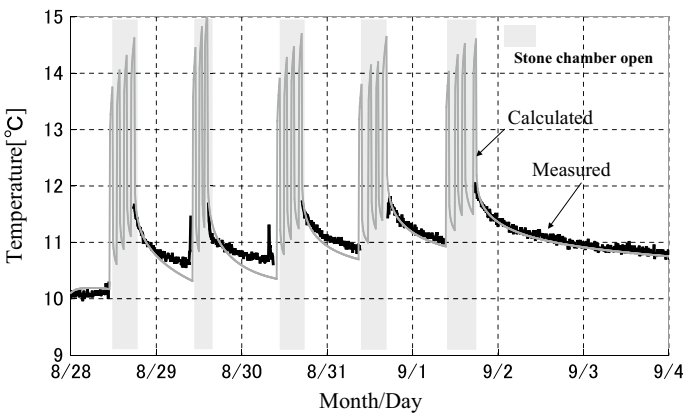
**Fig. 8** Temperature in the stone chamber during 5 days of work (August 28–September 3, 2006)

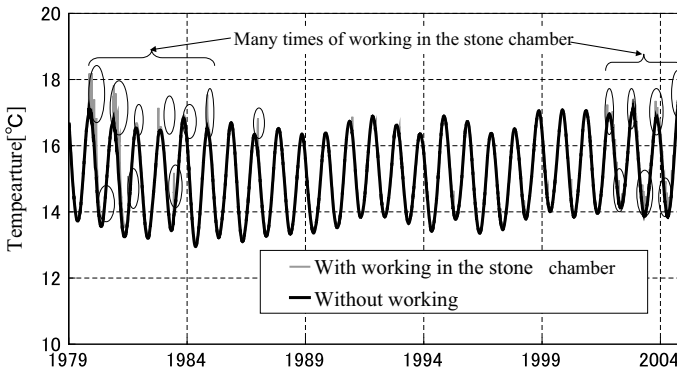
Fig. 9 Comparison between the results of work and non-work in the stone chamber

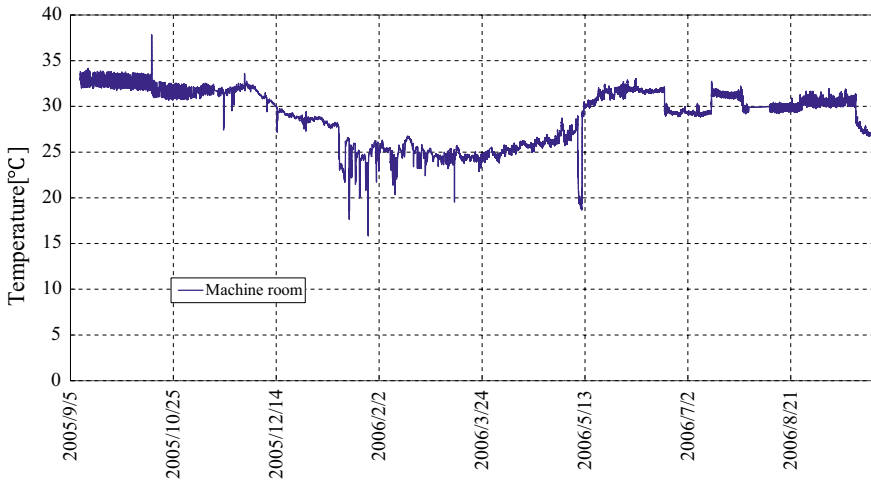
**Fig. 11** Machine room temperature before dismantling the stone chamber

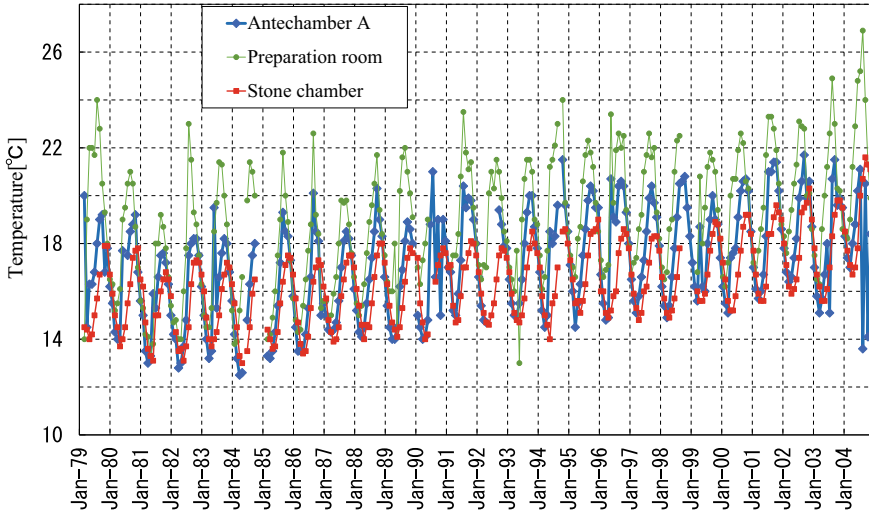
**Fig. 12** Preparation room, antechamber, stone chamber temperature measurements

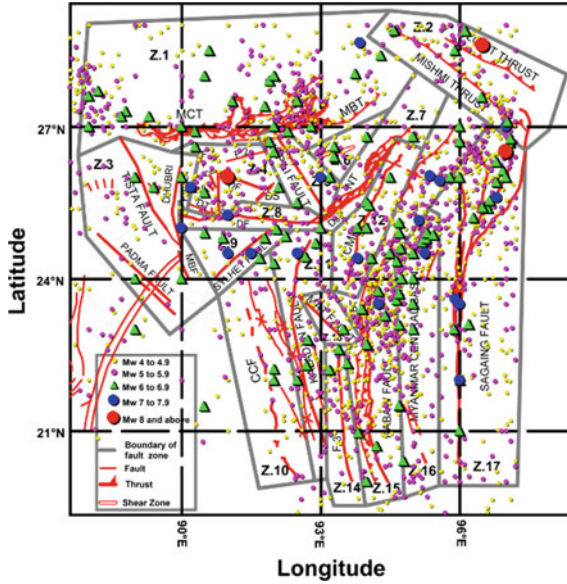
**Fig. 1** Delineated 17 identified seismic source zones in northeast India with seismic sources: Main central thrust (MCT), Main boundary thrust (MBT), Lohiti thrust, Mishmi thrust, Tista fault, Padma fault, Dhubri fault, Madhupur blind fault (MBF), Oldham fault (OF), Barapani shear zone (BS), Dapsi thrust (DT), Samin fault (SF), Dudhnoi fault (DhF), Chedrang fault (CF), F.1, F.2, Dauki fault (DF), Kopili fault, Naga thrust (NT), Disang thrust (DsT), Churachandpur Mao fault (CMF), Chittagong coastal fault (CCF), Kaladan fault, Mat fault, Eastern boundary thrust (EBT), Kabaw fault, Myanmar central basin (MCB), Sagaing fault. The earthquake distribution ( $M_w \geq 4.0$ ) collected from year 1731–2015 is also shown in the figure

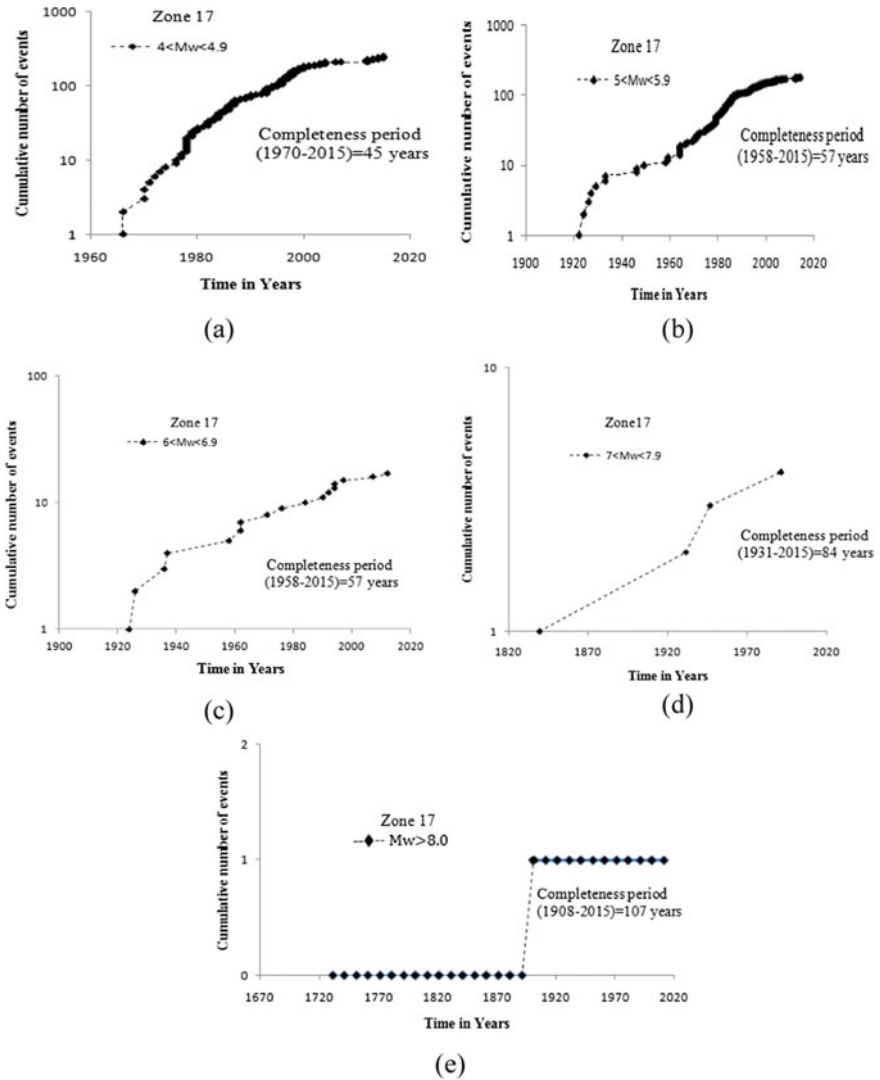
Fig. 4 a–e The figures show the completeness analysis of catalogue based on CUVI method

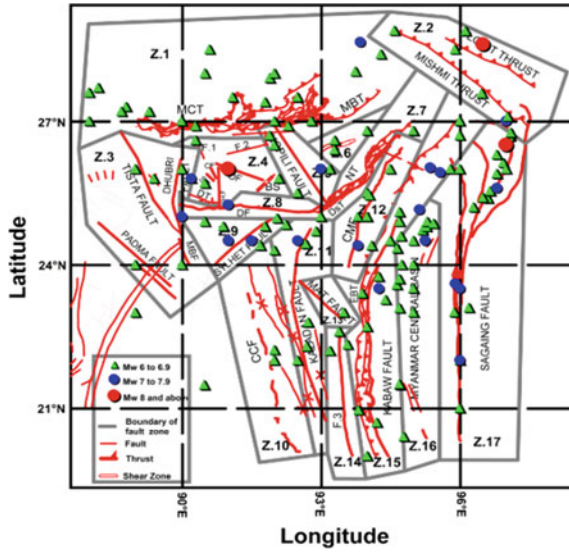
Fig. 5 Map shows epicentral distribution of earthquakes ( $M_w \geq 6.0$ ) used for prediction of earthquake magnitudes in the study area collected from year 1731–2015

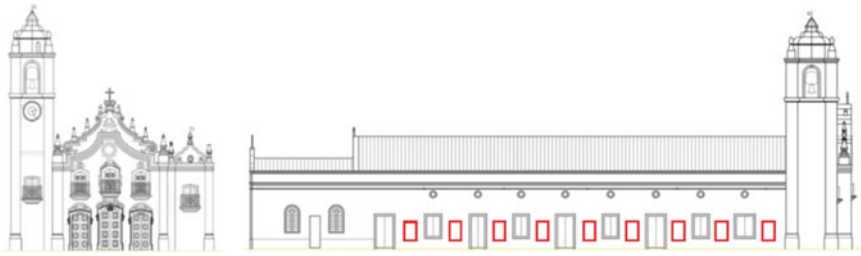
Fig. 1 Frontal façade and lateral section of the Nossa Senhora da Expectação Church

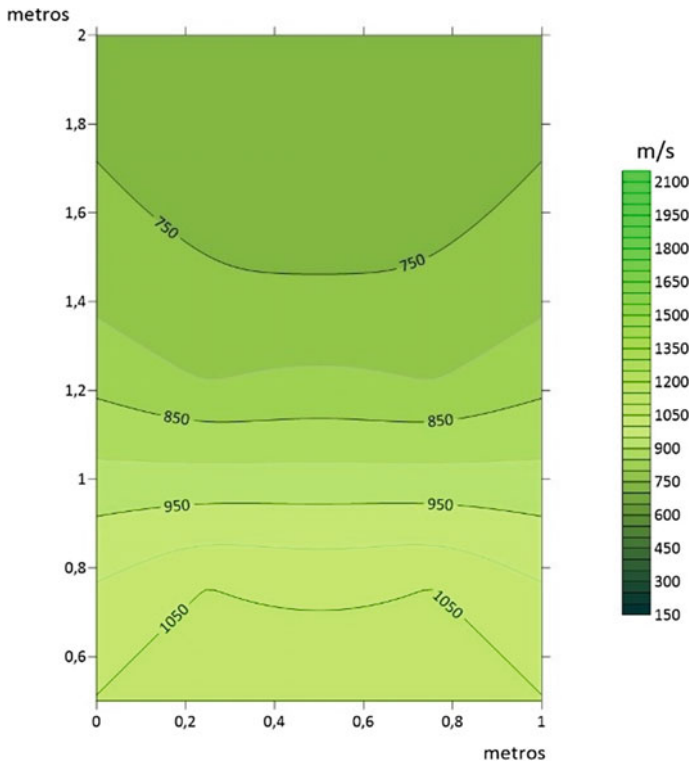
Fig. 5 Standard distribution of UPV along a masonry panel

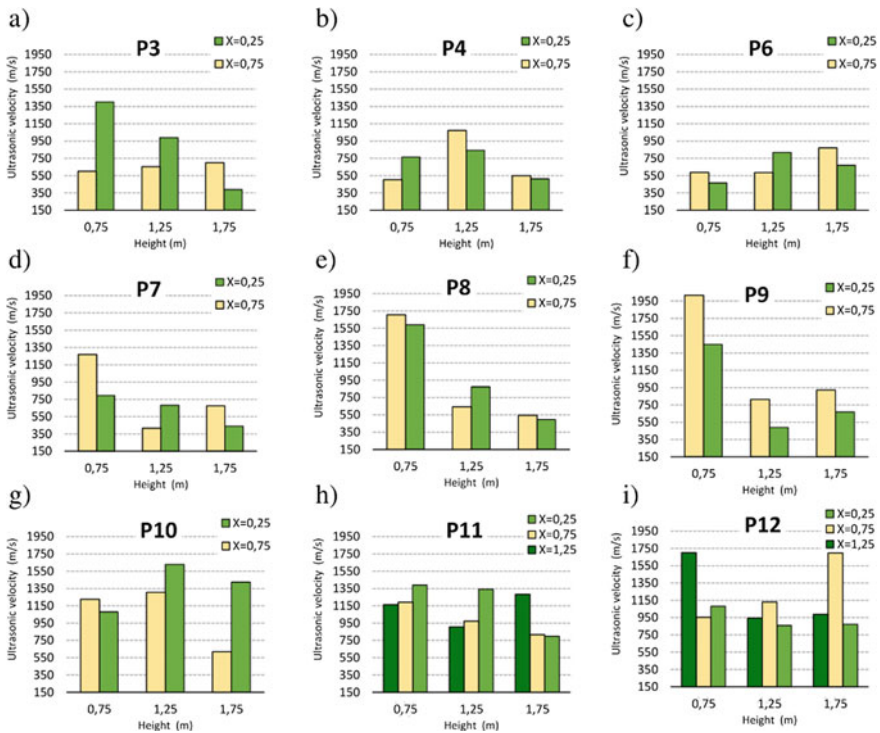
**Fig. 6** Influence of the height on UPV measured in the Northeast facade of the Nossa Senhora da Expectação Church

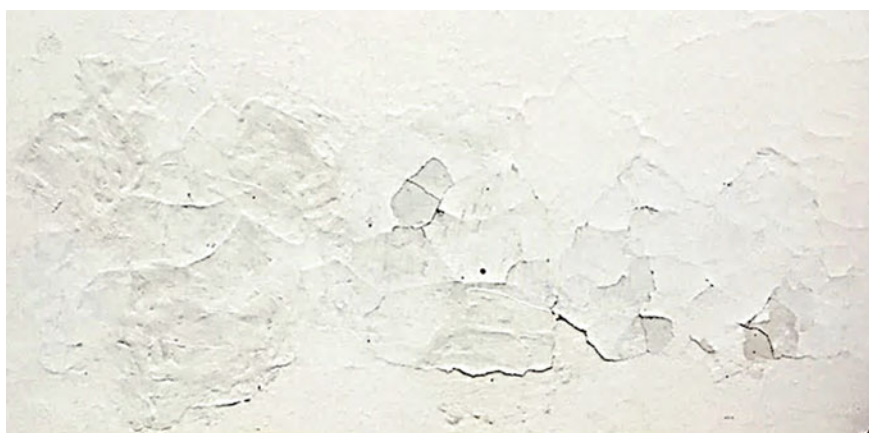
**Fig. 7** Panel P19 with cracks generalized along all panel

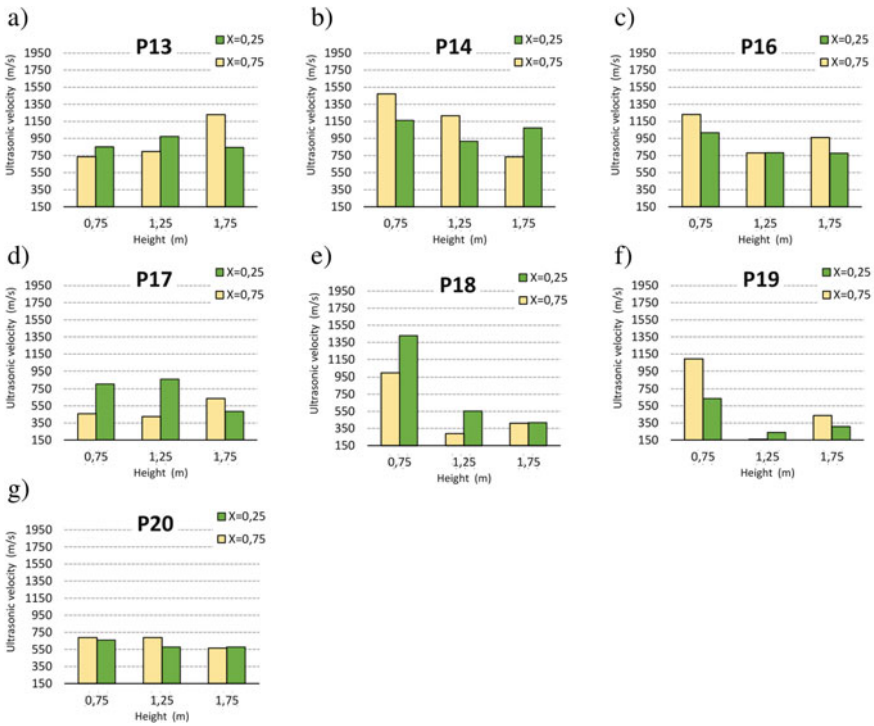
**Fig. 8** Influence of the height in the UPV of the Southeast facade of the Nossa Senhora da Expectação Church

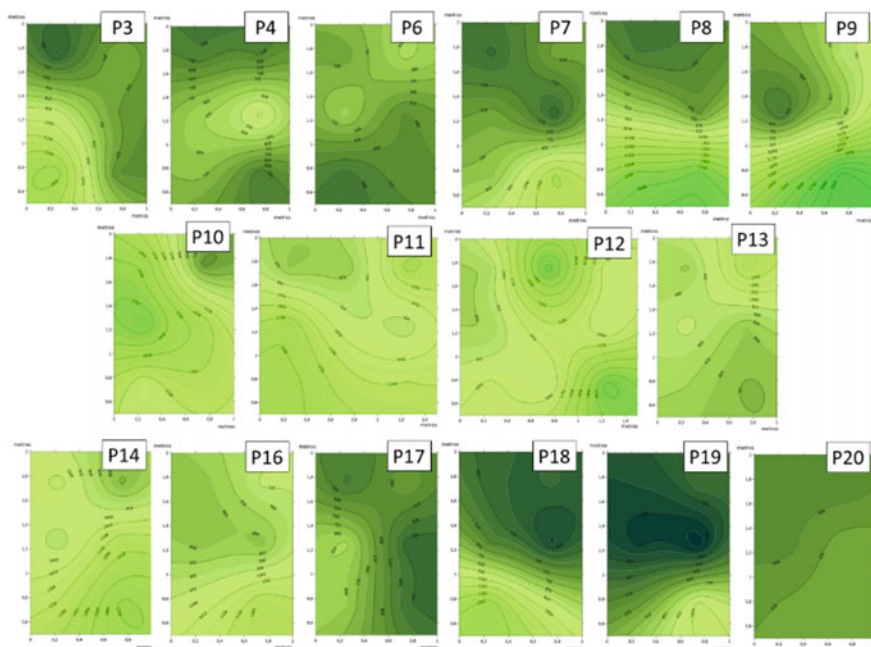
**Fig. 9** Ultrasonic velocity mapping of the masonry panels of the Nossa Senhora da Expectação Church

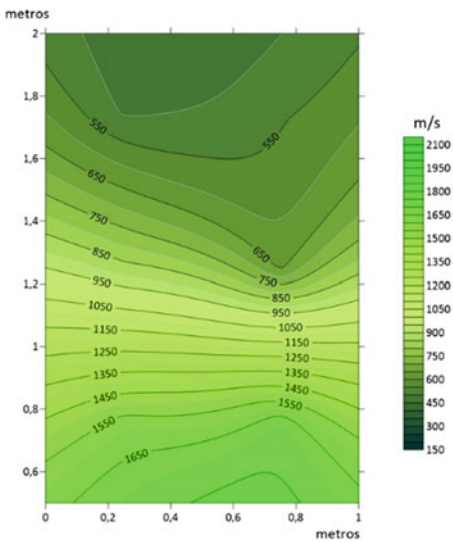
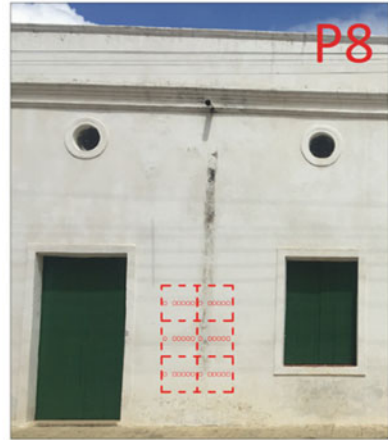
Fig. 14 UPV mapping of the panel P8

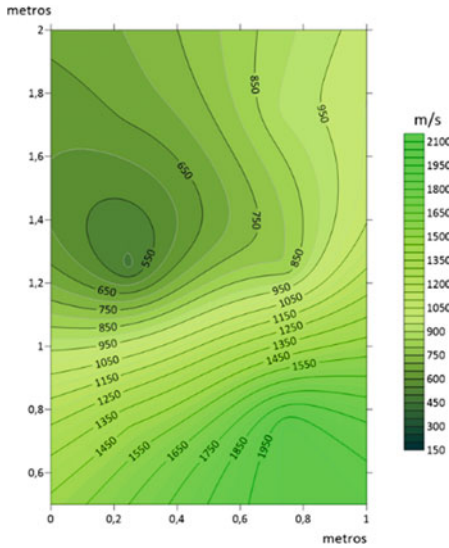
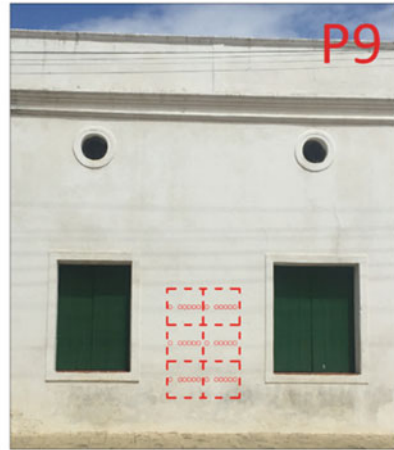
Fig. 15 UPV mapping of the panel P9

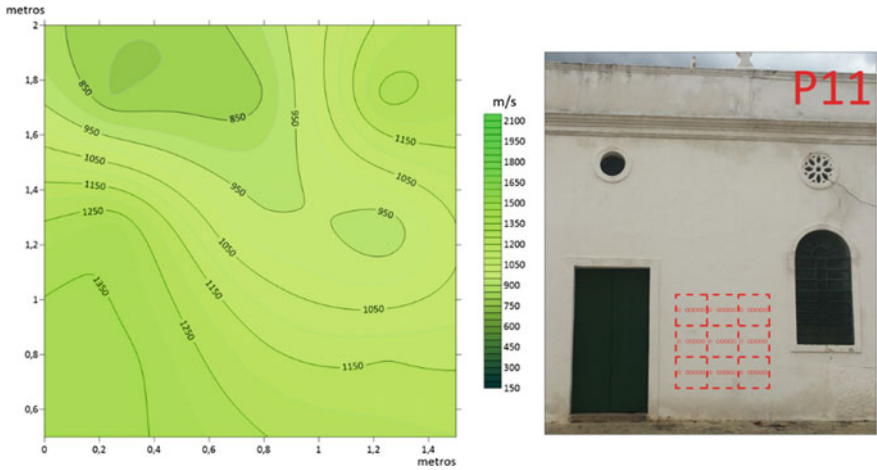
Fig. 17 UPV mapping of the panel P11

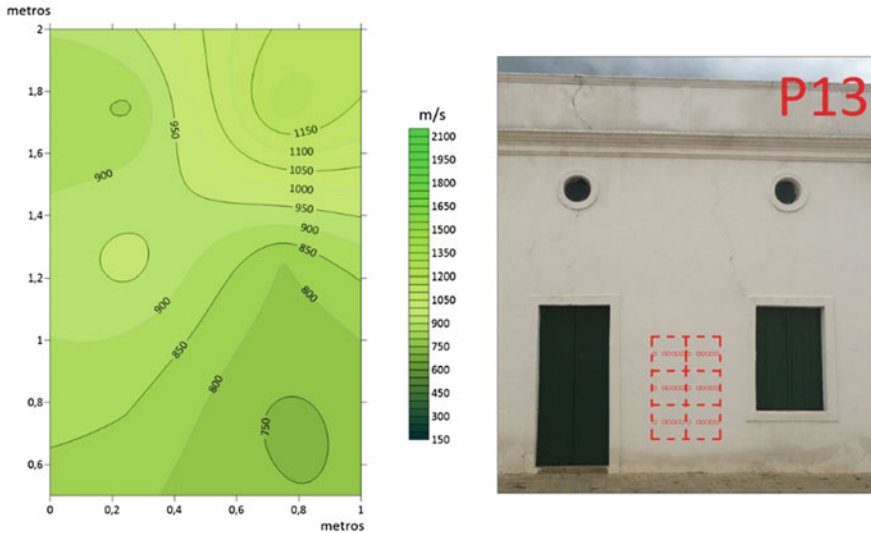
**Fig. 19** UPV mapping of the panel P13

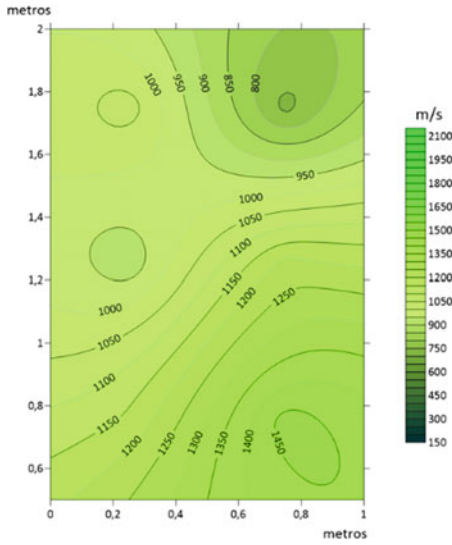
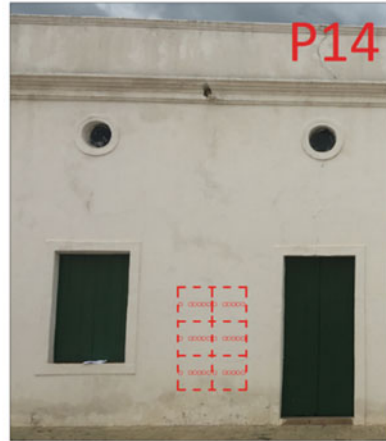
Fig. 20 UPV mapping of the panel P14

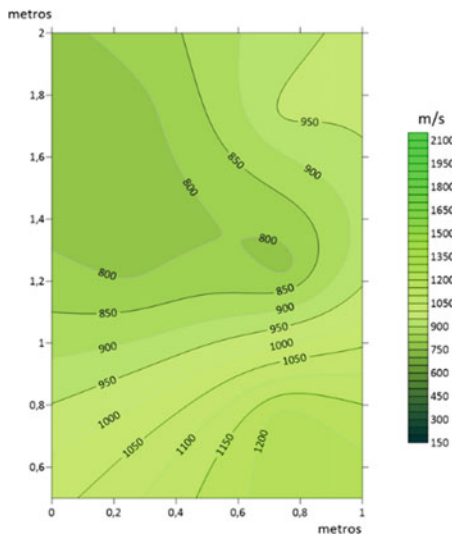
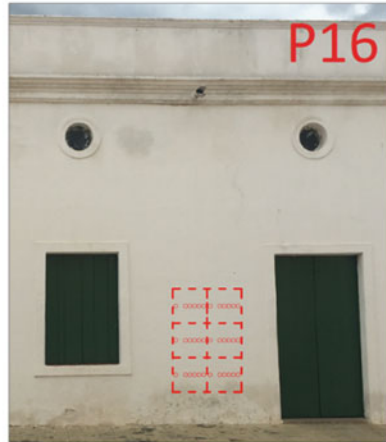
Fig. 21 UPV mapping of the panel P16

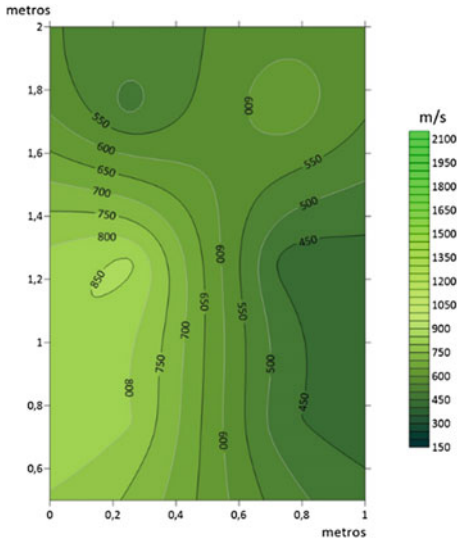
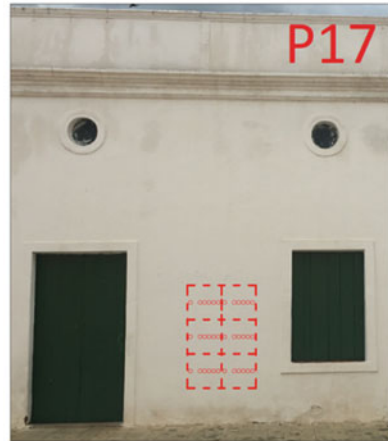
Fig. 22 UPV mapping of the panel P17

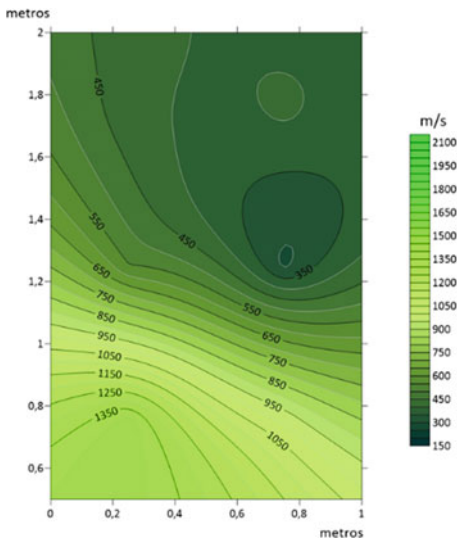
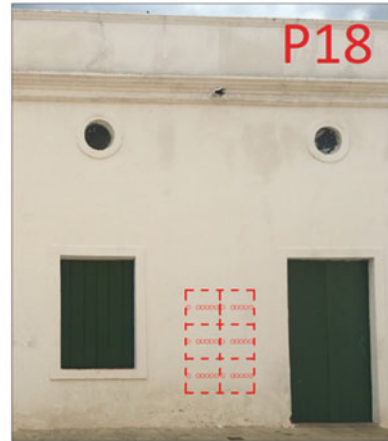
Fig. 23 UPV mapping of the panel P18

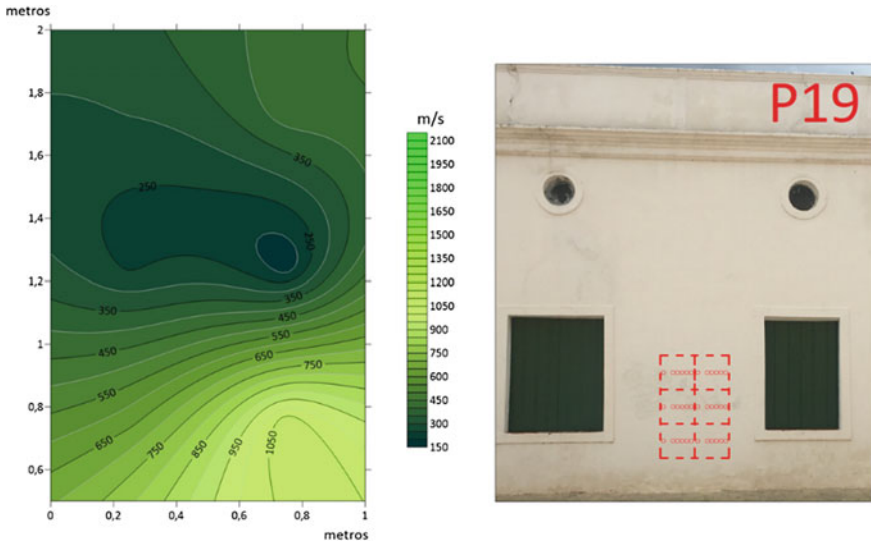
Fig. 24 UPV mapping of the panel P19

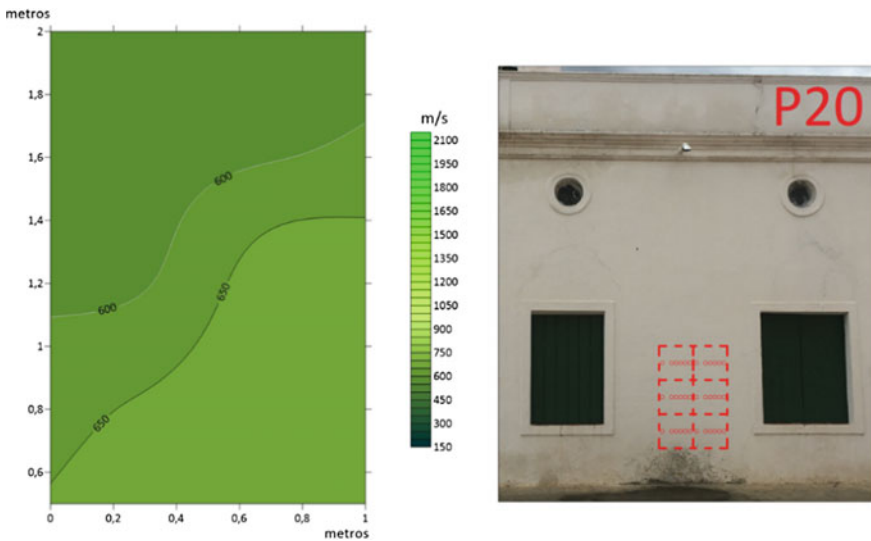
Fig. 25 UPV mapping of the panel P20

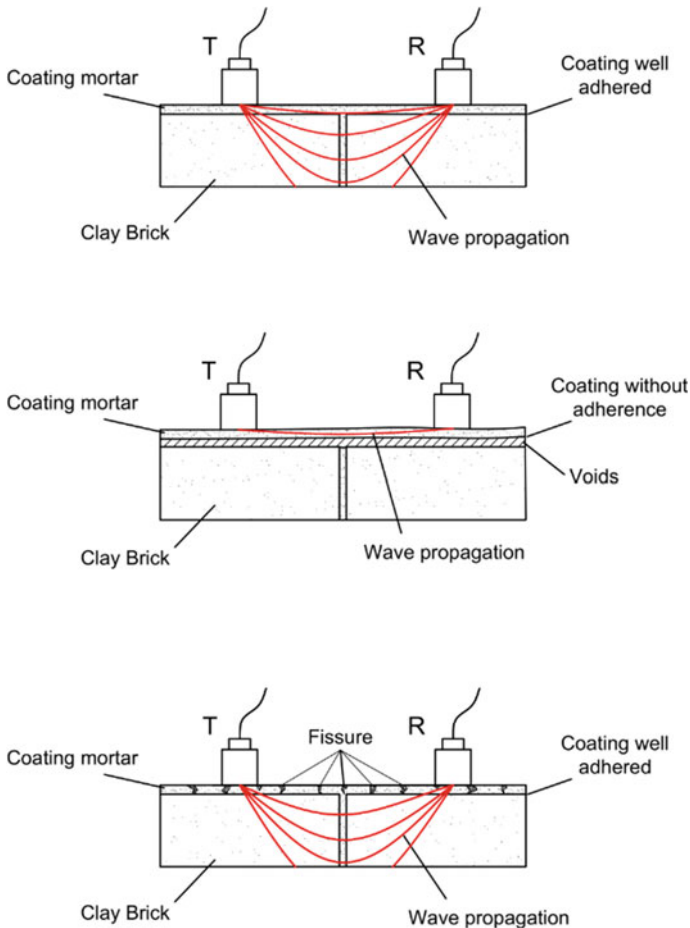
**Fig. 26** Schemes of ultrasonic waves propagation according coating mortar adherence quality

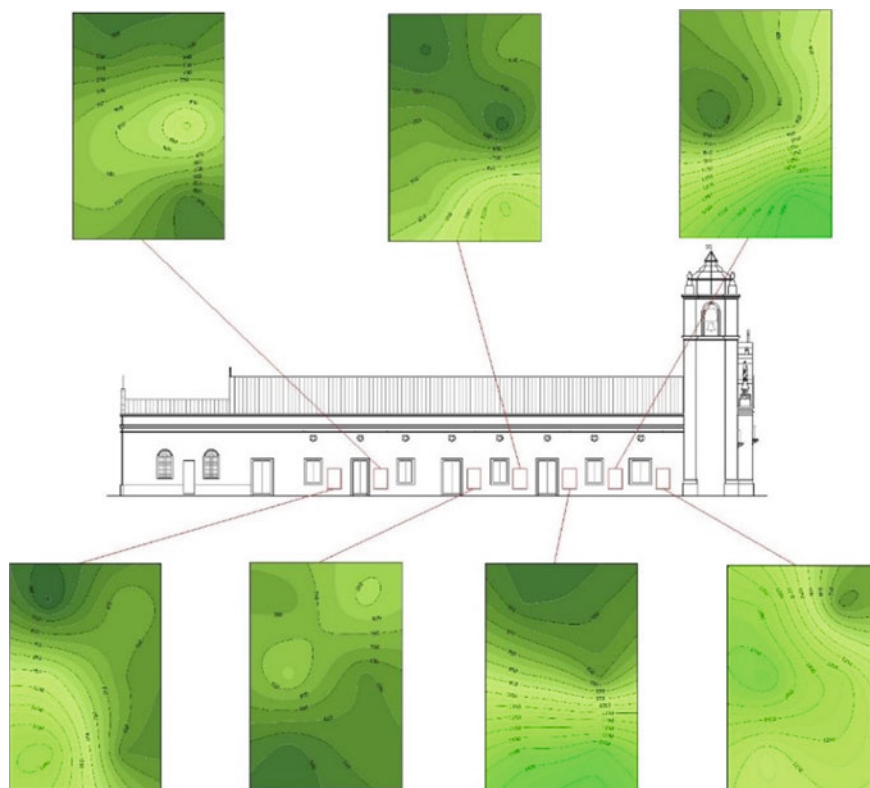
**Fig. 27** UPV mapping of the Northeast facade of the Nossa Senhora da Expectação Church

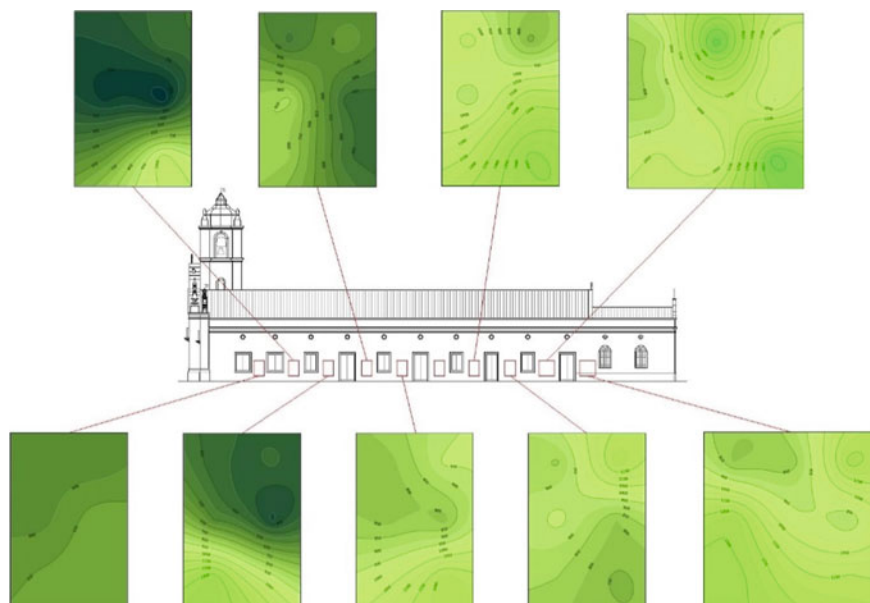
**Fig. 28** UPV mapping of the Southeast facade of the Nossa Senhora da Expectação Church

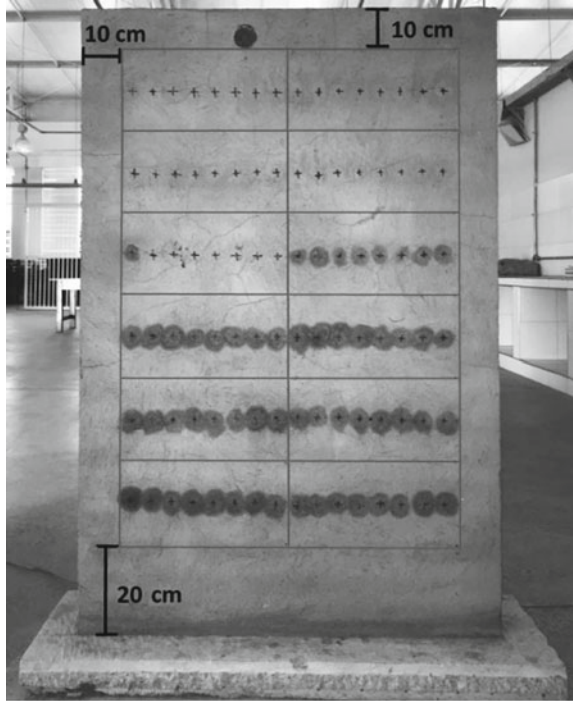
propagation was measured. Figure 5 shows the schematic view of ultrasonic indirect measures performed in the frames.

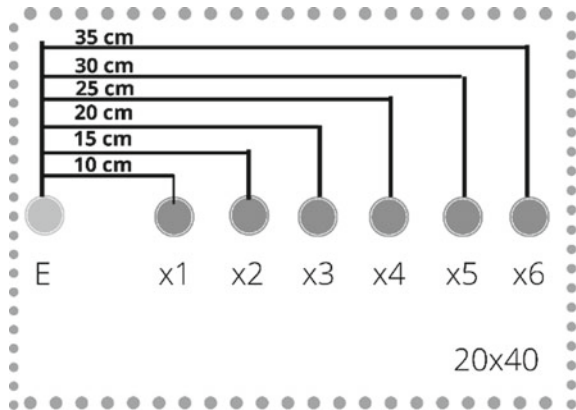
**Fig. 5** Schematic view of the indirect ultrasonic measurements performed inside the walls frame

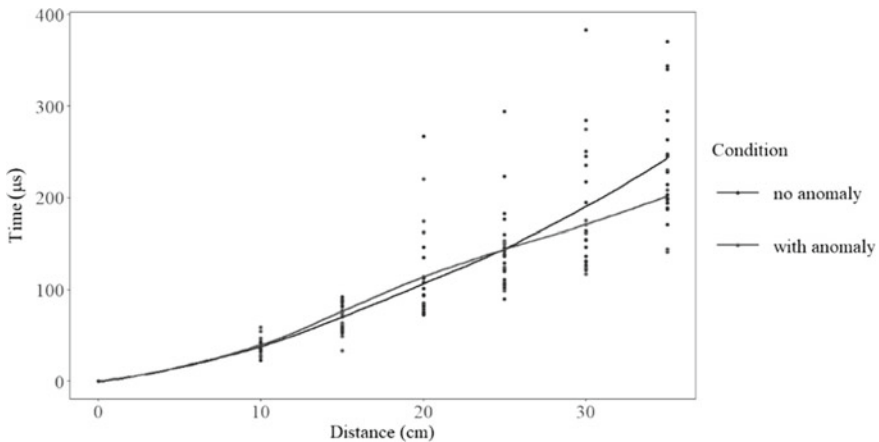
Fig. 6 Curves of the ultrasonic profiles plotted by logarithmic transform for time

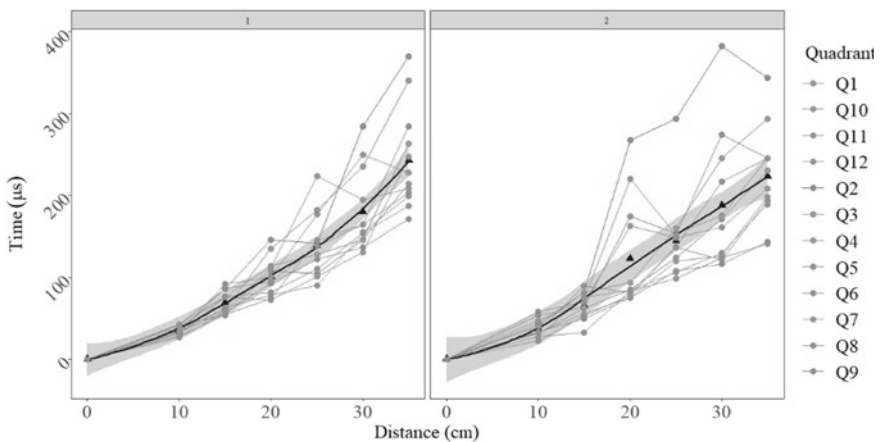
Fig. 8 Smoothed curves plotted by Lowess method

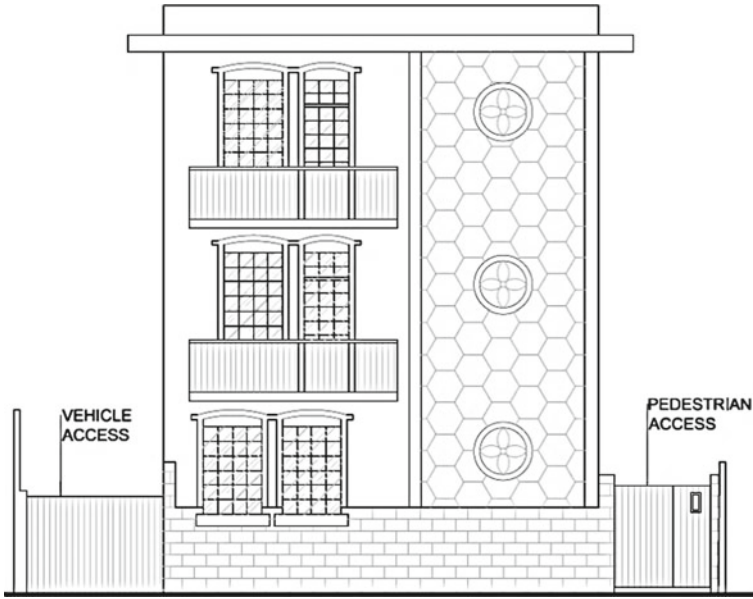
- Above the roof slab of the third floor is the water tank of common use in the building, and the wood structure of the roof. They are accessible only through the trapdoor found on the ceiling of the third-floor corridors.

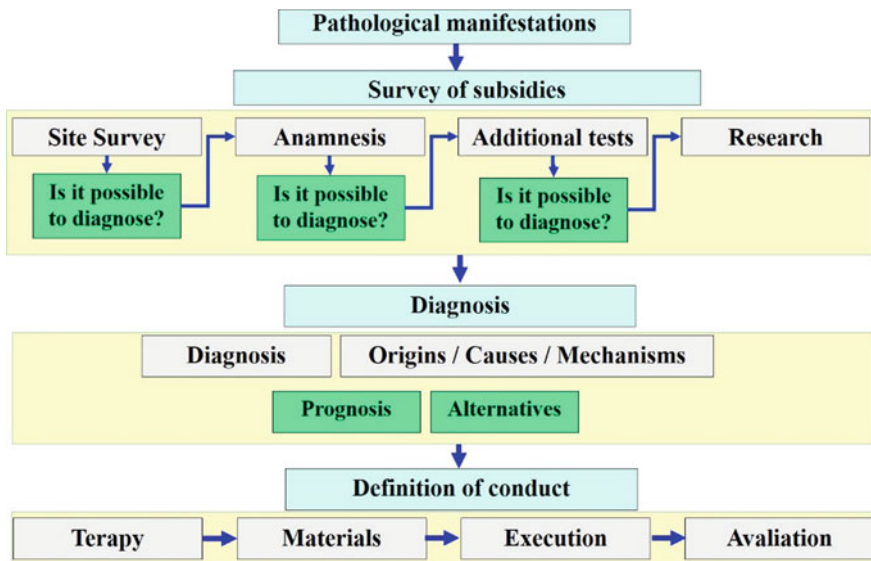
Fig. 8 Flowchart used inspection process

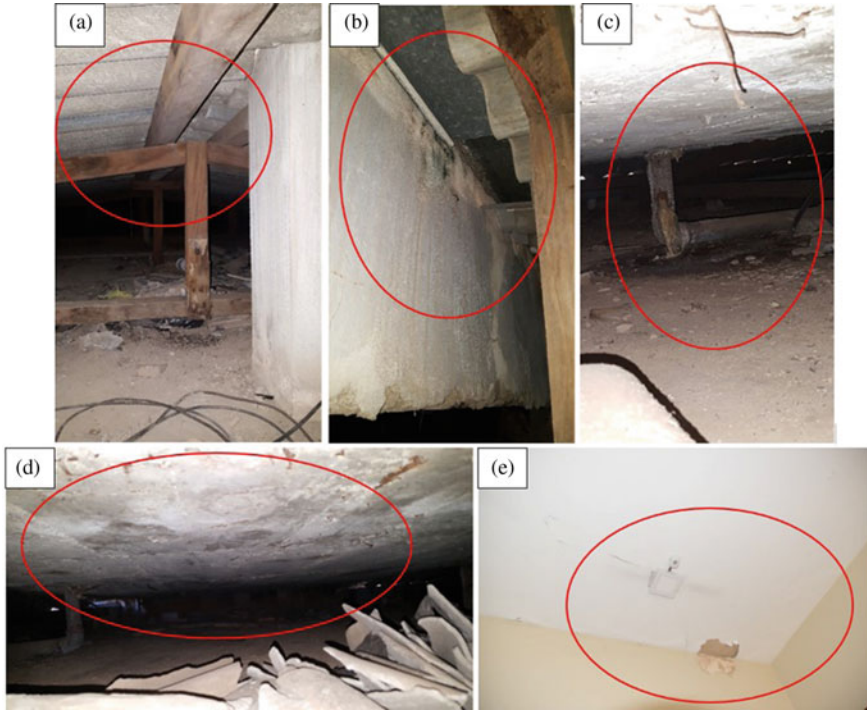
**Fig. 9** Moisture from leaking roof: **a** and **b** leaking at the meeting of the roof with the reservoir wall; **c** and **d** leaking at the upper reservoir and leaking metal pipes; **e** painting peeling off in the last slab in the corridor due to the presence of moisture

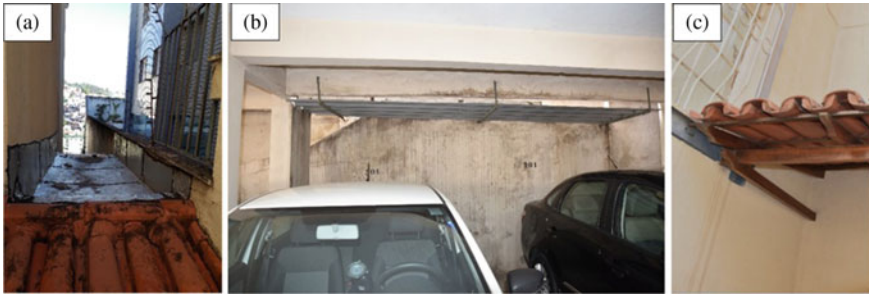
**Fig. 10** Moisture from leaking roof: **a** and **c** pedestrian entrance hall; **b** garage

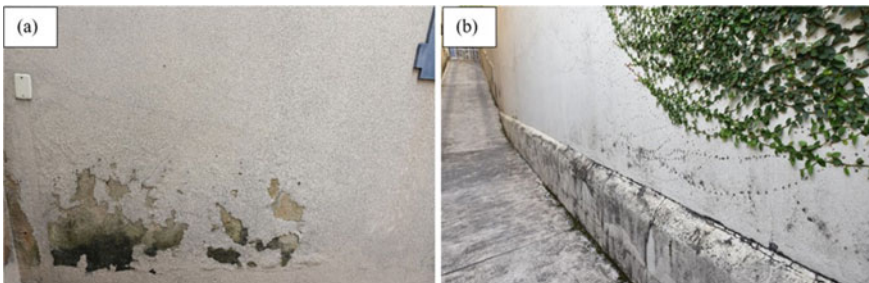
**Fig. 11** Humidity from rain splashes: **a** pedestrian entrance; **b** garage ramp

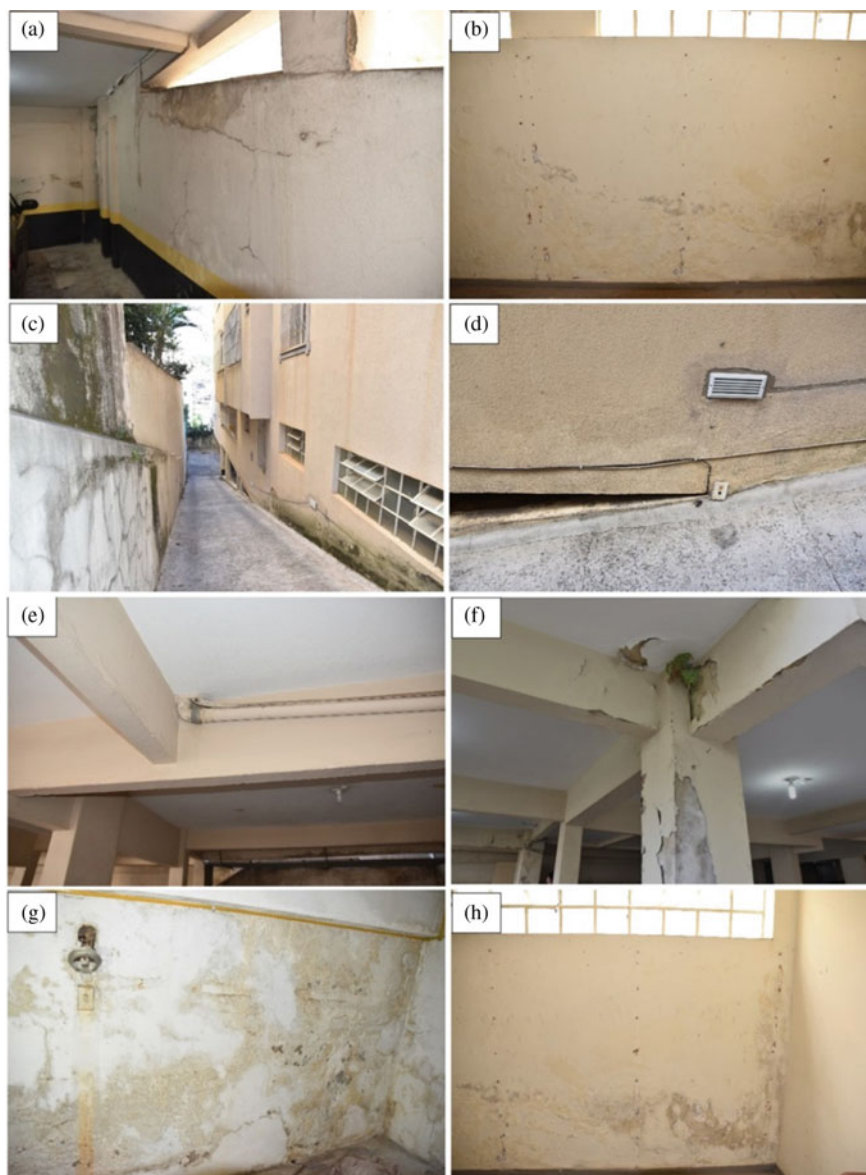
**Fig. 12** Moisture from inefficient waterproofing on the access ramp to the garage and pedestrians entrance: **a** in the garage; **b** in the party room—garage ramp; **c** garage access ramp; **d** detail of the meeting of the ramp floor and building wall; **e** fixing and tightness of the pipe meeting to sewage drain in the encounter with the slab structure; **f** disaggregation and proliferation of vegetation due to the presence of moisture and use of contaminated aggregate; **g** basement in the 1st underground; **h** wall of the party room in the 1st underground

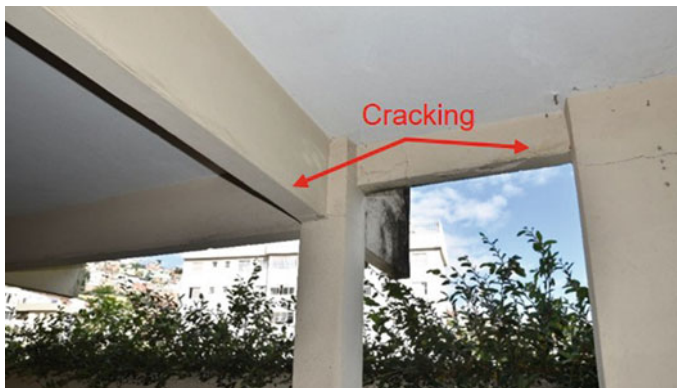
Fig. 13 Horizontal cracks in the columns at the back of the building's garage

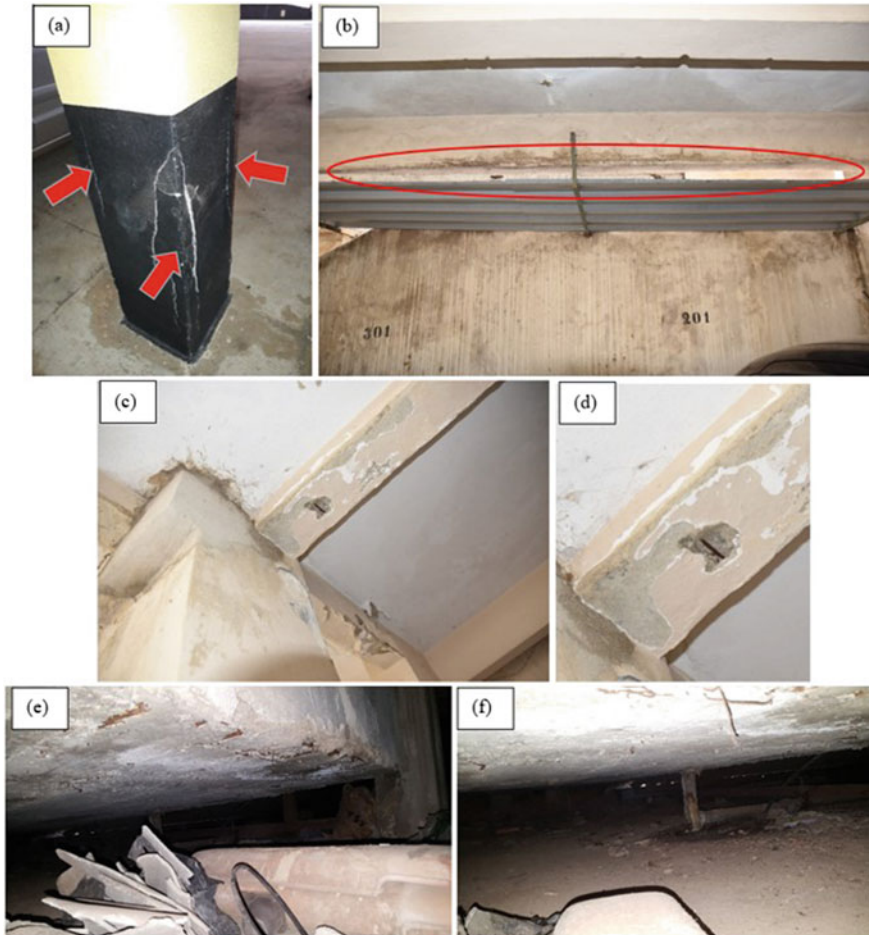
**Fig. 14** Cracking and swelling of structural elements in the building’s garage: **a** column; **b** beam; **c** exposed reinforcement on the beam; **d** detailing of the exposed reinforcement and **e** and **f** detailing of exposed reinforcement of the upper reservoir

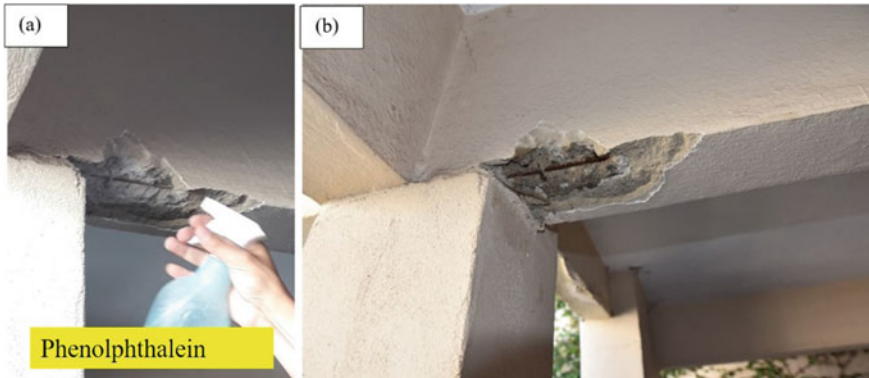
**Fig. 15** Lack of covering of the reinforcement of the beams and columns of the building’s garage: **a** application of Phenolphthalein and **b** carbonated concrete and without reinforcement covering

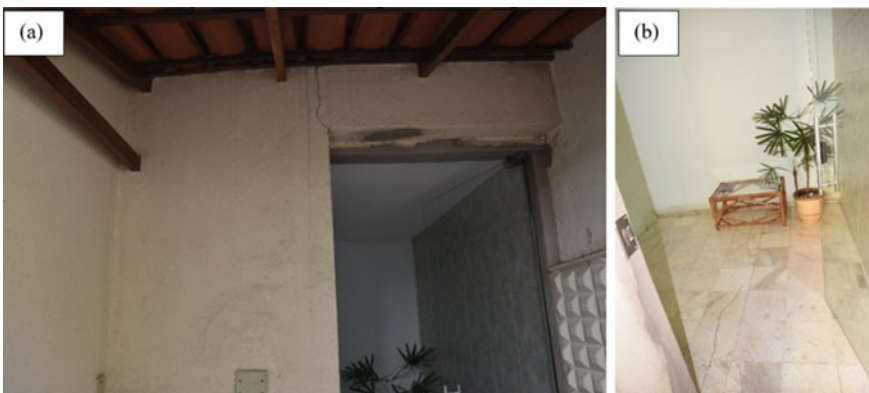
**Fig. 16** Crack on the wall (a) and on the floor (b) of the entrance hall

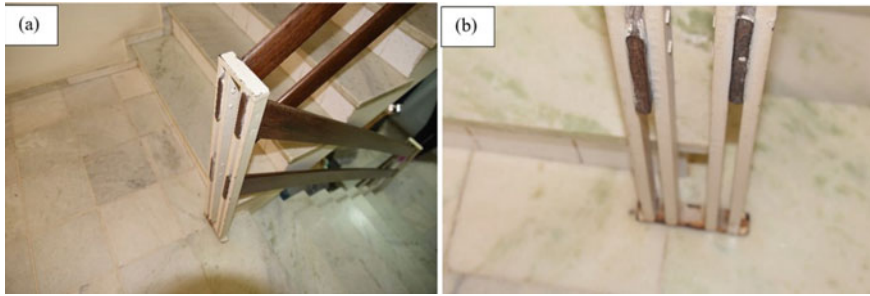
**Fig. 17** Handrail of access stairs to the condominium apartments: handrail profile (a) detail of the fixing system to the floor presenting corrosion (b)

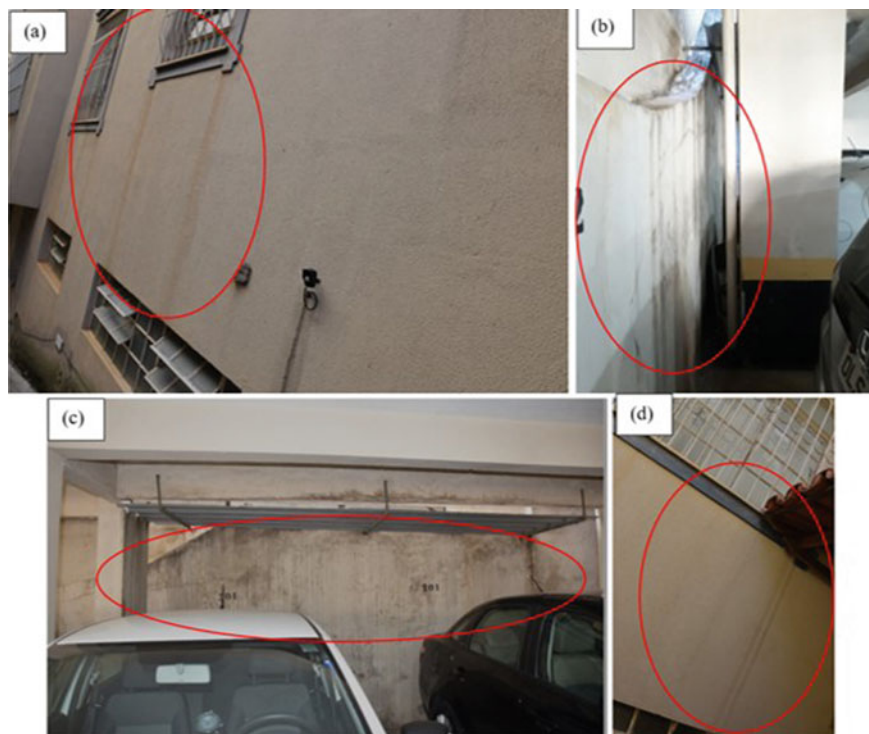
**Fig. 18** Stains on the wall due to carrying dirt: **a** inefficient drips under the windows; **b** lack of drips above walls; **c** lack of waterproofing against the roof and stop of the garage and **d** lack of waterproofing of the encounter of the roof and wall of the building of the west facade of the building
