Building Pathology and Rehabilitation

J. M. P. Q. Delgado *Editor*

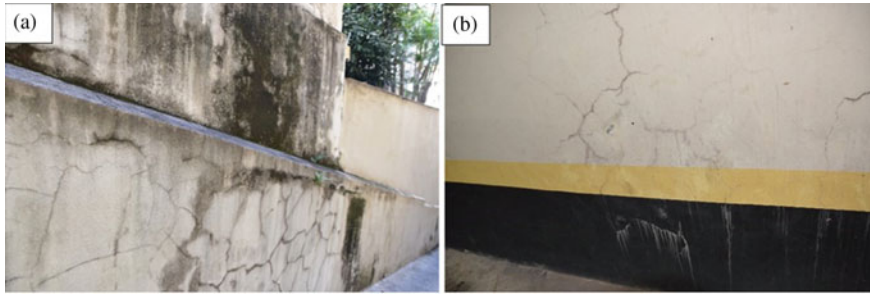
**Fig. 19** Detachment of coating mortar and painting: **a** on the walls near the garage; and **b** on internal walls of the garage

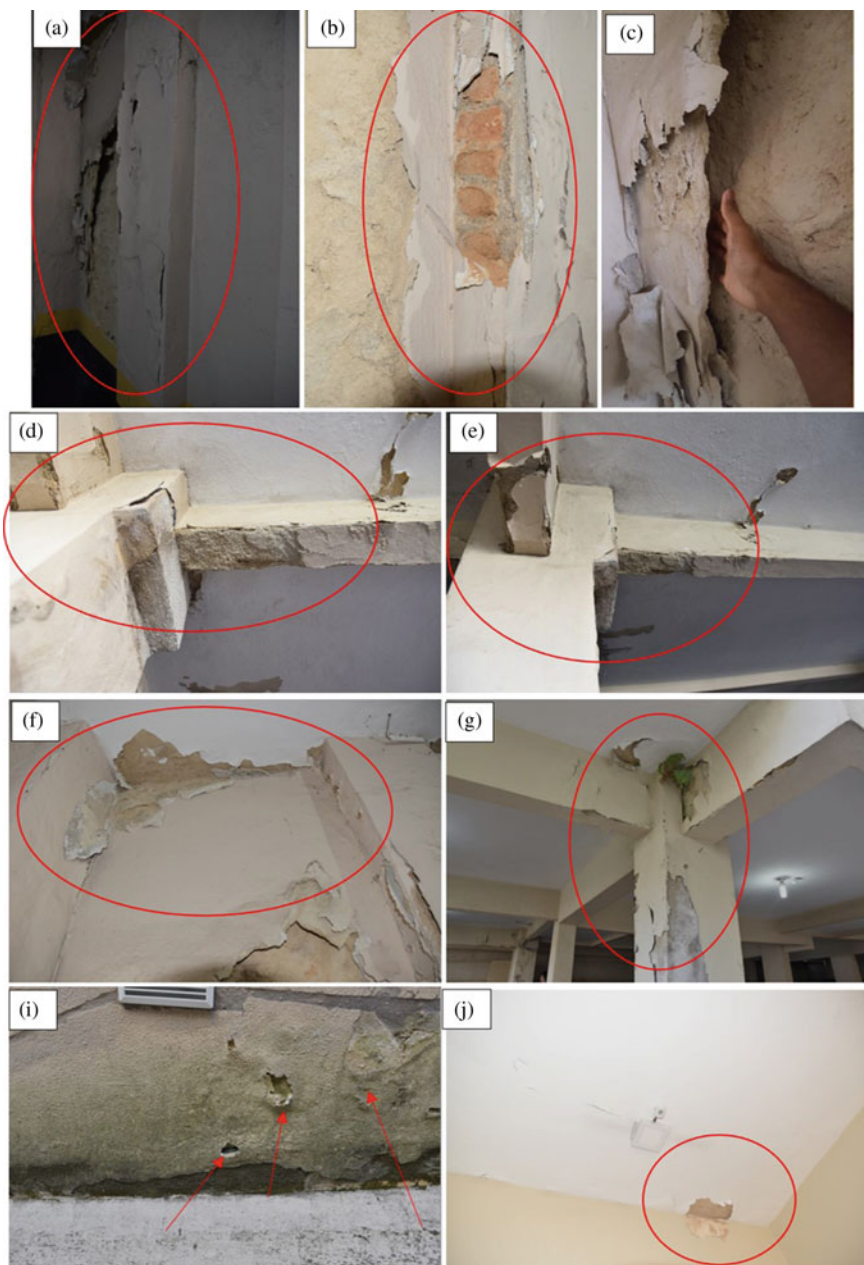
**Fig. 20** Powdery disintegration of mortars and paintings: **a–c** on the garage walls; **d–g** encounter of slabs, columns and beams; **h** on the walls of the building close to the floor and **i** on the ceiling of the last floor (under the roof)

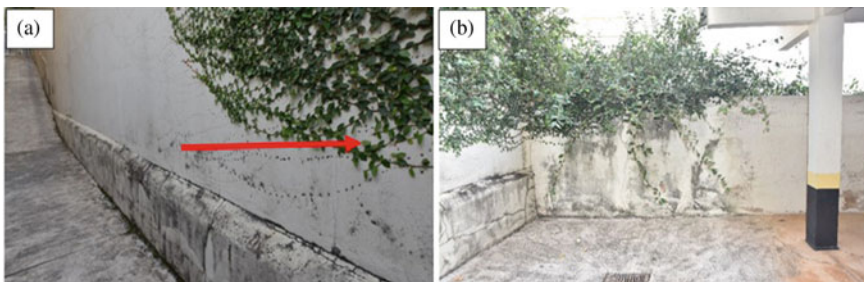
**Fig. 21** Vegetation rooted in **a** the wall of access ramp to the garage and **b** boundary wall

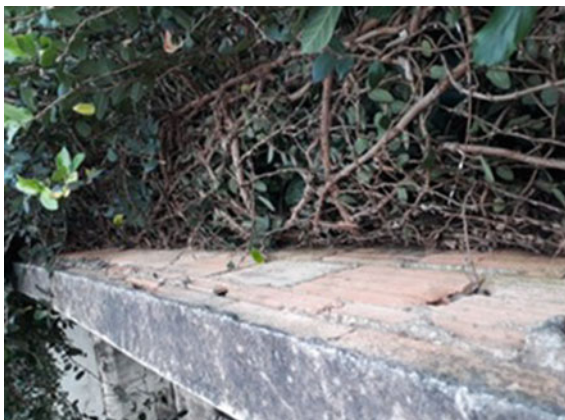
### 5.3.5 Lack of Coating on Boundary Wall at the Back of the Building

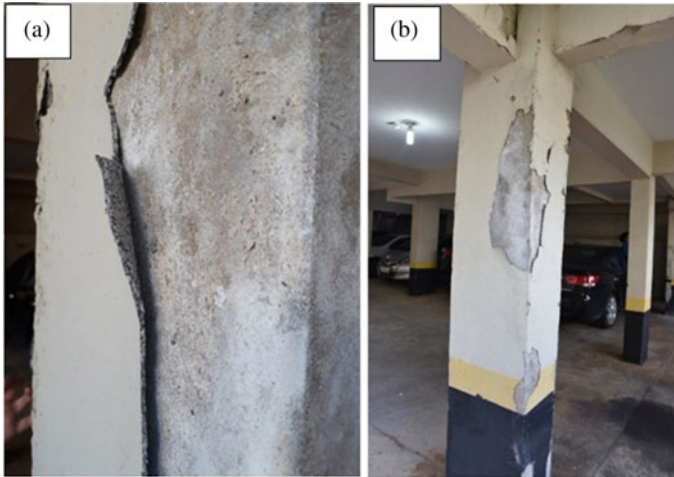
**Fig. 23** Detachment of the painting system on the columns

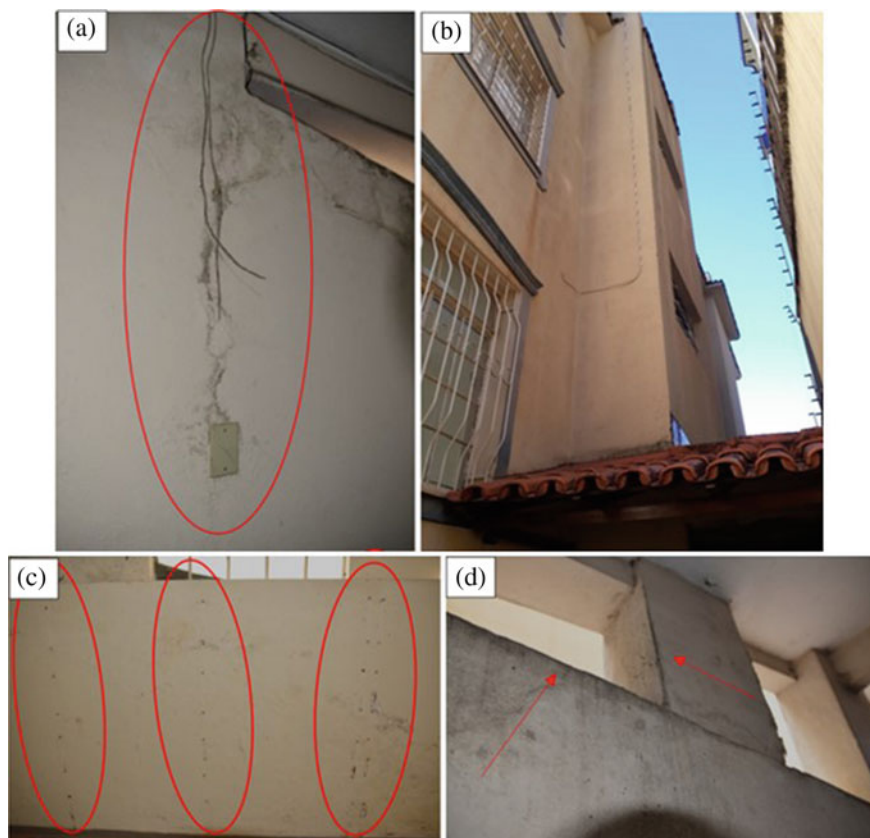
**Fig. 24** Stain and abrasion by age of mortar and painting system: **a** party room; **b** façade of the building; **c** party room; **d** side opening of the garage access ramp

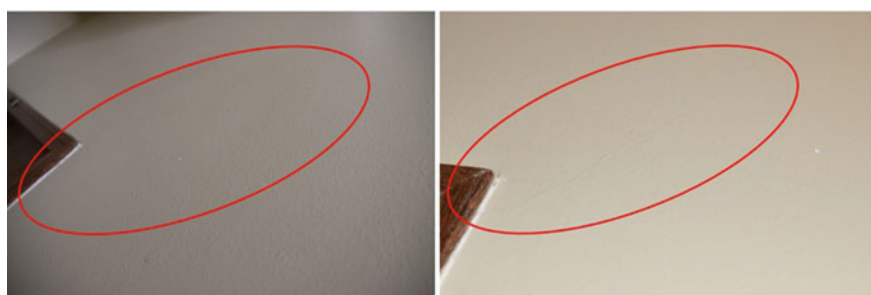
**Fig. 25** Fissure at the corner of the door of top floor's apartment

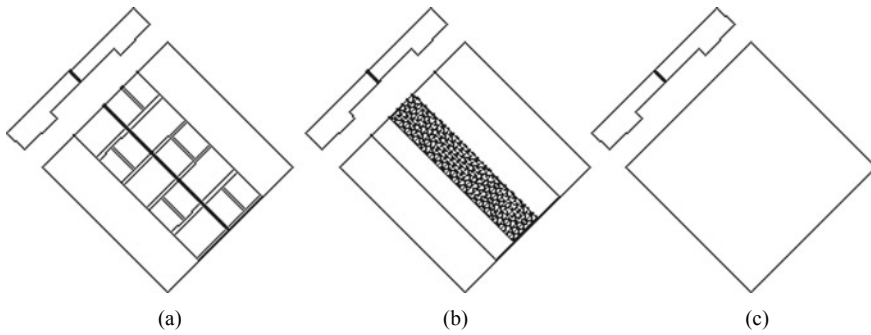
**Fig. 26** Correction of cracks caused by tension at the edges of windows and doors with wire mesh: **a** opening the wall's coating 30 cm on each side; **b** fixing a wire mesh or 20 cm bandage on each side; **c** execution of the new coating

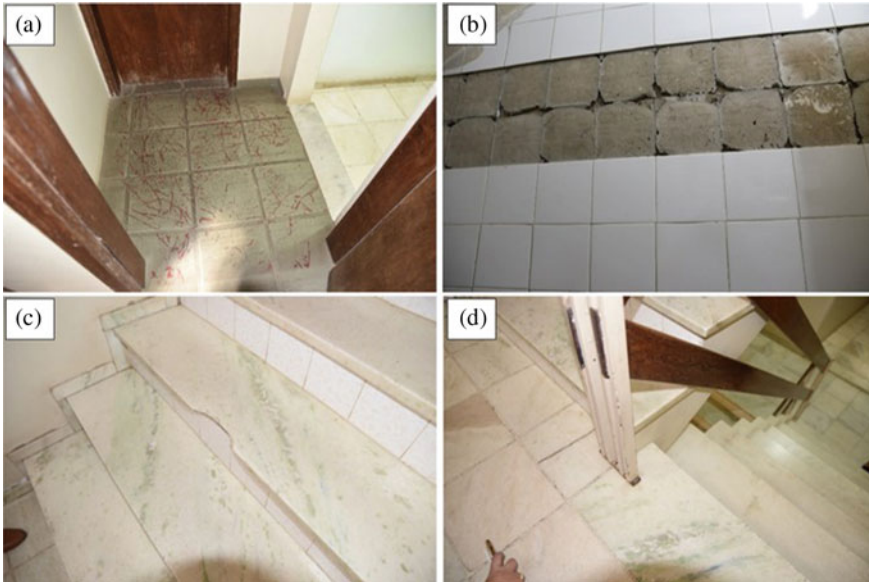
**Fig. 27** Floor situation: **a** painted ceramic tile in the entrance hall to the 1st underground and party room; **b** bathroom wall coating of the garage; **c** marble floors **d** and ceramic floors of the stairs from the access hall

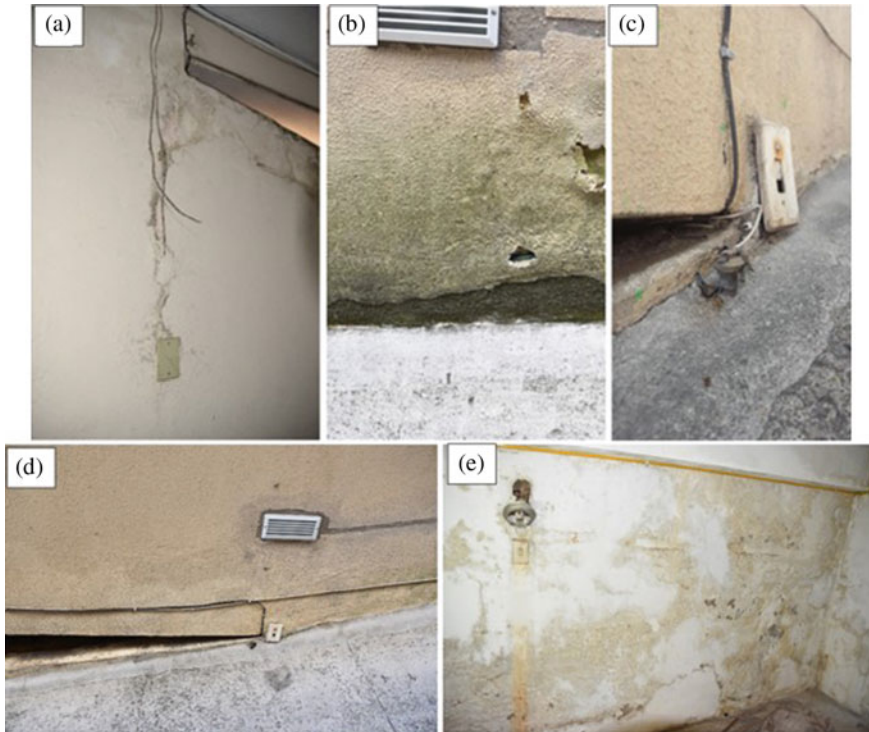
**Fig. 28** Status of electrical and telephony installations, and antennas: **a** loose wires detached from the wall; **b**, **c** and **d** interventions to renovate the electrical installations and electrical gate of the garage; **e** poorly fixed lamp and presence of humidity and mustiness

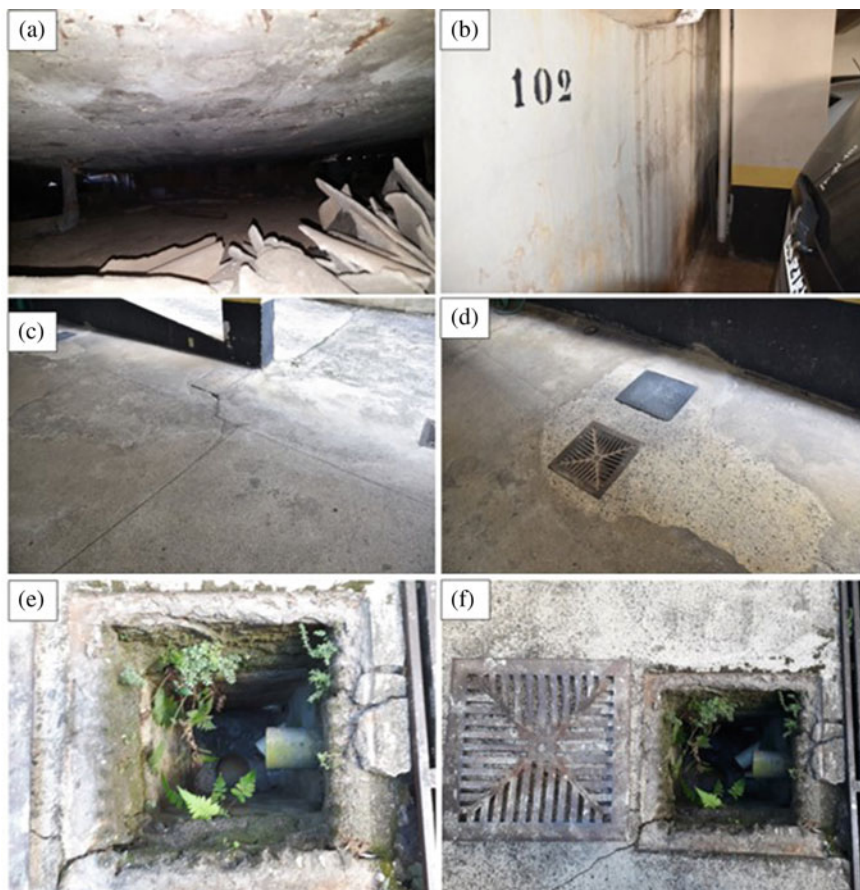
**Fig. 29** Situation of hydraulic-sanitary systems: **a** leakage of the metallic installations of the plumbs of the upper reservoir exit; **b** rainwater stains from the roof of the garage; **c** several cracks on the floor where the rainwater passes through; **d**, **e** and **f** passage boxes and drains made of concrete with precarious waterproofing

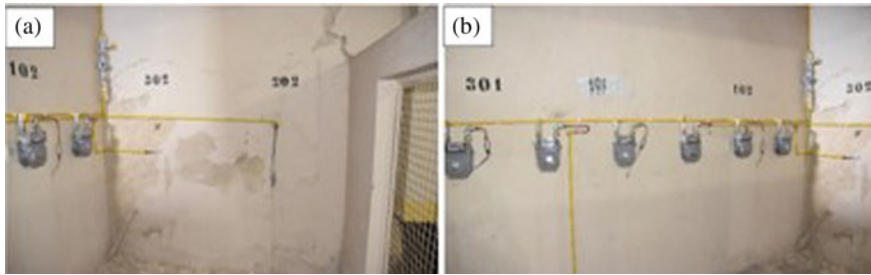
**Fig. 30** Location of gas measurer: **a** side view; **b** front view
