The Rehabilitation Process of an Emblematic Historic Building of Iasi County

Oana-Mihaela Banu¹ (✉), Sebastian Cusutură², Ioana Olteanu-Donțov¹,
and Mihaela Movilă¹

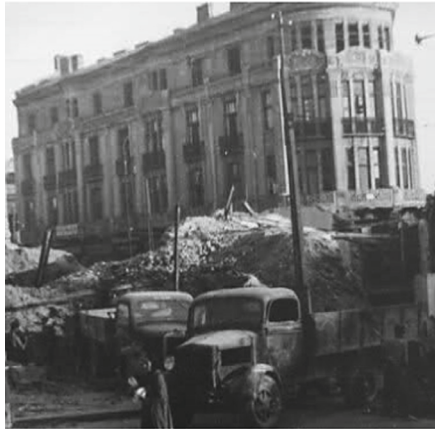
least preceded by an adequate damage evaluation process and haven't been executed conforming to a rehabilitation project. Unfortunately, these measures contributed to a progression of the damage state. They included: the exterior connection of the dome to the palace façade by means of some steel strips; the cracks repairing with inadequate filling mortar; local replacements of the masonry units with new types of bricks and mortar; plaster, coating and architectural finishes improper replacement; local concrete underpinning of the footings; improper repairing of the wooden roof structure and of the steel covering [16]. The next figure illustrates the palace after the World War II (Fig. 5).

Fig. 5. The central palace after the World War II [16]

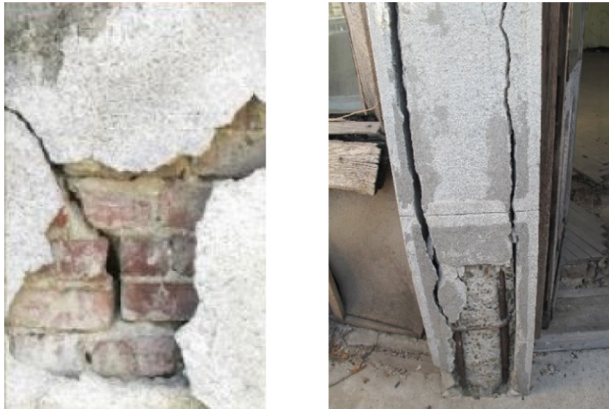
The foundation soil is a high compressible silty clay which actually has an increased moisture content. The level of the underground water is very close to the footings. The foundation soil suffered along the years differential settlements. The super-structure cracks have been initiated from the foundation structure (see Fig. 6).

Fig. 6. Cracks developed in the concrete cover and in the elements of the super-structure [16]

of the building, on two rows at a specified distance, so that to form in plane equilateral triangles (Fig. 10b). This process has to be very carefully executed so that to avoid any additional settlement or any local failure of the existing footings. The previous strengthening of the stone footings by cement injection is highly recommended [22].

The infrastructure consolidation is needed to increase the strength, stability and stiffness of the affected footings due to the differential settlements. This can be performed by using a framing system which consists of encasing the existing natural stone footings in a new reinforced concrete system with inferior and superior lateral ring beams vertically connected like the Vierendeel trusses and transversally connected together, as showed in Fig. 12 [23, 24]. The compound effect between the new RC system and the old foundations can be ensured by using some steel rods and grout or a special adhesive. The use of this kind of framing system has the advantage of enhancing the moisture transfer from the masonry walls. The construction of some additional transverse reinforced concrete beams is indicated for an improved load transfer at the foundation level and to ensure a better behaviour to any possible differential settlement.

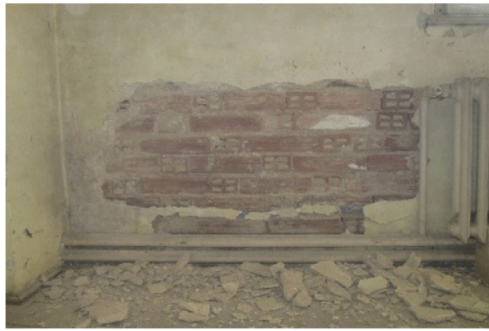
The open ground floor with some vertical RC elements and the various compartmentalization of the interior masonry walls form the upper stories do not provide the vertical regularity and that increases the seismic vulnerability of the palace [21]. The RC slabs of reduced thickness cannot behave as diaphragms to properly withstand horizontal earthquake forces. The masonry walls are not homogeneous structures since different types of masonry units have been used or replaced along the years: solid bricks and cored bricks (see Fig. 7). The utilized lime-cement mortar has reduced mechanical properties and the overall strength and stiffness of the masonry walls has been also impaired by the construction of some chimneys inside their structure.

Fig. 7. Plaster exfoliation revealing the non-homogeneity of the masonry walls [16]

In case of super-structure masonry walls, serious decay of the mortar joints and of the bricks have been observed on the façade of the palace. The repointing of the eroded joints, the mortar or grout injection of the occurred cracks and local repairs or even partial replacement of the masonry units which are deteriorated beyond repair are necessary. It is of utmost importance to previously determine the physical, chemical and mechanical properties of the existing materials and to use new ones with similar size, colour, texture and durability, as much as possible. The cleaning process has to be carefully done and only in justified circumstances so that not to induce more harm to the masonry [25].

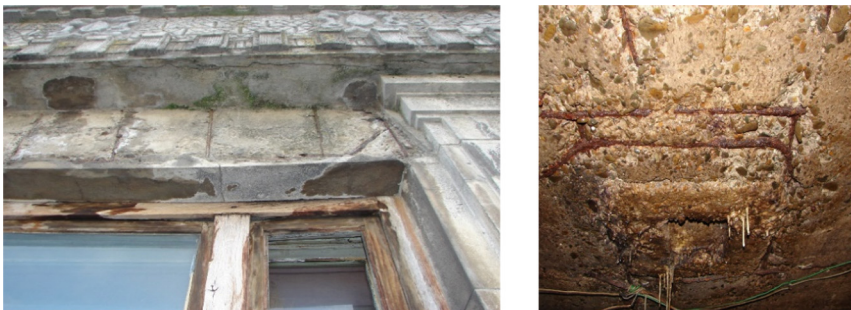
The plaster exfoliation caused by the environmental conditions determined the corrosion of the reinforcement, as Fig. 8 illustrates, and the severe damage of the masonry elements and of the exterior architectural finishes, as shown in Fig. 9.

Fig. 8. Plaster efflorescence and exfoliation followed by steel reinforcement corrosion

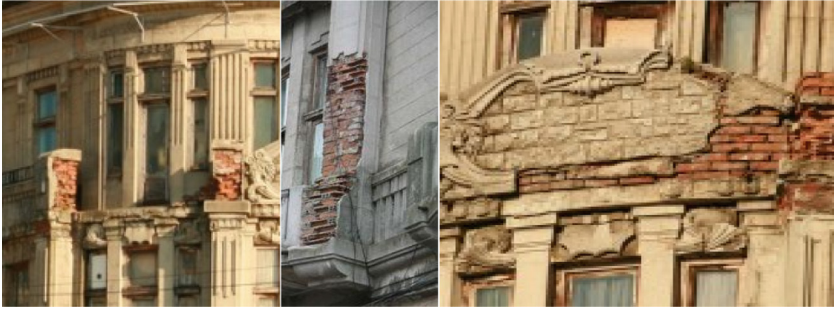
Fig. 9. The severe damage of the masonry elements and of the architectural finishes [16]

The interior and exterior decorative plasterworks and architectural finishes require a thorough restoration and reconstruction process, paying careful attention to the selection of the used materials and techniques in order to preserve the original Art-Nouveau style of the palace.

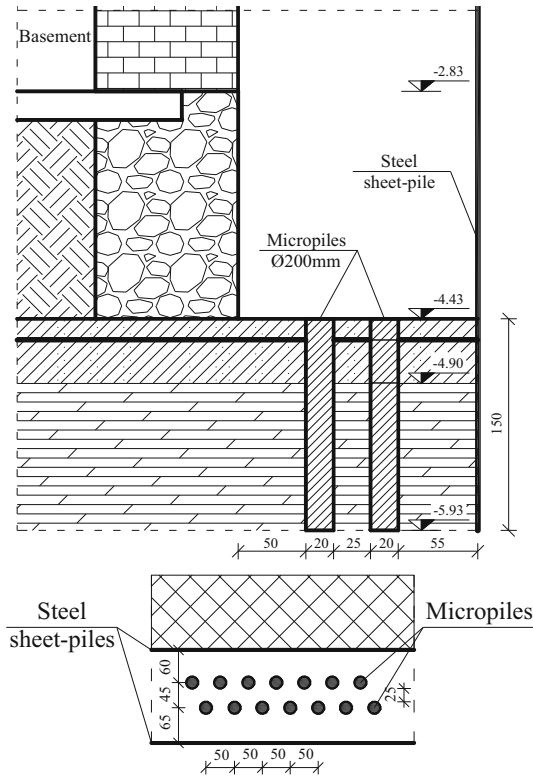
Fig. 10. a) The proposed soil stabilization solution; b) micropiles arrangement [16]

The underlying soil stabilization aiming to improve its strength and to increase the resistance to softening by water, can be achieved by jet grouting process. It consists of creating some micropiles under the existing foundation level, which have to be embedded in the good foundation soil (Fig. 10a). They need to be executed on the exterior contour

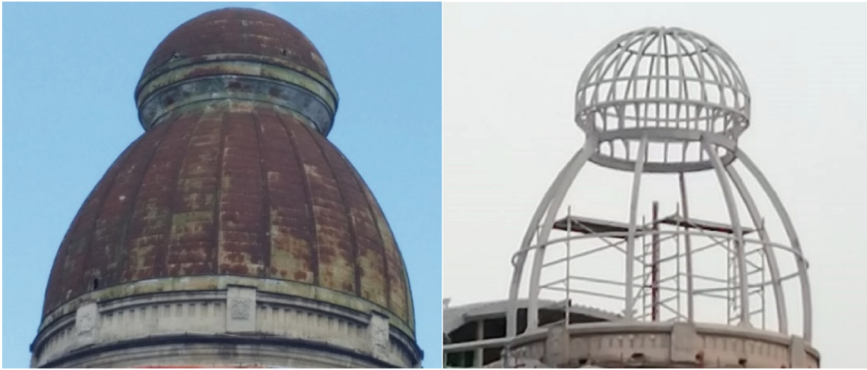
The integrity of the wooden roof structure and of the dome are badly affected by the water leaks and by the lack of maintenance works, which are so necessary in case of wood structural elements and of metal coverings (see Fig. 11).

Fig. 11. a) The dome metal covering badly affected by the environmental conditions [16]; b) current rehabilitation stage

Unfortunately, the severely damaged structure of the roof and of the dome cannot be saved. The entire wooden structure is intended to be replaced by a steel structure and the dome to be covered with a glass cladding system. The destination of the obtained space inside the dome is that of an art gallery, as the initial owner desired.

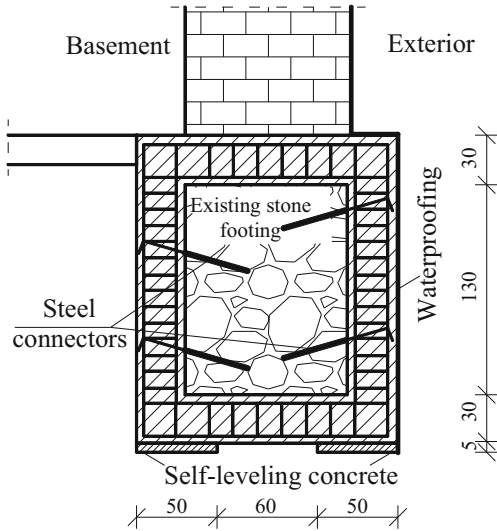
Fig. 12. Strengthening solution of the stone footings [16]

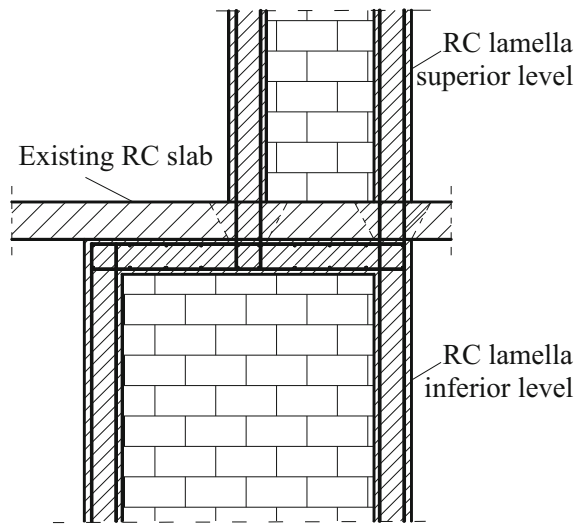
Fig. 13. Strengthening solution of the masonry walls with additional RC elements [16]

and by inserting some vertical RC elements (lamellar cross-section of 15–20 cm thickness) inside the structure of the load bearing masonry walls on the inner face, as shown in Fig. 13. At the same time, the chimneys embedded in the walls need to be removed and their structure to be reconstructed in order to improve their load bearing capacity. The use of a ring beam at the roof level is also needed to further enhance the structural stability. All these intervention measures have to be meticulously done so that not to impair much more the initial architectural features of the palace.
