Corrosion of AISI 316L Stainless Steel Pipe in a Complex Ammoniacal Medium

Keywords: Corrosion · Tube · Distillation · Ammonia · Incrustation

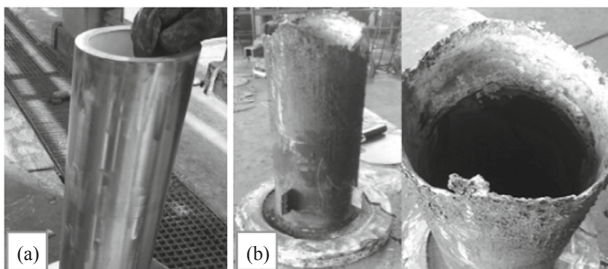
Fig. 2. AISI 316L stainless steel tube (a) new (b) after 12 months of industrial use.

Figure 2(b) displays the visual aspect of the tube, showing that the tube was deteriorated when compared with the new one (Fig. 2(a)). It can be seen that the length of the tube was reduced around 30 cm due to the exposition of ammonia, cyanide, sulfide, and chloride in an acid medium (pH of 5.05) subjected to high pressures and temperatures.

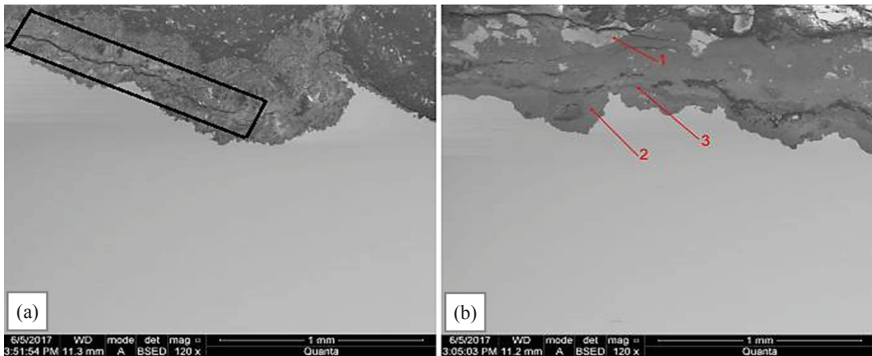
Figure 3 shows the electronic images of the most deteriorated region of the tube obtained by SEM. In the demarcated area, in Fig. 3(a), the crack propagation can be observed due to the sensitization of steel by the corrosive environment, such as by sulfides and chlorides, together with the high pressure of the steam and the distillation column [12, 13]. Table 4 presents the semiquantitative analysis of the spectra obtained by EDS of the areas numbered in Fig. 3(b), through which it was possible to identify the presence of corrosion product consisting basically of oxygen (O), phosphorus (P), and sulfur (S) elements.

Fig. 3. Electronic image with an approximation of 120x of the most deteriorated region (tip) presents in the tube, where (a) shows the demarcated area of crack propagation and (b) shows the points where spectra were obtained by EDS.

Figure 3 and 4 showed that the structure of the tip of the tube deteriorated. These images showed how intense the degradation of stainless steel was due to the contact with the compounds of sulfides, chlorides, cyanides, phosphates, and ammonia. It is observed that the material has a generalized corrosion, with many cracks and deformations on the exposed surface.

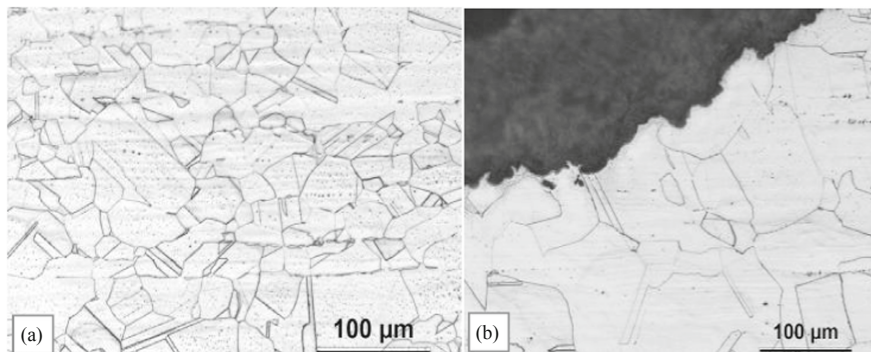
The micrograph of the tube, presented in Fig. 4, showed that the basic structure is constituted by austenitic matrix and little occurrence of ferrite. There were no structural abnormalities that could be associated with the tube corrosion; nonetheless, it is observed that the operating conditions to which the tube was submitted may have weakened this region. The small change in nickel and manganese content in Table 3 corroborates these data, as this material plays an important role in the stability of the austenitic structure at high temperatures [21–23].

Fig. 4. Micrograph of the tube after 12 months of industrial use, where (a) shows the basic structure present in the tube sample and (b) shows the microstructure in the corrosion region.

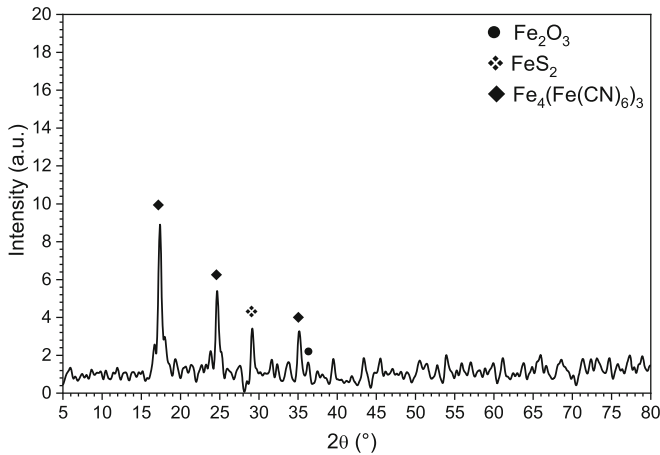
The composition of the incrustations was confirmed in XRD and XRF. The diffractogram is shown in Fig. 5, and the chemical composition of XRF is shown in Table 5. X-ray diffractogram of the corrosion deposits collected from the tube surface shown in Fig. 5 pictures the presence of characteristic peaks of ferric ferrocyanide (17.37° , 24.71° , and 35.16°), that responsible for the Prussian blue pigment found on the tube surface; of Pyrite FeS_2 (28.96°) and hematite Fe_2O_3 (36.04°). The presence of ferric ferrocyanide shows the influence of the cyanide ion on the corrosion process and in the deposit formation, since the Prussian blue coloration was also found in regions less deteriorated by corrosion [24]. The presence of hematite was also verified by XRF, as presented in Table 5, corroborating with the XDR analysis. As presented in Table 5 and Fig. 5, it was possible to verify that the column's operating temperature favored the formation of hematite in relation to other oxides, such as magnetite and goethite, probably due to the reactions occurring between the stainless steel and the compounds present in the column.

Fig. 5. X-ray Diffractogram of the tube incrustations after 12 months of industrial use.

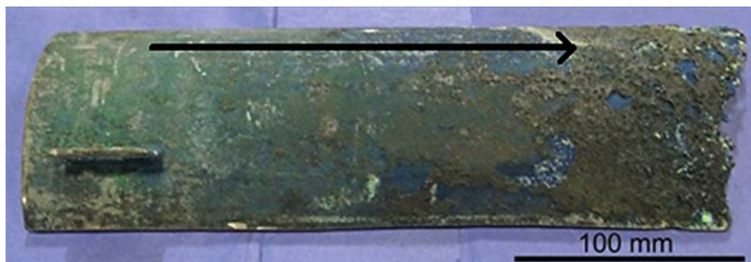
The joint action of the stresses caused by the fluid at this operating pressure and the medium's composition may have conditioned stress corrosion and wakening by hydrogen. In the tube shows in Fig. 6, it is possible to observe that the deterioration

intensity was greater in the area near the point that was completely submerged in the medium, as identified by the arrow.

Fig. 6. Visual analyses of the tube with the arrow indicating the direction of the steam flow.

As a suggestion to future work, it is interesting to explore ways to increase the useful life of steam injection tubes inserted in corrosive media, such as other types of materials or metal coatings to protect the material. It should also be used a higher number of samples to obtain more statistically significant results.
