# A Case Study of Slope Stability Assessment Thames River, London, Canada

Ron Xia<sup>1</sup>(✉) and Hui Qian<sup>2</sup>

<sup>1</sup> McClymont & Rak Engineers, Inc., Maple, Vaughan, ON, Canada

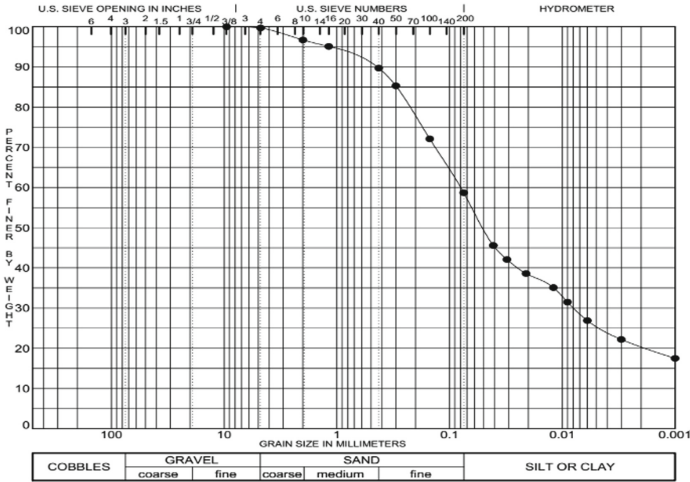
showing grain size analysis for a sample taken from the site are shown in Fig. 2. Results indicate that the sample soil is composed of 0.3% of gravel, 41% of sand, 33% of silt and 25.7% of clay. Soil samples taken for laboratory analysis and testing were collected on June 8<sup>th</sup>/2019. Locations of soil samples taken refer to Fig. 5.

**Fig. 2.** Gradation curve of a soil sample taken from the site at the bottom of the riverbank within the zone of slope toe, by the author, on June 8<sup>th</sup>, 2019.

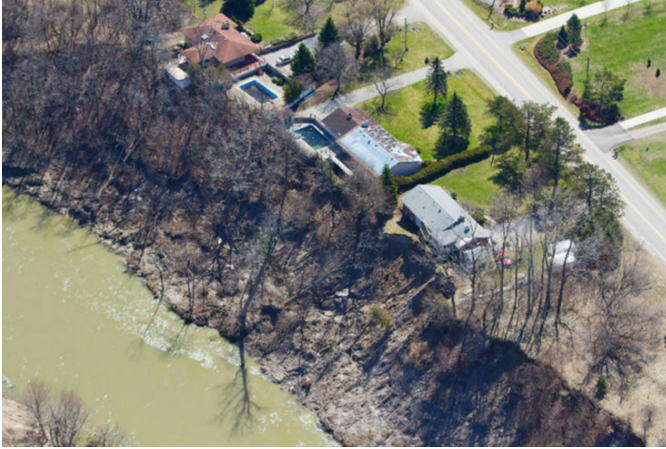
The site is in a critical condition of falling into the Thames River, as erosion of the banks is creeping ominously close to the homes (Fig. 3).

**Fig. 3.** Three homes on Adelaide Road are close to falling into the Thames River (Picture taking on April 17, 2013 by Mike Hensen 2013).

Home at bottom right in Fig. 3, was owned by David and Susan Shuttleworth. They bought the property and moved into house in 2001. The house was built up in 1969, right after the permit was issued. Backyard overlooking the Thames River was 40 ft long, if measured from the house to the top line of the riverbank slope (Patis 2014).

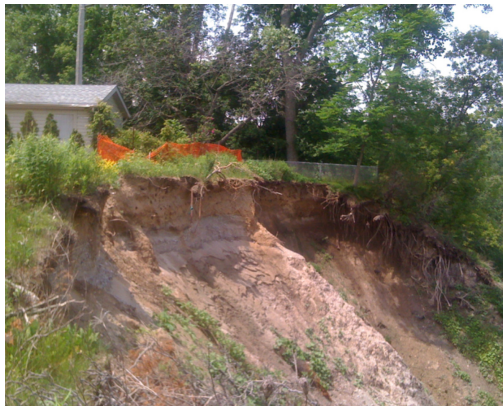
**Fig. 5.** Groundwater seeping out from sandy soil was observed at project site (picture taken by Ron Xia on June 11, 2015).

especially at the area of our study, contributes groundwater discharging to the river. Phreatic surface was high and groundwater draining/seeping out at upper zone of the bank slope was observed during our site visit on June 11, 2015 (Fig. 5).

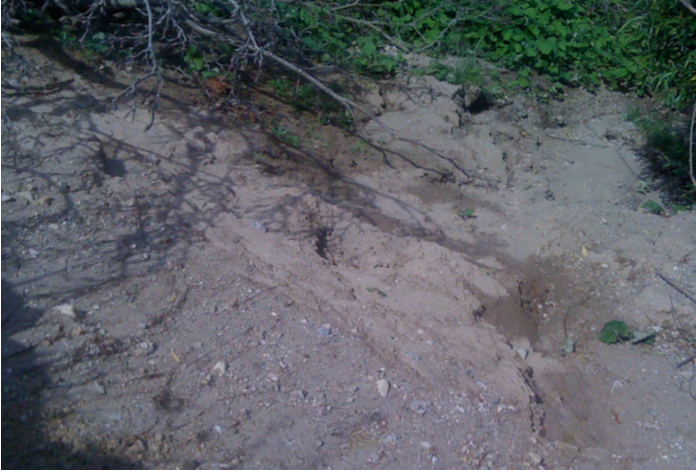
**Fig. 7.** Piping and mudflow was observed on bank-slope surface of Thames River at the study site (picture taken by Ron Xia on June 11, 2015).

Groundwater flow will slow down at the front of the substructures, raising water levels at local areas and seeking for new paths where soil is less competent to generate concentrated flow. The raised groundwater level and increased velocity at the area where saturated fine sand, silty sand, sandy silt and/or clayey silt is encountered, dilation/quick condition may happen at the surface of the bank slope, due to the increased hydrostatic pressure and hydraulic gradient (Fig. 7).

Fine material escaping and pore water status changing may create a commendatory condition to form localized collapse and stimulate slope erosion. Seepage erosion is also named as subsurface erosion and was well documented (Xia et al. 2002) and widely observed at the surface of bank slope at our project site (Fig. 7).

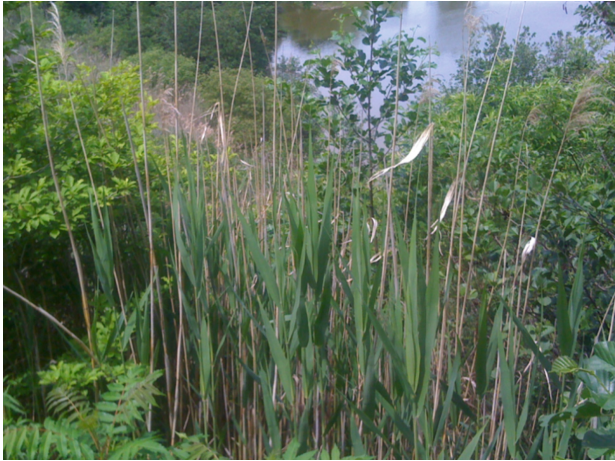
The impact of substructure on groundwater regime was found during our investigation. Caves formed by piping water at local area was noticed. Wetland plants reed-grasses growing on the bank slope top line were observed (Fig. 8). Wetland plants or vegetation cover the top of the riverbank slope would be an evidence of groundwater rising induced by subsurface barrier at the side of a former residence.

**Fig. 8.** Reed-grass grows on bank-slope top line of Thames River at the study site (picture taken by Tudor and Ron Xia on June 11, 2015).

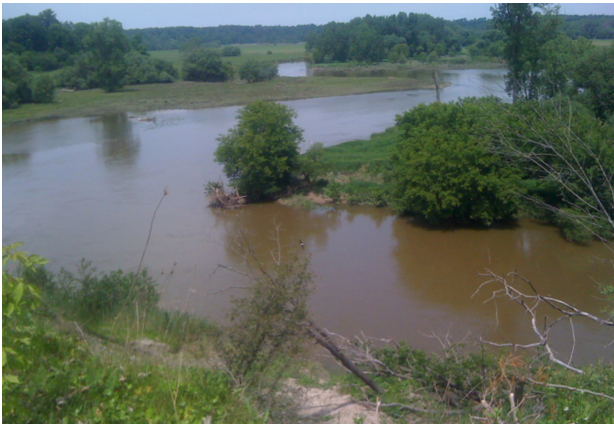
Streams of the Thames River cut through the sandy soil down to the base level of the river, creating steep-sided narrow *gulches* along its lower course. *Pool and riffle* formations are twisted. This alternating of deep (pool) and shallow (riffle) areas tends to be continuing a relatively long-term process (Fig. 11).

**Fig. 11.** Aerial view of tortuous meanders at the section of project site of the Thames River (picture taken by Ron Xia on June 11, 2015).

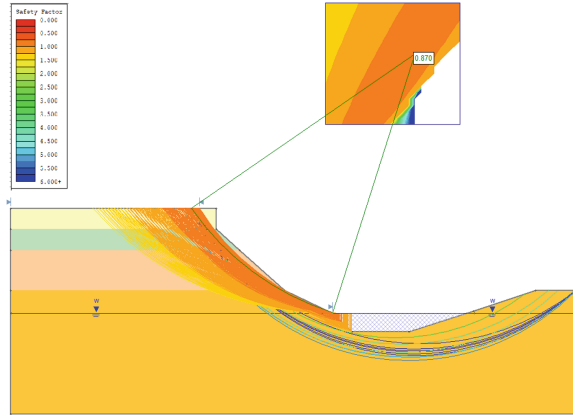
Results of computer analysis indicated that Factor of Safety  $FS = 0.87$ , for the existing riverbank slope at the section in our case study area. Factor of safety equal to 0.87 is less than the criterion required by Ontario Ministry of Natural Resource (OMNR). As a result, the existing slope cannot be considered as a long-term geotechnical stable slope (Fig. 13).

**Fig. 13.** Stability analysis for a section of existing slope, using Rocscience Software Slide 6.0, indicated Factor of Safety  $FS = 0.87$  (Analyzed by Ron Xia 2019).

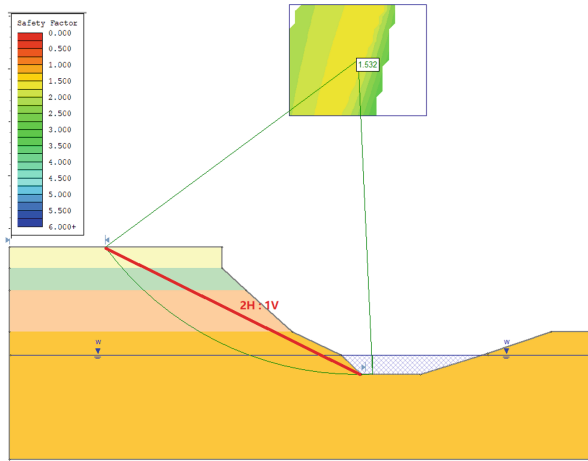
Back calculations were carried out on purpose of searching for long-term stable safe slope (LTSSS). With Factor of Safety equal/greater than the required criteria of  $FS = 1.5$  for long-term stable slope, the theoretical calculated inclination would be about 2H: 1V (Fig. 14).

**Fig. 14.** Long-term stable slope back calculated, using Rocscience Software Slide 6.0, with inclination 2H: 1V (Analyzed by Ron Xia, 2015).
