Lessons and Mitigation Measures Learned from One Deep Excavation Failure Case

Wei Xiang, Yu-shan Luo^(✉), and Zhi-rong Liang

Shanghai ShenYuan Geotechnical Co. Ltd., Shanghai 200011, China

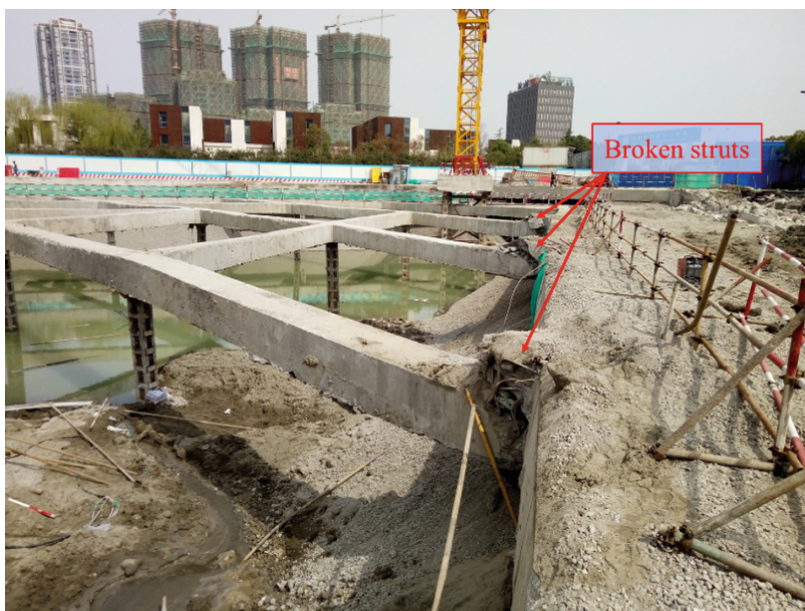
Fig. 3. Picture of the failed deep excavation

In order to avoid further expansion of the settlement and damage, the emergency plan was adopted in-time. The northeastern and northwestern part was temporary backfilled until the deformation was stable. Specially, the areas closed to retaining piles were backfilled with gravel soil (adding some cement slurry as soil improvement) to help control deformation. The distribution range of backfill treatment could be seen in Fig. 4.

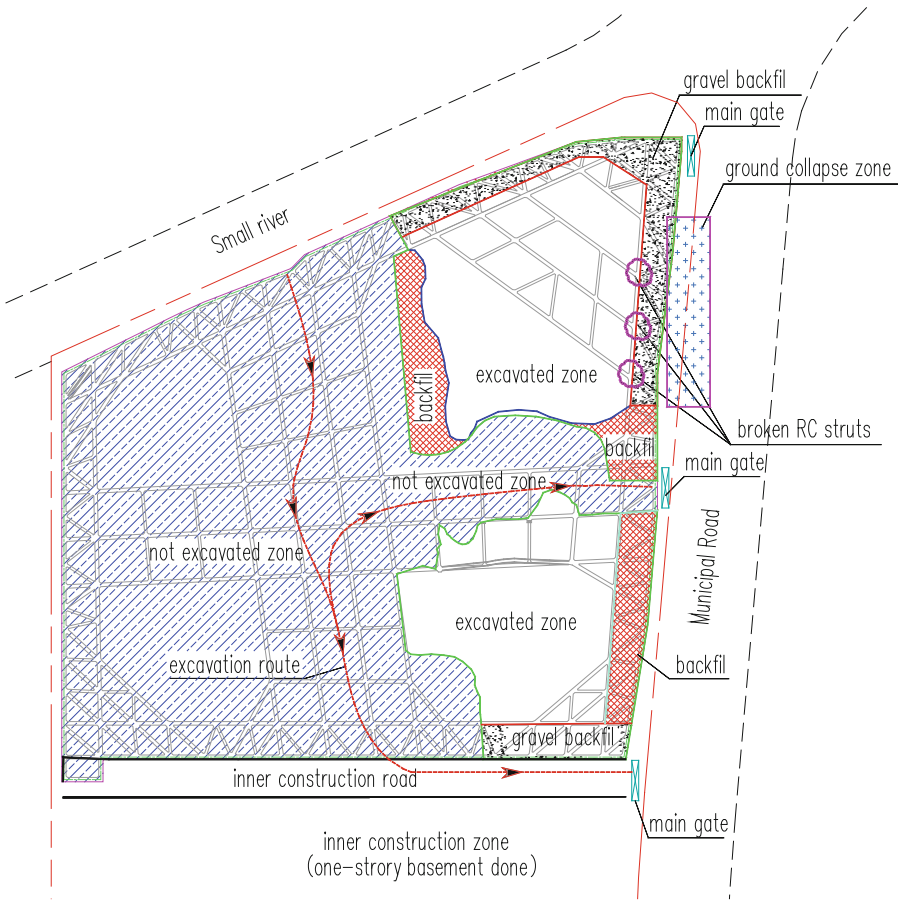
Fig. 4. Schematic diagram of the failed excavation (broken RC struts was marked by circles) and temporary backfill treatment

Table 2 indicates that the length of tested retaining bored piles were all insufficient, 0.46 m–1.60 m shorter than original design. According to the geotechnical investigation report, the elevation of bottom of Layer ④ was -12.05 m--14.19 m. The shortest tested piles probably embedded only 0.31 m underneath Layer ⑤1-1, where the insufficient embedded depth was too small to provide anchoring force. Large deformation thus generated quickly from the bottom and finally led to “kicking” failure of the whole excavation.

The original design required the RC struts to be straight so as to decrease the external forces. However, the in-situ investigation found out that at least 21% of the struts in excavated zone had deflection like fish belly beyond the requirements of design and standards. In the northeast side of the excavation where struts had visible ruptures or even broken, a series of investigations detecting the reinforcement and concrete qualities were carried out in 15 different RC struts by Company C. The investigation indicated that the reinforcement arrangement and quantity of the tested struts basically meet the original

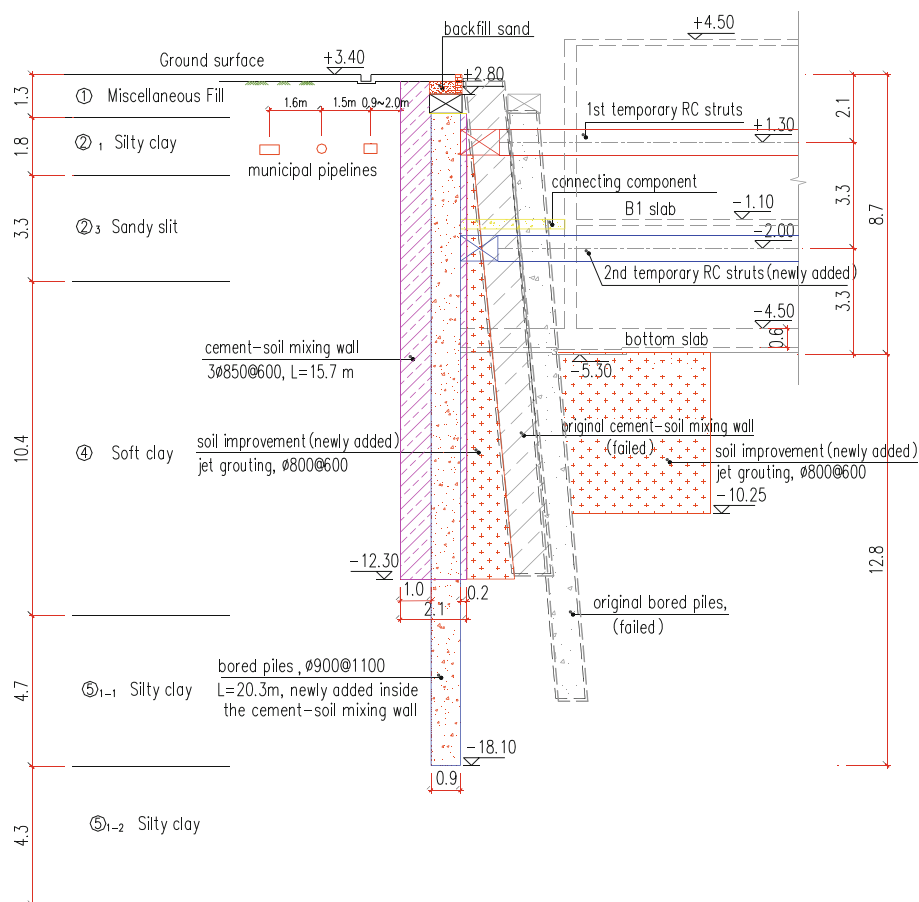
Fig. 5. Typical mitigation measures of retaining structures at the failed zone (Mitigation measure B)

Besides the mitigation measures in Mitigation measure A, the following measures are still needed (refer to Fig. 5).

1) clear underground obstacles and increase ground stiffness with deep cement-soil mixing wall; 2) install new bored piles inside the deep cement-soil mixing wall; 3) improve soils between the original failed retaining pile and new retaining piles, and those inside excavation (under the bottom).
