# Microscopic and Durability Evaluation of In-Situ Extracted Internal GFRP Reinforcing Bars After Temporal Exposure

Ali F. Al-Khafaji<sup>1</sup>, John J. Myers<sup>1</sup>(✉), and Antonio Nanni<sup>2</sup>

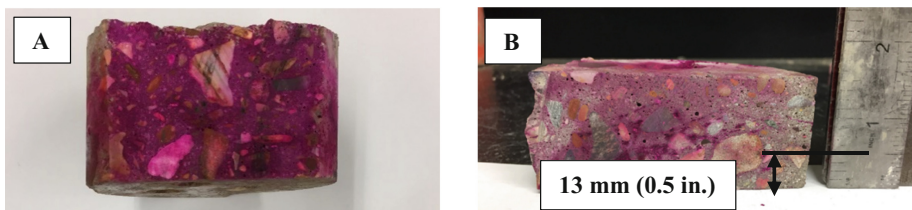
**Carbonation Depth** – This test was performed to see if there were any signs of carbonation reaction which is the reaction of  $\text{CO}_2$  from the atmosphere with the alkalis from concrete. When carbonation reaction takes place, pH level of concrete decreases to around 10 or 9. As a result, the concrete layer became relatively acidic. It has been suggested that when the carbonation depth is equal to the concrete depth corrosion occurs (Wang 2017). RILEM-88 (RILEM and Materials 1994) was utilized in this study to perform the test where a 1% of phenolphthalein-70% ethyl alcohol solution was sprayed to a fresh cut of the concrete surface. If there were carbonations on the concrete surface, the surface color would not change due to the acidic environment, otherwise the surface color would turn into purple color due to the alkalinity of surface. The more purple the surface is, the more alkalinity is available. In Southview Bridge, the test results were negative which confirms the high results of pH found in that concrete. In Sierrita de la Cruz Bridge, some spots of carbonations about 13 mm (0.5 in.) was found. The results are shown in Fig. 3.

**Fig. 3.** Carbonation depth (A) Southview Bridge, (B) Sierrita de la Cruz Creek Bridge

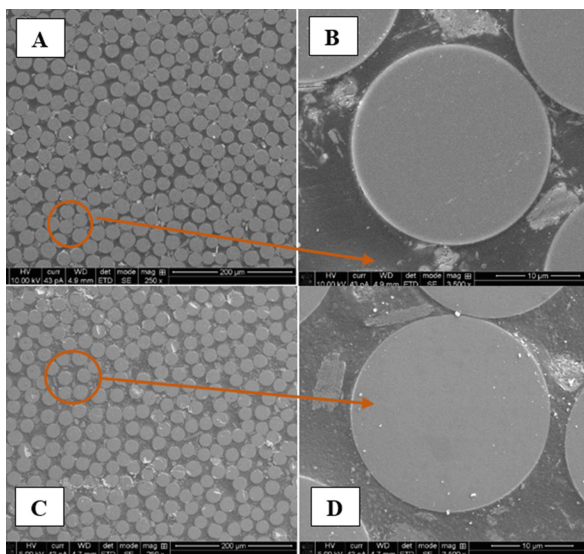
**SEM Test** – This test was carried out to see if there were any microstructural degradations resulted from the real-time weather exposure. Slices of  $25 \times 25 \times 25$  mm ( $1 \times 1 \times 0.25$  in.) were cut from the bridges' cores and were then ground using different levels of sand papering. After that, the specimens were then polished and coated with gold to make the specimens conductive (since neither glass fiber nor concrete is conductive). After that, the specimens were conditioned to get rid of any excess moisture picked up from preparation of samples. The samples were then tested in the SEM apparatus where different magnification grades were explored to examine not only the surface of GFRP bar for microstructural deteriorations, but also the interfacial transition zone (ITZ) between the concrete and bar. The tests results showed that there were no obvious signs of microstructural deteriorations in fibers, resin, and neighboring areas of the bar. Also, there were no distinct signs of bond loss around the ITZ of the concrete-to-bar. Figure 4 shows SEM images from the tested bridges.

**Fig. 4.** SEM images (A) Sierrita de la Cruz at 250 $\times$  magnification, (B) Sierrita de la Cruz at 3500 $\times$  magnification, (C) Southview at 250 $\times$  magnification, (D) Southview at 3500 $\times$  magnification

within its embryonic stage, because SEM tests results did not show any obvious signs for chemical-related deteriorations.

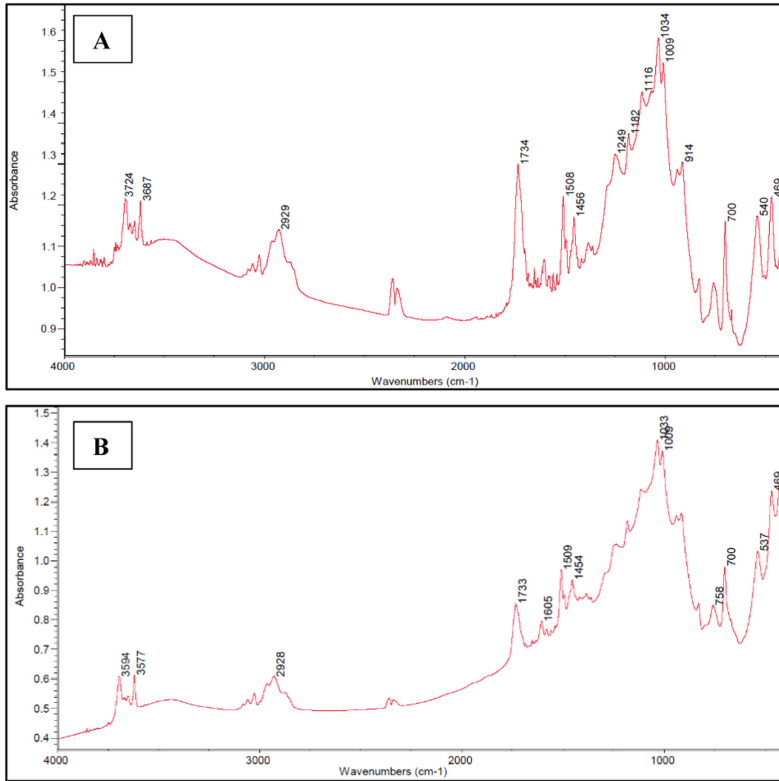
**FTIR Test** – This test was carried out to check for the hydroxyl levels in the GFRP. The pH levels of one of the bridges (Southview) was high, therefore this test was necessary to conduct. Small chunks of the GFRP bar were taken around 2 mg and were then ground with bromide potassium (KBr) to make a halide disk. The specimens were then exposed to infrared in the FTIR apparatus. In Sierrita de la Cruz, the hydroxyl group were found to be within the normal range which is between  $3000$  and  $3600$   $\text{cm}^{-1}$ . On the other hand, in Southview Bridge, the results of hydroxyl group were a little high (a little over  $3700$   $\text{cm}^{-1}$ ). This confirmed the high pH seen in the concrete core. Figure 5 shows the FTIR results.

**Fig. 5.** FTIR test results (A) Southview Bridge (B) Sierrita de la Cruz Bridge

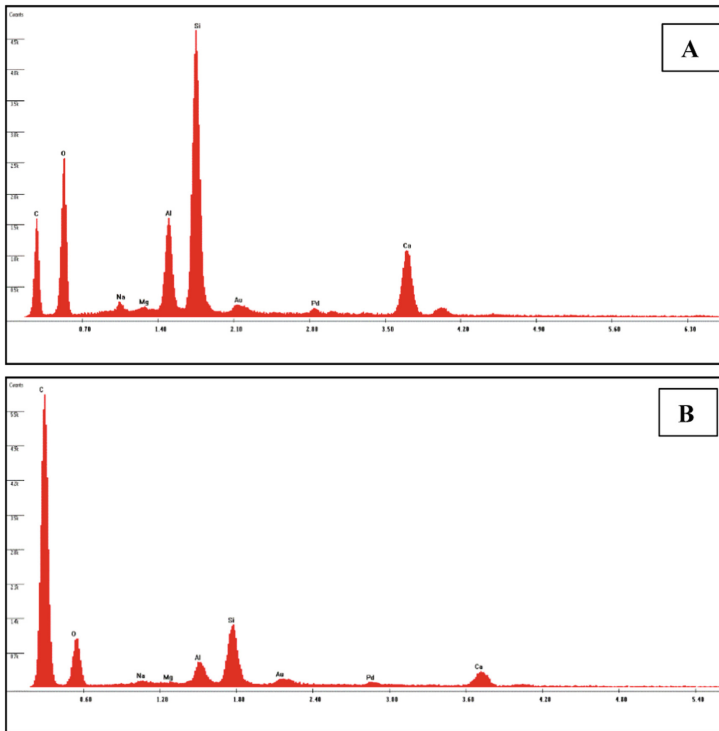
leaching issue might take place. Leaching in fibers is the process where the alkalis of fibers are extracted by hydroxyl group to form a more stable chemically compound such as sodium hydroxide (Nkurunziza et al. 2005). It is important to note that EDS apparatus cannot detect elements lower than sodium, and appearance of alkalis in the resin matrix can be used as a sign of leaching. In this test, a 10–20 keV electron was exerted on the same specimens used for SEM test. The results showed that there were no zirconium which confirms the glass fibers were not alkali-resistant type of fibers (Kamal and Boulfiza 2011). Furthermore, the constituent's elements of fibers were detected including aluminum, calcium, silicon, sodium, and oxygen. In addition to those elements, magnesium was observed too which confirms that the fibers were E-glass and not ECR-glass (Gooranorimiet al. 2016). Elements such as gold and palladium were detected too, but they were present as a result of coating process of the specimens. For the resin, carbon, the main element, was found as well. In Sierrita de la Cruz, all the main elements of fiber and resin were detected. However, sodium, and silicon were seen in the resin too which can indicate for alkali-hydrolysis attack and/or leaching issue (Kamal and Boulfiza 2011), but those elements were detected too in the control specimens as well as, to further confirm, the pH results were within the normal range (not high enough to make the environment highly alkaline). In Southview Bridge, the main elements were seen too, but sodium and silicon were detected in the resin. The pH results of this bridge were a little high, so there is a significant chance for alkali-hydrolysis attack at least a little. To confirm the attack, FTIR test was performed to reveal the hydroxyl levels in the GFRP bar. The FTIR test results showed a high hydroxyl level, therefore there is a strong chance that alkali-hydrolysis occurred. However, even if it did occur, it is still

**Fig. 6.** EDS test results of Sierrita de la Cruz Creek Bridge (A) fiber (B) resin

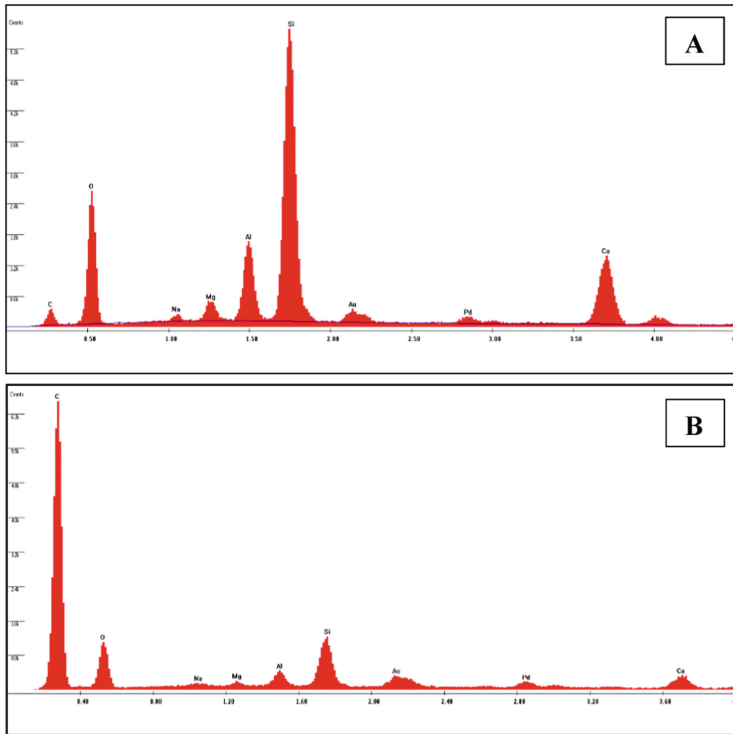
Fig. 7. EDS analysis of Southview Bridge (A) fiber (B) resin
