# Application of Non-destructive Techniques for the Investigation of Old Masonry Structures

**Abstract.** This study aims at the acquisition of a reliable image of the non-visible parts of historical masonry buildings in Greece by in-situ application of non-destructive techniques (NDTs). To serve the purpose of obtaining overall conclusions on the documentation of the monuments' internal condition, the deriving results are examined and combined together with the in-situ observations. The structures under investigation are the Katholikon of Osios Loucas Monastery (Boeteia), the Monastery of Kaisariani (Attica), the Agia Paraskevi Church (Chalkida) and the Nativity of Christ's Church (Athens). The main investigation method applied on all monuments was that of the Ground Penetrating Radar. Additionally, the methods of Boroscopy and Schmidt Hammer Testing were also used when further investigation was required. The techniques were applied on targeted areas, representative for the entire examined structure. Thanks to the assessment of the results, it was possible to identify data relevant to the dimensions and the type of stones used in the piers and the three-leaf masonries, the thickn

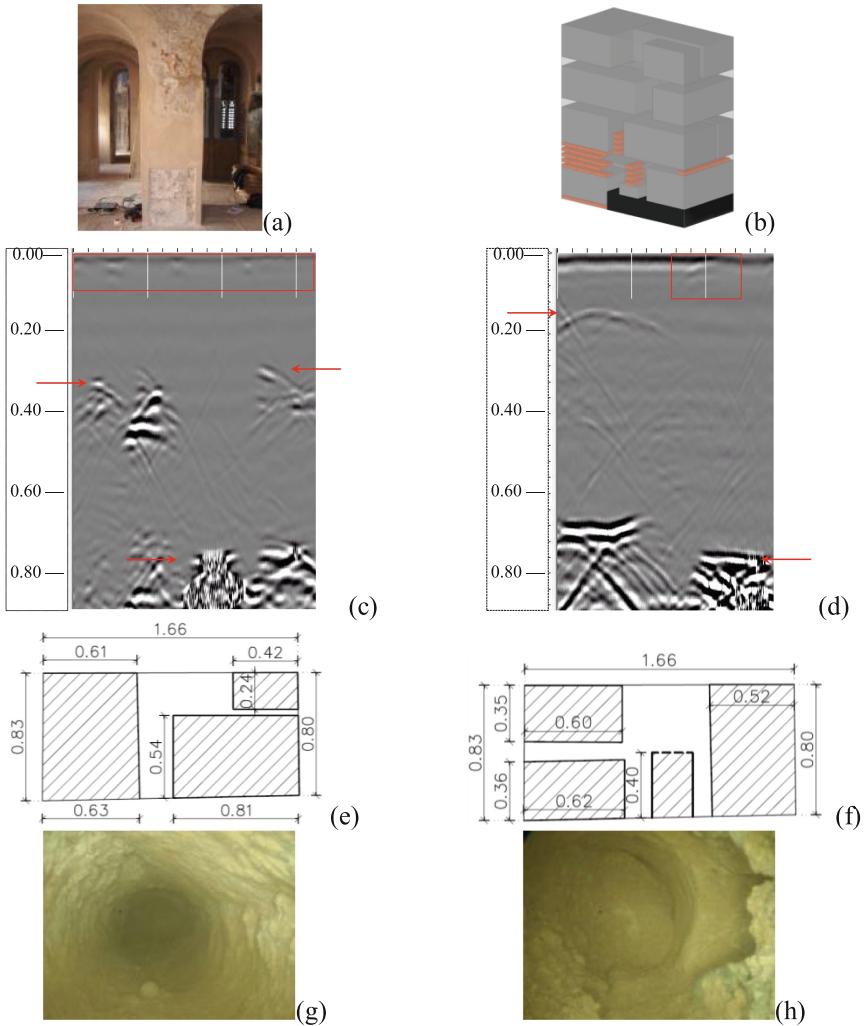
**Fig. 2.** (a) Pier Y25 of the Yperoon, (b) Three-dimensional drawing of the pier, depicting the overall findings of the visual inspection and the applied NDTs, (c) Radar profiles of vertical and (d) horizontal path along the pier: the arrows indicate the thickness of the identified distinct stones, whereas the frame denotes reflections created due to the presence of bricks, (e)– f) Horizontal sections at two levels (0.30 m and 0.80 m respectively), measured from the floor level, as derived from the GPR findings and the visual confirmations (where possible). Only the stones, and not the bricks, are depicted in the sections. (g),(h) Images taken at various depths (45 cm and 49 cm, respectively) of the borescope’s path along the hole drilled in mortar area, between stones placed up and down.

As observed in Fig. 2(c) and (d), the reflections corresponding to the adjacent stones are strong and very clear. Thanks to the penetrating capacity of the antenna, the entire thickness of the pier could also be identified, in some cases. By combining the scans of the grid, the horizontal sections in two different levels are drawn (Fig. 2e, f), revealing a solid construction, with large-size cut stones, interconnected along the vertical axis of the pier. As visually noticed, also bricks were used at specific areas of the pier at its lowest part, depicted only in the three-dimensional drawing (Fig. 2b). The findings correlate well with those reported in Vintzileou et al. 2008, where similar observations yielded regarding pier Y32 of the gallery.

As for the nature and the quality of the mortar, its investigation was attempted via boroscopy. It seems to be rather stable and uniform along the hole, as illustrated in Fig. 2 (g) and (h). The perimeter of the hole provides the observer with information relative to a stone surface (up and right- Fig. 2g). The stone is visible until a depth that is lower than its thickness, as estimated with the radar. This could indicate that the stone is semi-cut, so its surface does not follow the axis of the horizontal hole, and therefore, its entire dimension cannot be identified with the borescope. Also, the existence of some voids of insignificant magnitude (right- Fig. 2 h) can be identified.

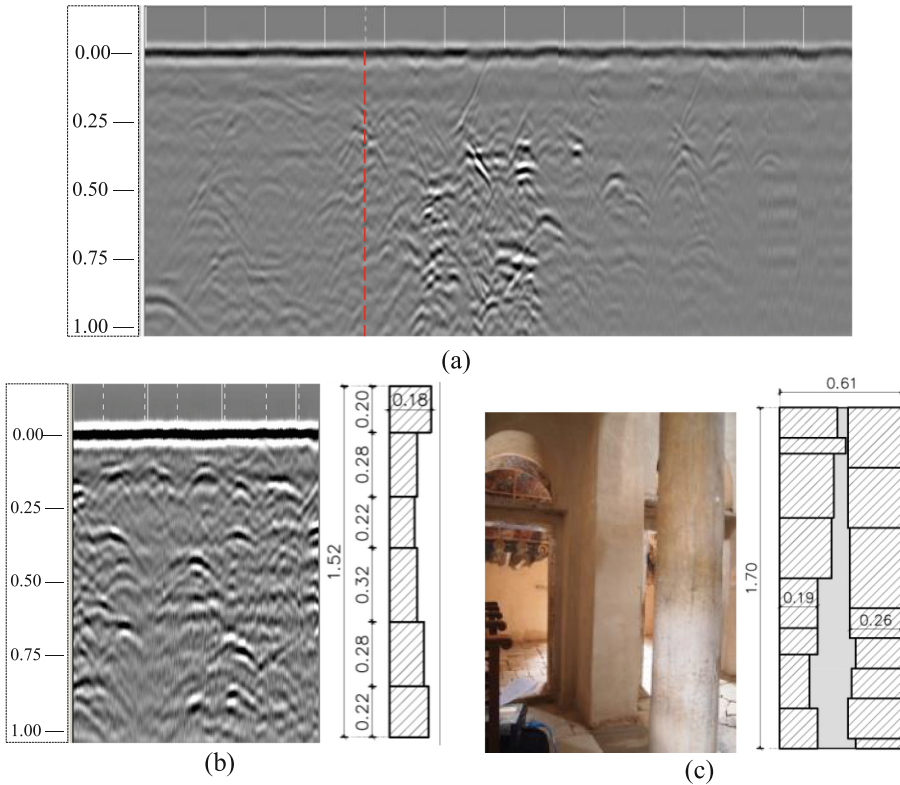
It is noted that in some areas the obtained radar images are not reliable: The stones are of small dimensions, leading to the acquisition of multiple reflections, the humidity in the lower part of the masonry may be high, decreasing the accuracy of the obtained image, while, on the other hand, the radar images differ between parts of the masonry constructed in different phases (Fig. 3a). Nevertheless, the systematic radar measurements together with the application of the boroscopy gave the possibility of measuring the width of the exterior masonry leaf in most of the areas of the monument (Fig. 3b), and drawing conclusions about the construction type of the piers (Fig. 3c).

**Fig. 3.** (a) Radar profile of horizontal scan at the exterior (Northern façade). The red line stands for the limit between the two different construction phases, (b) Radar profile of vertical scan at the east façade of the Katholikon and the respective masonry section, (c) The scanned masonry pier and the vertical section deriving from the radar measurements. Only indicative dimensions are provided in the sections.

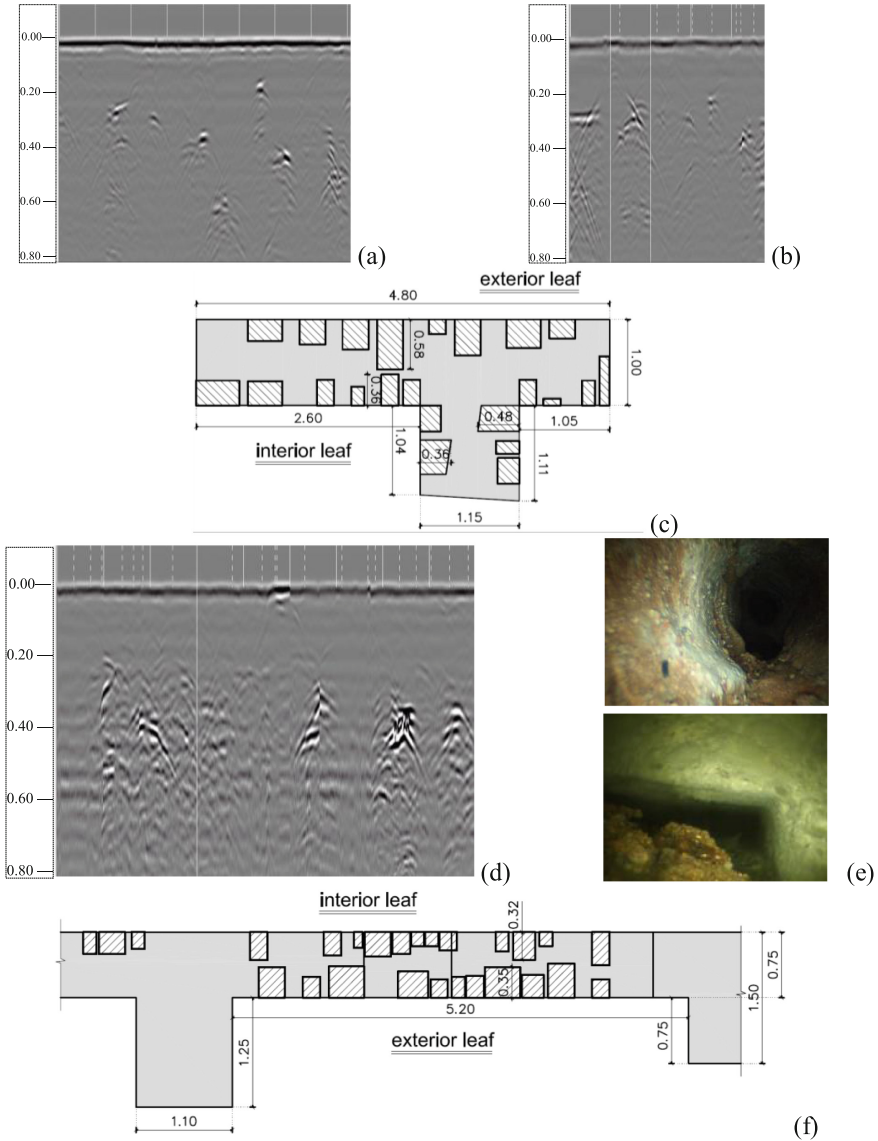
The most important findings from representative areas of the west and south perimeter walls are presented herein. Since the same number, level and direction of scans was kept for the interior and the exterior leaf of the three-leaf masonries, the direct combination of the findings became feasible. Regarding the west examined area of the monument, the façade is covered with plaster, whereas the interior is not, allowing thus for the positions of the stones and bricks to be known. Despite the presence of plaster at the façade, the obtained image has great clarity, with strong reflections indicating the thickness of the stones comprising the exterior leaf (Fig. 4a). The image of the interior is also clear, and the vertical short dotted lines of the file (Fig. 4 b) denote the joints between adjacent stones. Local horizontal sections depicting the geometry of the three-leaf masonry can be reproduced and, as observed in Fig. 4 (c), the average thickness of the infill is not negligible; a fact that demonstrates that further investigation is required.

This is valid for the south examined area (Fig. 4f) as well, where the thickness of the infill is estimated to be slightly smaller. The radar image exhibited less clarity (Fig. 4d), as the existence of numerous interfaces made the accurate interpretation of the files rather questionable, especially at areas constructed extensively with bricks. As structural units with various characteristics (cut-stones, rubble stone, oblong stones, bricks) have been used at the examined areas and different construction phases coexist in the structure, the acquired images significantly vary from region to region. For an overall survey of the south masonry, two interior positions were also examined with the borescope: the captures of Fig. 4(e). The first image corresponds to hole positioned right by gothic stone of the interior south wall, in proximity to the Sanctuary. The surface of the stone can be clearly identified at the left side of the hole's perimeter, as well as the drilled mortar of reddish shade. In a short distance within the same area, another hole is drilled (Fig. 4e-second image) right over a horizontally placed long timber element, at area where a buttress exists at the exterior. The images taken from this position are significantly different compared to the previous one: the light-colored mortar is unstable, powdered due to drilling, and several voids can be identified. In addition, near the end of the hole, a rectangular cross-section can be clearly observed together with a dark-colored fragment, which could be an indication of timber element position.

**Fig. 4.** (a) Radar profiles of horizontal scan at the exterior and (b) respective horizontal scan at the interior of the examined west area: the clear reflections correspond to the thickness of the identified distinct stones, (c) Horizontal section of the west wall, at the level of +2.0 m measured from the ground floor, as derived from the GPR and the visual findings, (d) Radar profile of horizontal scan at the exterior of the examined south area, (e) Images taken at various depths (24 cm and 95 cm respectively) of the borescope's path along two different holes in the examined south area, (f) Horizontal section of the south wall, at the level of + 1.70 m measured from the ground, as derived from the GPR and boroscopy findings. Only indicative dimensions are provided in the sections.

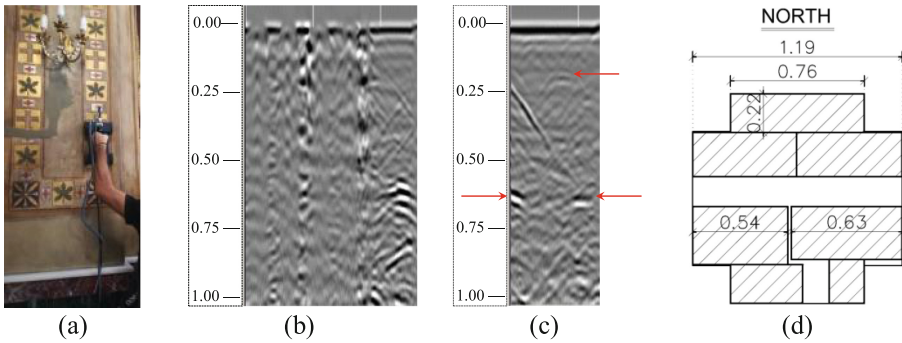
The great effect of the frescoes on the radar image is depicted in Fig. 5(b): when the antenna crosses the area where gold color has been used in the frescoes (Fig. 5a), the signal propagation is totally obstructed and no information can be acquired by the image. When the antenna is moved in other areas of the same side of the pier, a very clear profile is obtained, as observed in the vertical scan of Fig. 5(c), where the thickness of the adjoining stones is depicted with clarity, revealing the consistent interconnection between them. Thanks to the existence of adequate surfaces without frescoes, the geometry of the pier can be represented in indicative horizontal sections (Fig. 5d).

**Fig. 5.** (a) Scanning on the frescoes of the pier, (b) Radar profile of vertical path along the pier: the gold color of the frescoes does not allow for the propagation of the signal, (c) Radar profile of vertical scan along the pier, path without frescoes: the arrows indicate the thickness of the identified stones. (d) Horizontal section, as derived from the GPR findings: only indicative dimensions are provided.
