Two Year Exposure of 3D Printed Cementitious Columns in a High Alpine Environment

Timothy Wangler¹(✉), Asel Maria Aguilar Sanchez¹, Ana Anton², Benjamin Dillenburger², and Robert J. Flatt¹

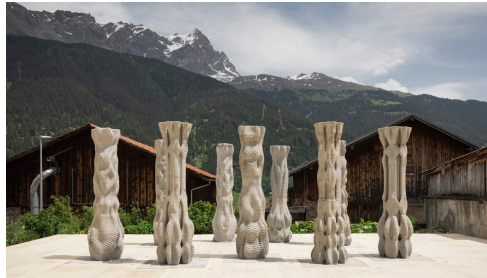
Steel reinforcement cages were inserted and the inner core was cast with a standard C25/30 concrete between 7 and 30 days after printing. Casting took place in two sessions, with half of the core filled first, and the rest of the core filled two days later. The columns were then transported via truck from the production site to their installation site in Riom, Switzerland in early June 2019. The columns were initially left open on the top, accumulating rainfall during the summer of 2019, before having a bituminous layer applied on top to seal them. The bituminous layer has degraded over the two years on certain columns, likely due to wildlife and moisture (Fig. 2).

Fig. 2. Concrete Choreography columns in Riom, Switzerland, in June 2019. (Photo: Benjamin Hofer)

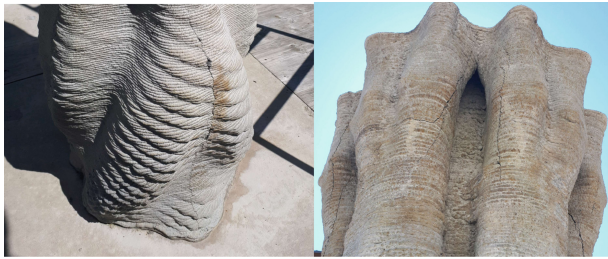
The vertically oriented macrocracks have been observed in the first trip, with a small increase in number on the next trip, depending on the type. These cracks are predominantly associated to the columns that have been designed via trigonometric functions, tend to be closer to the bottoms of these columns, and tend to track within depressions. A particularly severe example is shown in Fig. 3 (left). On the columns of the mesh subdivision typology, macrocracks are much less common, but tend to be associated to the top of the columns (Fig. 3, right), especially where moisture can accumulate. This type of damage is also observed on the tops of some of the trigonometric typologies, but only where the moisture can pool.

Fig. 3. Macrocracking damage observed on columns. (left) Vertically oriented crack near foot of a trigonometric typological column. (right) Cracks near the top of mesh subdivision typological column, in areas where moisture could pool.

The observed macrocracking of these columns is most likely due to one of two reasons: 1) thermal or shrinkage cracking, or 2) water pooling and freezing. Both of these mechanisms are most likely at play, depending on the design. For example, large, vertically oriented macrocracks tended to be associated only with the trigonometric typology, and one can see in Fig. 1a that the external shell is rather far from the core, with a very high effective diameter, and only connected by a few “spokes”. As this exterior shell shrinks, its only restraint comes from the concrete slab at the bottom and the “spoke” points. Stresses should tend to concentrate in the depressions and protrusions as well, which is what is observed. All of these observations point to shrinkage cracking as the main culprit in this typology. These cracks did not significantly worsen from the first trip to the second, as well, indicating that most of this type of damage was already completed within the first year, and corresponding to shrinkage processes.

The macrocracking that appears in the mesh subdivision typology, however, is more likely due to freezing. As seen in Fig. 1, there is not an exaggerated exterior shell diameter, so shrinkage stresses are lower compared to the trigonometric typology, and overall these columns are in quite good condition from a macrocracking standpoint. The cracks in the top of the column appear only where water can pool at the top, are only evident in columns with poor coverage of the top bituminous layer, and worsened from one year to the next, indicating a repeated damage process such as freezing and thawing. As a final point on the macrocracking issue, it should be stated that water pooling and freezing at the bottom of the trigonometric typological columns could also be a contributor to the cracking on those columns.

Overall, the main conclusions that can be drawn from this study are that for printed formwork columns, the design plays an enormous role in durability. Obvious design rules such as minimizing zones of moisture accumulation should be taken into account, but it should also be noted that if printable concrete is acting as formwork, the tendency to shrink on the cast concrete core should be taken into account by proper material matching, or adequate mitigating measures. The connection between processing and durability must also be investigated more thoroughly, especially as tight process requirements tend to limit certain fixes, such as adding an admixture.

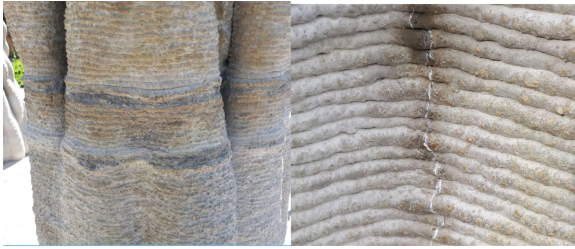
Superficial granular disintegration is depicted in Fig. 4 (left). This type of damage is rather widespread on all columns and not generally associated to macrocracking, but is sometimes more severe in specific areas, such as specific layers, and of note is that this particular column suffered a production pause of 45 min where the damage is the highest. Similar to the granular disintegration, efflorescence was observed globally, especially in the first trip. However, strongly localized efflorescence could be observed in some macrocracks, as seen in Fig. 4 (right). A scraping and subsequent analysis of the efflorescence revealed predominantly alkali carbonates. These high concentrations of efflorescence also tended to be associated with darker spots on the cracks of the columns, indicating high local moisture transport.

Fig. 4. (left) Superficial granular disintegration, where filament protrusions can be seen to have eroded. The high damage zone on the bottom is associated with a cold joint. (right) Efflorescence in a vertical macrocrack, with dark zone indicating moisture.

The granular disintegration can possibly be caused by either crystallization of salts, or freeze-thaw damage, but more likely from the latter. Another study has shown that a similar printed mixture to the one of these columns starts showing superficial granular disintegration after about 150 freeze-thaw cycles [5]. With five months where the average low temperature dips below zero in Riom, this amount of cycles can certainly be reached within a year or two. It is also worth noting that this damage was observed to have worsened from one year to the next, indicating a continual degradation from freeze-thaw cycles. Localization of this damage, especially to certain layers, could also indicate a certain dependence of the material properties to susceptibility of this type of damage.

It is possible that certain layers where the production process was not consistent, for example with either too much or too little fluidity, allow for locally susceptible points for damage, as seen in Fig. 4.

The efflorescence indicative of salt crystallization did show some interesting aspects related to moisture transport. The near global presence of efflorescence on all columns indicated that the general movement of moisture out from the core, and localized efflorescence tended to come from areas where moisture accumulated as well, further highlighting the need to understand how design and moisture transport could be inter-linked. Finally, while damage from freezing seems to be the source of the disintegration observed, salt crystallization cannot be completely ruled out as a reason.
