Analysis of Dynamic Compaction Effects – Tavira Case Study

Abstract. Ground vibrations are associated with different types of elastic waves propagating on the ground, and wave propagation depends on the soil stiffness, dumping and distance from the source. Urban activities also generate vibration, which are mainly associated to traffic of heavy vehicles, railway compositions, infrastructures construction, and maintenance. On site construction, ground wave propagation occurs when pile driving, dynamic compaction, blasting, and operation of heavy construction equipment is required. Regarding vibration energy analysis in structures, the Peak Particle Velocity (PPV) is the reference parameter and according to the Portuguese standard NP 2074 (2004), “Evaluation of the vibration impact on buildings, caused by explosions or similar construction procedures”, the PPV can range from 5 mm/s up to 20 mm/s, for rigid structures founded, respectively, on sandy soils and soft clays, or rocks and hard clays. The study hereby presented is a real case study where the effect of heavy vibratory tandem compaction, associated to the construction of an industrial parking in the vicinity, caused extensiv

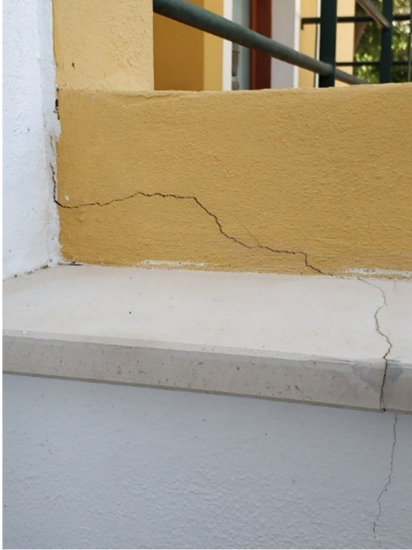
A technical assessment was carried out to determine the extension of the damages on the building, affected by the vibrations, and no structural anomalies were founded. However, extensive non-structural pathologies were easily perceptible and visible, especially on the wall coverings and ceilings, both exterior (Fig. 7a, b) and interior (Fig. 7c, d).

a) Joint displacement with implication to other elements of the contiguous dwelling.

The equipment, initially used for the parking sub-base and base aggregates compaction, could be considered adequate and efficient for the purpose if the rocky substrate was not so close to the surface. Also, the compaction roller drums frequencies were within the range of values usually used in this type of soil. This parameter is not the most determinant in the compaction effect, but it is for vibrations propagation. Thus, given the proximity to other structures built in the area, it can be stated that the initial compaction equipment was not the most appropriate, having transmitted the vibration into the rocky substrate, which were subsequently transmitted to the building foundations and superstructure.

Regarding the interior wall coverings repair, it was proposed the replacement of the cracked ceramic elements, as well as the ceiling/crown molding, followed by a complete painting. For the external elements, a slimy armed mortar was prescribed. However, the criteria requests for waterproofing, permeability to water vapor, support compatibility, and durability had to be taken into consideration when choosing the coating. The repairing procedure for the affected regions, was:

1. Pressure water washing to remove non-adherent paint, dirt, and other contaminants. Surfaces should be dry and without residues of aged paints afterwards.
2. Treatment of fungi with Antibiosis Decontaminant, N/Ref. 18-220, and wait 24 h before painting.
3. Plastering, with proper mortar, the bigger cracks, and for the smaller ones application of "Tapa cracks, N/Ref. 18-110".
4. Application of Primary Cynolite HP, N/Ref. 10-850 on the repaired areas.
5. Application of a general fiber mortar Princol, N/Ref. 29-573.
6. Application of a sandy mortar, N/Ref. 29-575, for plaster regularization. The painting should only be done after 10 to 12 days after the mortar.
7. Application of a primary layer of painting Cinolite HP, N/Ref. 10-850.
8. Application of two to three coats of Novatex HD, N/Ref. 10-175.

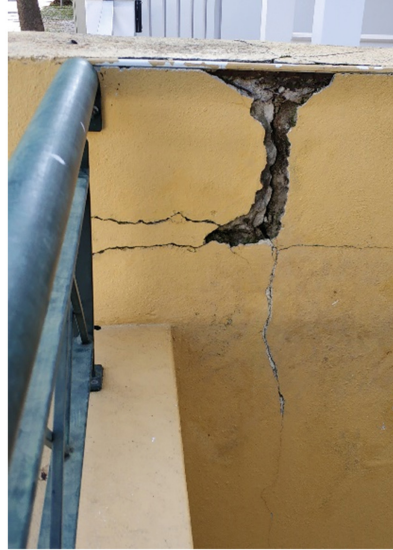
b) Cracking on the balcony wall.

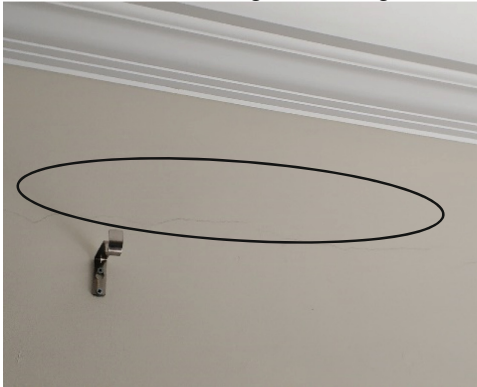
c) Cracks on the living room near the ceiling.

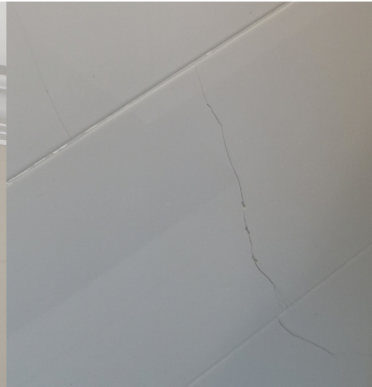
d) Tiles from the bathroom fractured.
