# Failure Analysis of a Conveyor Belt Rail (Tripper) of Mineral

Carlos Fosca<sup>(✉)</sup>

Pontificia Universidad Católica del Perú, Lima, Peru  
cfosca@pucp.edu.pe

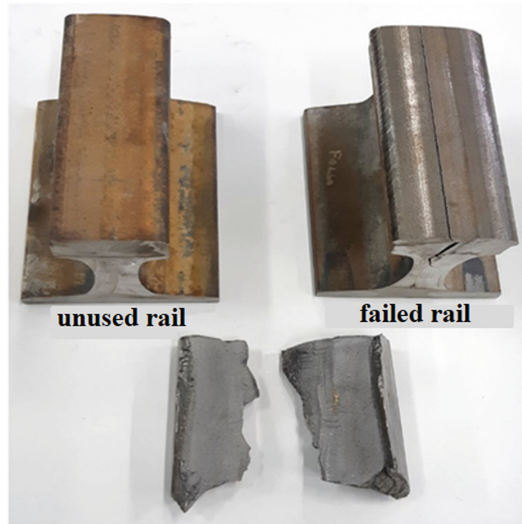
The present study corresponds to the fractured rail failure analysis corresponding to a mineral conveyor belt (tripper). Figure 1 shows a piece of the fractured rail next to an unused rail, which were supplied to determine the root cause of the failure. The tripper has four wheels per side, the rails support vertical forces of up to 1027 KN. The amount of cycles per day is 250 on average. After two years of operation, the rail system suffers the fracture at one of its ends.

Fig. 1. View of the parts of a rail system, supplied for analysis.

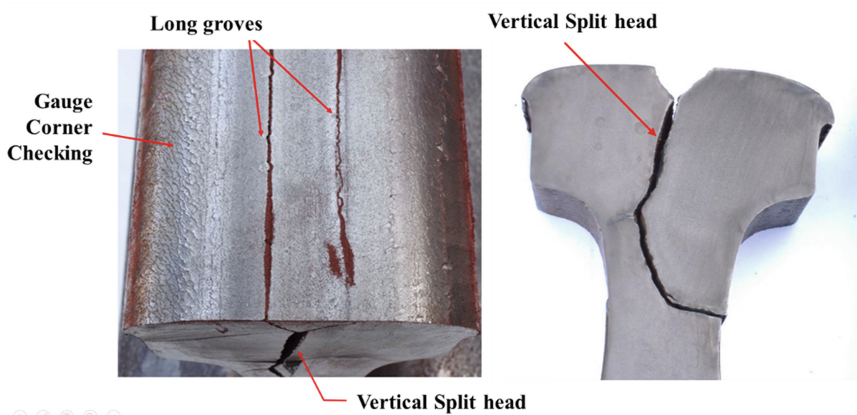
Fig. 2. Long grooves, gauge corner checking and vertical split heads present in the fractured rail.

Two longitudinal cracks (long grooves) were observed on the head of the rail (Fig. 2) that spread into the interior of the material. Subsequently, a vertical crack was developed (vertical split Head). Another important observation is the strong plastic deformation observed in the head of the rail, appreciating a reduction in the height of the same of 3 mm and a widening of the edge of the rail (gauge corner region).

The cyclic loading originated by the contact between the wheel and the rail, generated rolling contact fatigue damage in different parts of the head of the rail (gauge corner checking) and long grooves more associated with laminations or manufacturing defects, but that was accelerated by cracking in strain hardened layer due to contact fatigue. The confluence of these cracking fronts resulted in the fracture of the component through a vertical crack (vertical Split Head).

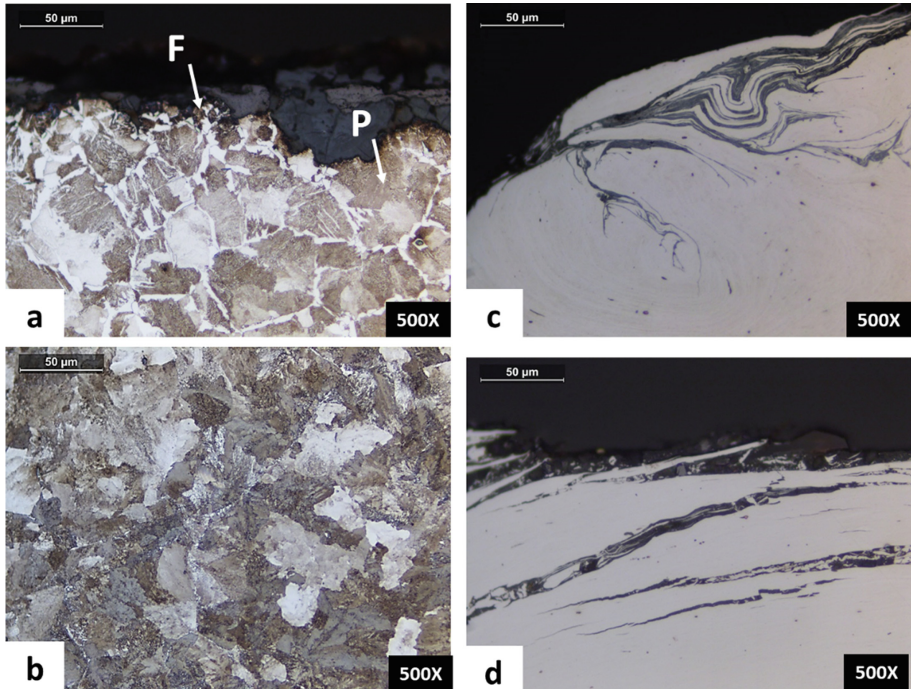
reagent. The microstructure of the new rail in the surface of the head was Proeutectoid Ferrite (F) and Pearlite (P) (Fig. 3.a) while the microstructure of the area immediately under the surface was constituted by equiaxed grains of Pearlite (P) (Fig. 3.b). This last microstructure is close correlation with the chemical composition of the steel of the analyzed rail. The microstructure of the head surface is consequence of a decarburization process during the rail manufacturing.

**Fig. 3.** [a] [b] Micrographs of the original rail (new) showing decarburization zone in the surface [a] (etching: 2% Nital). [c][d] Non etching micrographs of the head zone of failed rail showing non-metallic inclusions strongly deformed and aligned [c] and propagation of micro-cracks following the paths of aligned non-metallic inclusions [d].

The head of the fractured rail presented in the rolling contact area a strong plastic deformation (180–350 microns) that caused the deformation and realignment of non-metallic inclusions (Fig. 3.c). In addition, microcracks that follow the paths of the realigned non-metallic inclusions were observed (Fig. 3.d).

The fractured rail exhibited a combination of defects that acted synergistically in its premature failure (approximately two years). The head rail presented a decarburized surface with the presence of pro-eutectoid ferrite, which coupled with the presence of segregation of realigned non-metallic inclusions, caused a mechanically weak region, compared to the severely strain hardened pearlite.

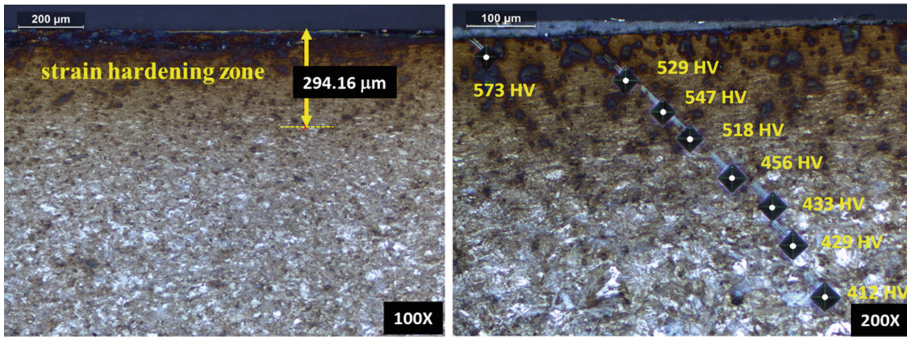
The strain-hardening layer observed in the head of the fractured rail presented hardness values of up to 573 HV0.5, while the region of the material away from the hardened area it presented hardness between 412–430 HV0.5 (See Fig. 4). Due to the differences in mechanical properties between the pro-eutectoid ferrite (decarburized zones), much

more ductile, and the perlite, the deformation does not occur uniformly at the microstructural level and the pro-eutectoid ferrite is constituted in points of preferential start of fatigue micro-cracks [4–6]. Similarly, ductile non-metallic inclusions such as manganese sulfide can become nucleation points of rolling contact fatigue cracks (RCF) in strongly deformed areas of the rolling surface [7].

**Fig. 4.** Micrographs of samples extracted from the head of the fractured rail where the strain-hardening zone and the hardness (HV0.5) values can be seen
