Restoration of Architectural Stone Heritage Damaged by 2011 Great East Japan Earthquake

Abstract. The Great East Japan Earthquake of 2011 caused serious damage to a number of architectural heritages. Fukushima Photo Museum (Former Laboratory of Electrics Ministry of Communications), constructed in 1922 and designated as the local governmental important cultural property, was damaged. This heritage structure was categorized into an unreinforced stone structure with local tuff stones. The strong ground motion caused cracks in the stone walls, tilting of the pediment, and falling of the stucco ceiling in the rooms. The multi-disciplinary expert committee for the restoration project was established. In order to discuss the seismic reinforcement of this damaged stone building, structural survey was performed at the first stage of the restoration project. The construction material was the local tuff stone characterized by its rather low specific gravity of 1.2. While the joints were made of cement with insufficient bonding strength, the friction coefficient of the joints was evaluated to be as high as 1.5. Finally, the committee proposed the seismic reinforcement by employing prestressi

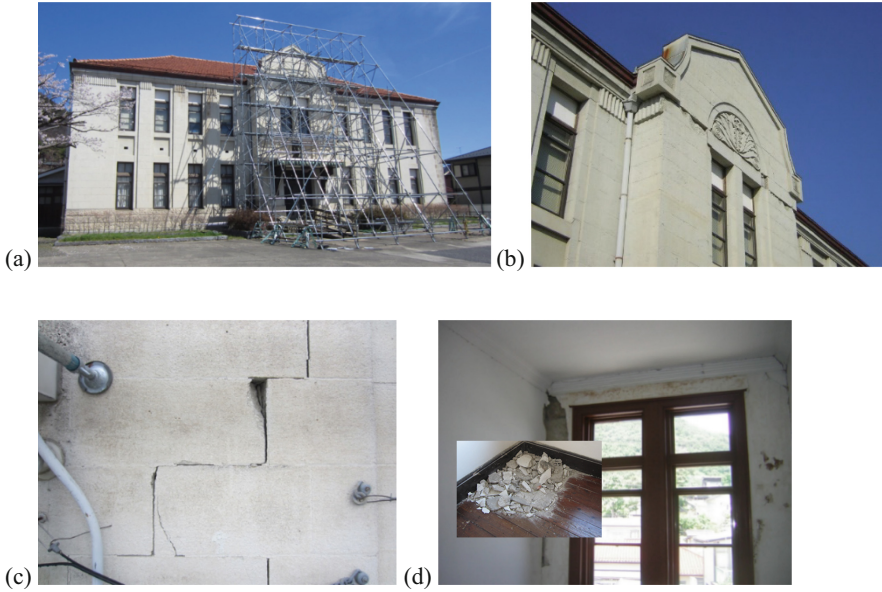
Fig. 2. (a) Appearance after earthquake (b) Tilting of pediment (c) Cracks at SW corner (d) Falling of plaster finishing

Major damage found after the earthquake included the tilting and the cracks in the decorative pediment above the entrance (See Fig. 2(a) (b)). To support the pediment, the temporary scaffolds were erected as an emergency countermeasure, shown in Fig. 2(a). In addition, visible cracks and the slight movement were found near the southwest corner (See Fig. 2(c)). Inside of the building, there were cracks at the corner of the openings, Some plastering of interior walls fell as well, shown in Fig. 2(d). For safety reason, the museum had been closed since the earthquake occurred. In April 2011, an investigation was conducted by the Architectural Institute of Japan. In November of the same year, Cultural Properties Doctor Dispatch also surveyed the building. In September 2014, Fukushima City, the owner of the building, decided to restore the building to use as a regional cultural asset.

As shown in Fig. 2, the pediment just above the entrance was damaged and tilted. It was needed to restore and strengthen it. Reinforcement was done by employing steel frame (See Fig. 13).

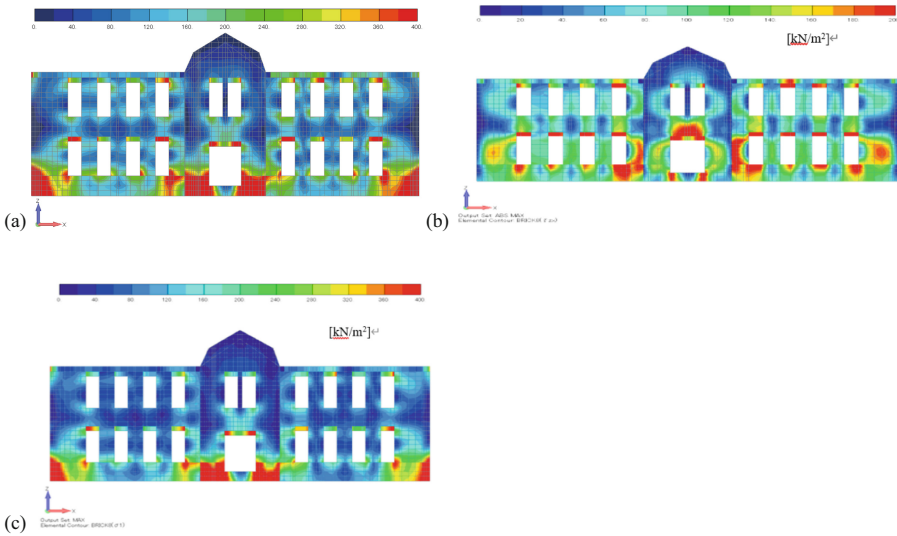
First, the dynamic response analysis was performed for the case of the ground vibrations due to the Great East Japan Earthquake of 2011. Figure 7 shows the peak normal stress (tensile stress) of the south wall. It can be found in this figure that higher tensile stress was generated at the base stone as high as 600 kN/m^2 , which is lower than the

tensile strength of the base stone, $1,400 \text{ kN/m}^2$ evaluated from the mechanical material tests (See Sect. 4.1). Furthermore, the tensile stress was generated around the openings, in particular, rather high tensile strength was shown at the lintels. However, as the mean stress was less than 300 kN/m^2 , it would not be anticipated that the structure would collapse by the failure of the wall stone. The lintels had enough strength because they were of reinforced concrete. Figure 7 shows the in-plane peak shear stress of the south wall before the reinforcement. The analysis indicated that the shear stress would exceed locally the shear strength, however, it would be caused just in a small area. The stone wall was damaged at the small area near the SE corner (See Fig. 2) by that devastating earthquake, but was not destroyed. The analysis was consistent with the actual damage.

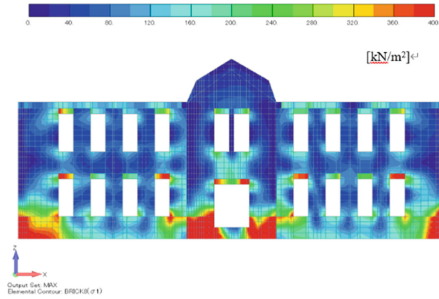
Fig. 9. Peak normal stress after reinforcement induced by strongest earthquake given by Japan Building Code

As analysis results, we determined that the prestressing tensile force should be 50kN for each steel bar. After reinforcement with applying prescribed high tensile force to the steel bars, the dynamic response analysis was conducted by utilizing FEM. Figure 9 shows the peak normal stress induced by the strongest ground motion given by the Japan Building Code. The analysis showed that the peak stress approximately 600 kN/m^2 was generated at the base stone, which was enough smaller than the tensile strength 1340 kN/m^2 . On the other hand, the peak tensile stress generated in the lintel of the opening was larger than the tensile strength of the local tuff stone of 370 kN/m^2 , however, the lintel was of RCC, therefore, it would be judged to be safe.

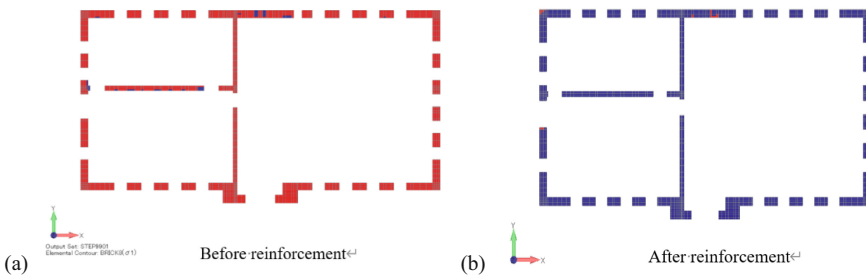
Fig. 11. Normal stress generated at 99.19 s for the case of the strongest ground motion by Japan Building Code (a) induced tensile stress exceeded tensile strength of joint (b) induced tensile stress was lower than tensile strength of joint

In order to verify the effectiveness of the prestressing force, the normal stress induced at the section of the walls was described. Figure 10 shows the section level where the peak stress is compared between before and after the reinforcement. The peak normal stress generated by the strongest earthquake ground motion by Japan Building Code is presented in Fig. 11 comparing before and after the reinforcement. It can be recognized in this figure that the reinforcement employing prestressing method is effective in reducing the tensile stress generated during the most severe earthquake. The peak tensile stress induced during the strongest ground motion was evaluated to be 155 N/mm^2 , which was enough smaller than the tensile strength of the high strength steel bar of 1080 kN/mm^2 .

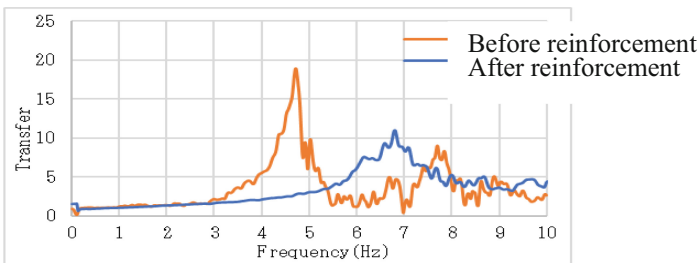
Fig. 14. Transfer function before and after reinforcement

In the present case study, microtremore measurement was done to verify the effectiveness of the seismic reinforcement. Figure 14 compares the transfer function (amplification) direction in EW (out-of plane) direction from the base to the top of the east wall, pointed in Fig. 2, before and after the reinforcement. Shown in Fig. 14, the reinforcement rose the natural frequency and reduced the peak amplitude. This figure demonstrated that the reinforcement increased the rigidity of the structure and would reduce the seismic response. The same effectiveness in dynamic response was found in the other measuring points, a total of 9 points.

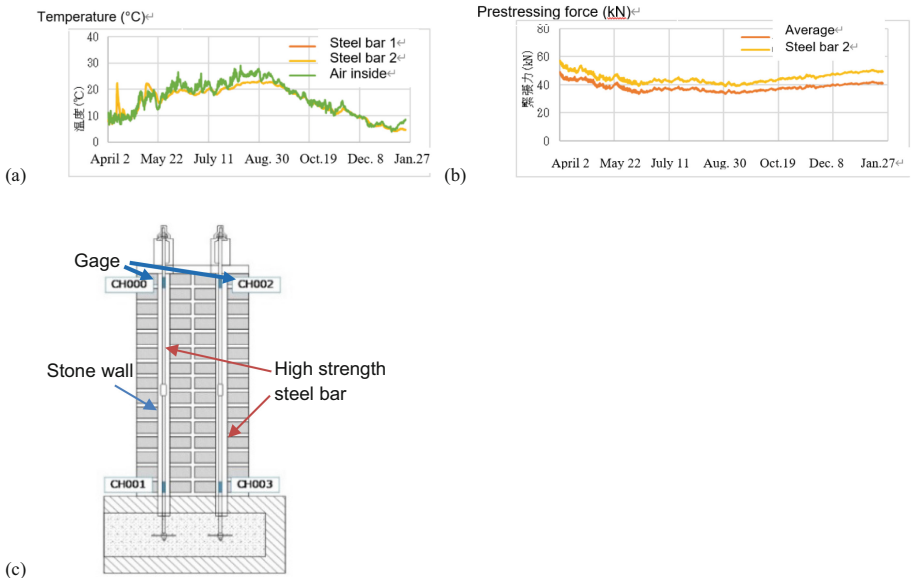
Fig. 15. (a) Strain gage installation (b) Temperature (c) Prestressing force

As described in Sect. 5.4, wooden materials were introduced for the connection of the structure as the girders placed at the top of the stone walls. There is a creep phenomenon in the properties of wood. Also, there is a possibility of such tuff stone. Therefore, the long term monitoring of prestressing force has been conducted to investigate the effect of relaxation of the prestressing force due to creep phenomenon. Shown in Fig. 15, a total

of 4 strain gages to measure the variation of the prestressing force were installed at 2 steel bars. Since material's strain is affected by temperature, the temperature at the holes where the steel bars were inserted has been also monitored as well. The monitoring started at the same time when the prestressing force was induced on April 2, 2020. Figure 15 describes the temperature and the tensile force calculated from the measured strain, respectively. Figure 15 shows that, although the prestressing force was reduced just after the loading and affected by the temperature, it varied within allowable criteria shown in the prestressed concrete structure standard in Japan. The monitoring has been ongoing to endure the prestressing force.
