# Cosmic Rays Pavilion: Candela's First Experimental Hypars - Analysis of Current

A. Muciño-Vélez, C. Guillén-Guillén<sup>(✉)</sup>, A. Tahuiton-Mora,  
and J. Del Cueto-Ruíz Funes

National Autonomous University of Mexico, Av. Universidad 3000, Mexico City, Mexico  
cguillen@unam.mx

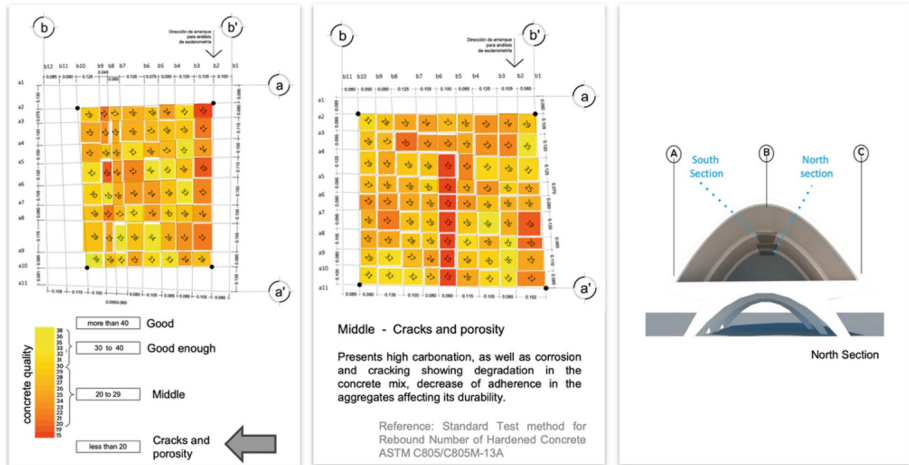
Regarding the determination of the rebound index using the device known as a sclerometer, we can observe that in the southern section and the northern section, according to the Guidebook on non-destructive testing of concrete structures (5), they present areas of cracks and porosity (red areas) which means that there is high carbonation, as well

as corrosion and cracking showing degradation in the concrete mix, therefore, there is a decrease in adherence in the aggregates affecting their durability. This shows in Fig. 7 where the two sections are located, and the red-orange shading represents areas where the concrete has the previously mentioned deficiencies.

**Fig. 7.** Concrete Strength and Uniformity Testing Using Rebound. North and South Section. Made by the authors.

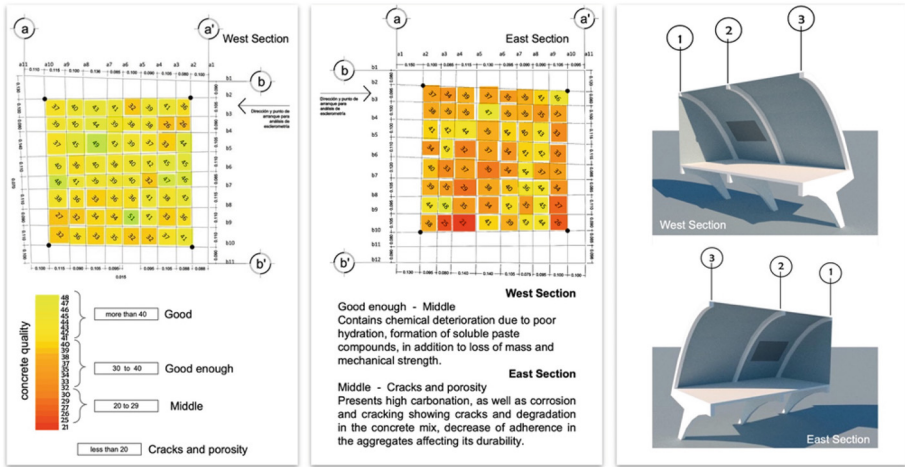
The eastern section is very similar to the southern and northern ones, since there are findings of cracks and porosity, while the western section does not show deterioration as present as in the previously described sections (Fig. 8). The western section, according to its rebound index, presents a chemical deterioration due to poor hydration of the mixture, which promotes the formation of soluble compounds and a loss of mass and mechanical resistance, all this according to Guidebook on non-destructive testing of concrete structures (Fig. 8).

**Fig. 8.** Concrete Strength and Uniformity Testing Using Rebound. West and East. Made by the authors.

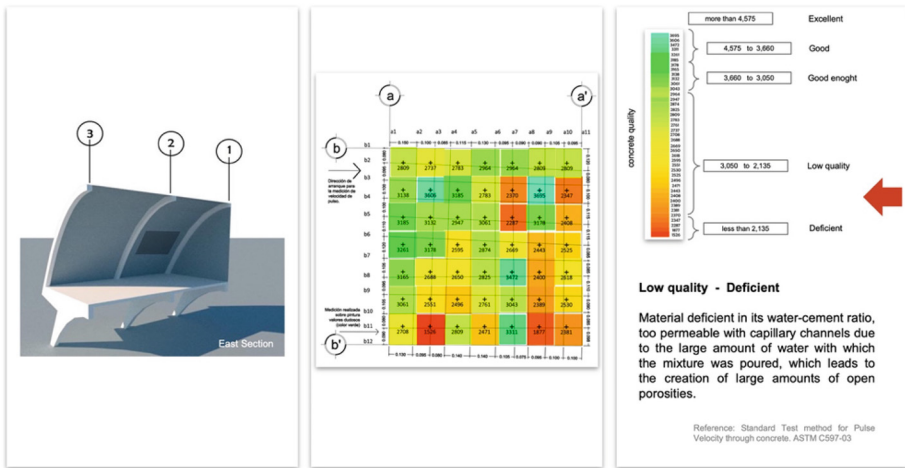
**Fig. 9.** Analysis using ultrasound pulse velocity. East Section. Made by the authors.

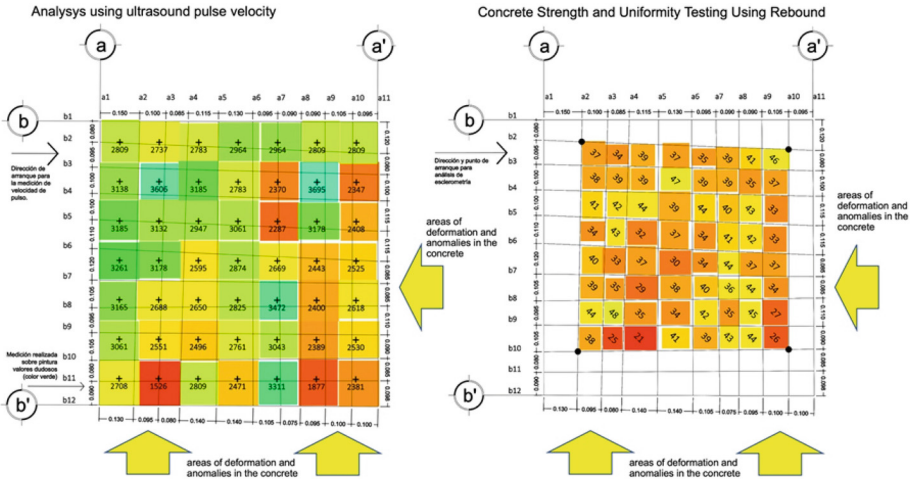
Regarding the analysis carried out on the eastern section, since it sought to relate and corroborate the data found by sclerometry through the speed of the ultrasonic pulse, we found something very similar since in the lower part of the images composed of colors and the lower part Right, it is observed according to the pulse velocities obtained, (Fig. 9) that there is currently a low quality or deficient concrete since the material may be too permeable with capillary channels. This is due to the excess water with which the mixture was applied at the time of its preparation, which leads to the creation of a large number of open porosities (Fig. 10).

Fig. 10. Comparison of sclerometry techniques and ultrasonic pulse velocity. Made by the authors.

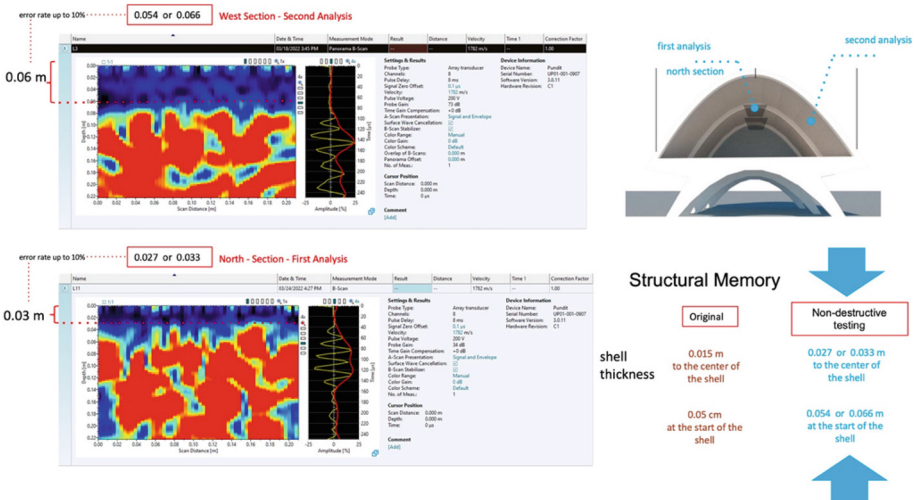
As the fourth technique implemented, the Echo ultrasonic pulse technique was used, the purpose of establishing this method is to search and find with the least possible uncertainty the thickness of the concrete shell in the upper part. With the ultrasound pulse, possible delaminations, lack of vibration, internal cracks and cavities were detected. The important thing to highlight is that when implementing this technique it was shown that what was reported in the structural memory does not coincide with the current state since the thickness at the top is between 2.7 and 3.3 cm, contrary to what is written where

reports a thickness of 1.5 cm. At the ends of the shell, the thickness ranges from 5.4 to 06.6 cm, which is close to what is described in the structural memory. It is worth mentioning that the percentage of error is around 10%, and it was taken into account to present these results (Fig. 11).

Fig. 11. Analysis by the ultrasonic pulse Echo, Made by the authors.
