# Application of the Electrical Resistivity Tomography Technique in the Assessment of Historical Buildings in the State of Aguascalientes, Mexico

**Abstract.** Diagnosis of historic buildings is relevant because it contributes to their preservation in adequate and safe conditions; in the present work, the Electrical Resistivity Tomography (ERT) technique is applied on horizontal and vertical planes to study aspects of humidity, to recognize the internal geometry of elements, and to detect resistivity anomalies in two old buildings in the state of Aguascalientes, Mexico; these buildings are the Temple of the Inmaculada Concepción and Terán House. In the first, the electrical profiles obtained from the subsoil show a zone of low resistivity associated with a saturated layer that damages the wall due to rising dampness. On the second, the resistivity images obtained from measurements on two walls with humidity problems show the source and define some flow patterns. It could be concluded that using the obtained results ERT technique generates valuable information for the preservation of built heritage and, therefore, is viable for the diagnosis of historical buildings, mainly in the s

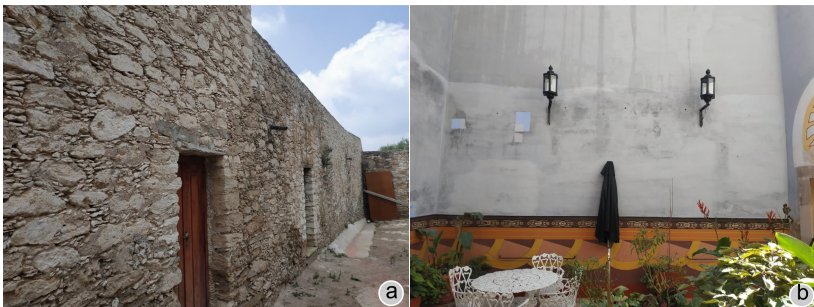
The wall of Temple Inmaculada Concepción is in the Northwest, and it has a 0.5 m thickness and is 6 m height, with limestone joined with lime-soil mortar and gravel. Nowadays, it has a high level of deterioration in joins to 2 m height (Fig. 3a). The causes of humidity are the land topography due to water going to it in the rainy season, which stalls and filtrates to the subsoil where the building is.

The wall of Terán House (Fig. 3b) is on the perimeter of the building in the zone of one yard. It is a divider wall because it is the only element that divides into the surrounding buildings. It was built with mud and joined with raw land and gravel with 0.70 m thickness and 5.5 m height. At the moment of these measurements, damages by humidity were in an area of 1 m above the soil to 3.5 m high.

**Fig. 3.** View of the interested walls a) Northwest wall of Temple of Inmaculada Concepción b) Surrounding wall of Terán House

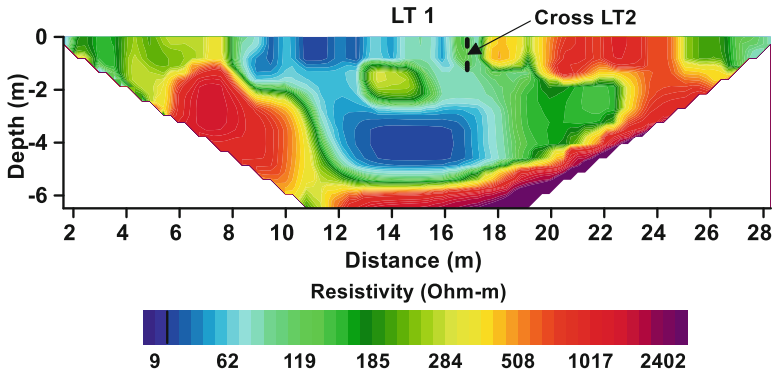
The longitudinal profile is located on the side of the wall (Fig. 4) and shows resistivity values in the range of 1 to 2600  $\Omega$ -m. In the central part of the model, there are concentrated low resistivity values from 1 a 100  $\Omega$ -m. In extremes of the profile, resistivity values increase from 200 to 2600  $\Omega$ -m, between 16 and 17 m of distance crossing a short transversal profile (Fig. 6). The model defines the superficial resistive stratum in the extremes; the central zone is a hollow that probably is presented by alluvial deposits poorly consolidated. On the surface of the measured soil, a compacted limestone outcrop could link resistivities higher than 500  $\Omega$ -m in yellow and tones.

**Fig. 6.** Longitudinal electrical profile LT1. The crossing of LT2 is indicated.

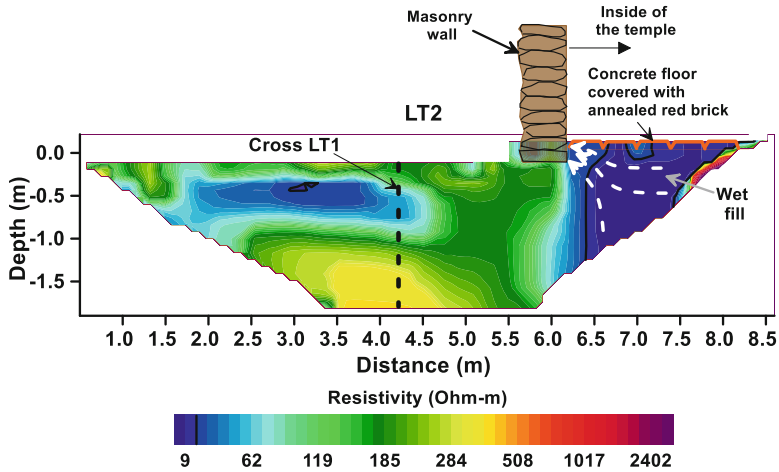
A transversal form of the building is in Profile LT2 (Fig. 7). It is a division of resistive anomalies between 6 and 7 m distance; to the left side of the profile, the resistivity values are under  $500 \Omega\text{-m}$ , and to the right side, the resistive anomaly is in the range of 1 a  $50 \Omega\text{-m}$ . The resistive anomalies contrast 5 and 6 m under the wall, which divides the interior and exterior. After a 6 m distance to the interior of the building is defined as a stratum of approximately 1 m depth with values lower than  $20 \Omega\text{-m}$ ; this suggests the existence of a material with a high amount of humidity. The following are some factors that could be causing the concentration of moisture in this area: a) the use of incompetent filling materials with poor compaction during the construction of the temple's side spaces, and b) the low rate of moisture evaporation because these spaces are not exposed to the sun.

The lack of foundations or any element could inhibit the increases of humidity vulnerable the constructive system of the wall; consists of limestone stone joined with lime mortar and raw land. The proximities of the stratum to the wall could generate a higher rate of humidity filtration and a humid front with higher elevation in the wall. The last factor is possible to corroborate because superficial humidity in the wall is visible in the darker joins until 3 m height. According to [12, 27], the elevation of the humid front is because of three main factors: the rate of infiltration soil to the wall, high content of pores in the materials and the thickness of the wall.

**Fig. 7.** Electrical profile LT2 transversal to the building is by the cross of the profile LT1, present in the wall of interest. Moisture flow lines are marked, indicating the possible upward flow of moisture from the subsoil to the wall.

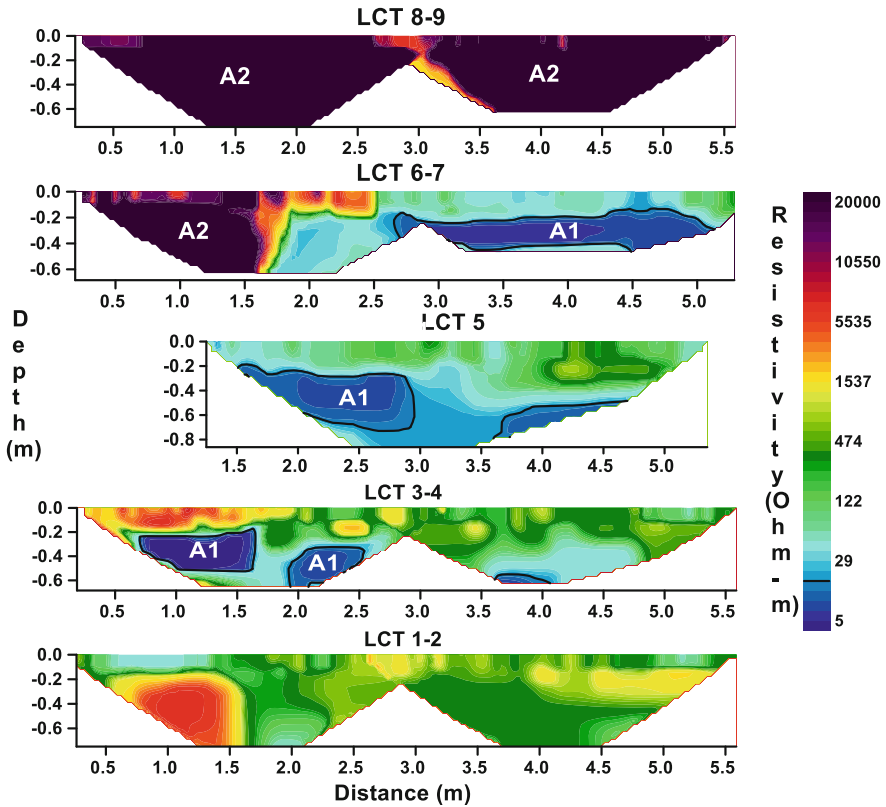
The obtained profiles on different heights from the wall show a rate of resistivity from 1 to  $20,000 \Omega\text{-m}$ . Figure 8 shows the profiles where two resistive anomalies highlight due to they are in one or two zones. The anomaly in color dark blue (A1) with values under  $20 \Omega\text{-m}$  is in the profiles LCT 3, 4, 5, and 7. The resistive anomaly in the color purple (A2) with values higher than  $10,000 \Omega\text{-m}$  with prevalence in profiles LCT 6, 7, and 8.

**Fig. 8.** Horizontal electrical profiles LCT 1-LCT 9 on the wall of Terán House. The most relevant resistive anomalies, A1 and A2, are indicated.

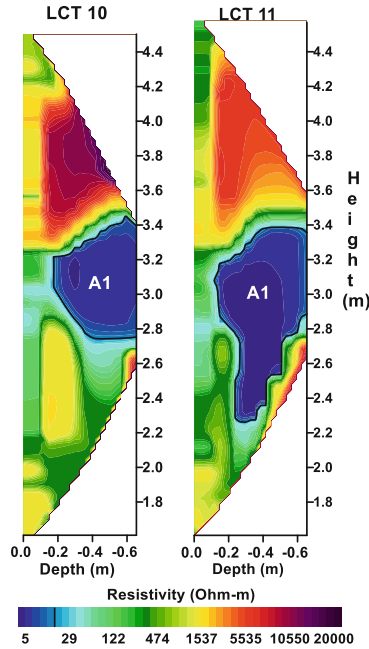
The vertical profiles LCT 10 and 11 are on 1.95–4.92 in the longitudinal sense of the wall (Fig. 5) matches with the distributions of the resistive defined anomalies in the horizontal profiles (Fig. 8, profiles LCT 3 and 7). Anomaly A1 highlights in both profiles between 2.6 and 3.6 m height from the floor level under 0.15 m dept. Anomaly A2 in purple is in the top part of profile LCT 11 (Fig. 9).

**Fig. 9.** Vertical profiles LCT 10 and 11 located at 1.95 and 4.92 along the wall. The resistive anomaly A1 is indicated.

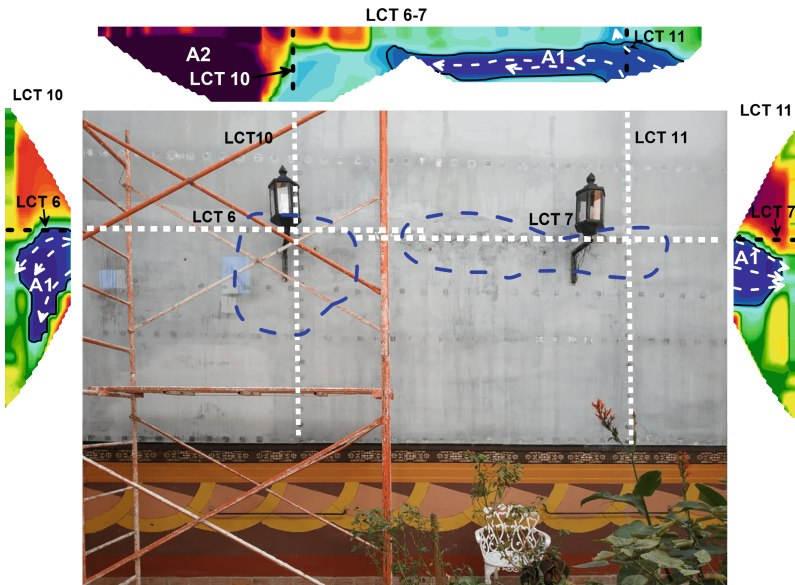
Figure 10 shows the models of the horizontal measures (LCT 6–7) and vertical (LCT 10 and 11) of higher interest and the image of the wall as a reference element. It is possible to observe that the anomaly with low resistivity in dark blue matches the superficial deteriorated zones due to the presence of humidity in dark tones marked with a divided line in blue when comparing the image with the resistivity models; this means that anomaly A1 is related to a humid mean; this is by the distribution of Anomaly A1 that the source of humidity comes from the adjacent construction; it is in the wall at an elevation of 3.4.

**Fig. 10.** Image of the perimeter wall with the most important tomograms. Horizontal lines LCT 6 and 7 and vertical lines LCT 10 and 11 with their perspective models located in the exterior of the wall image. Also, the pointed line in blue marks the zones of dark tone due to humidity. Each model presents the electrical lines; at an orthogonally cross.

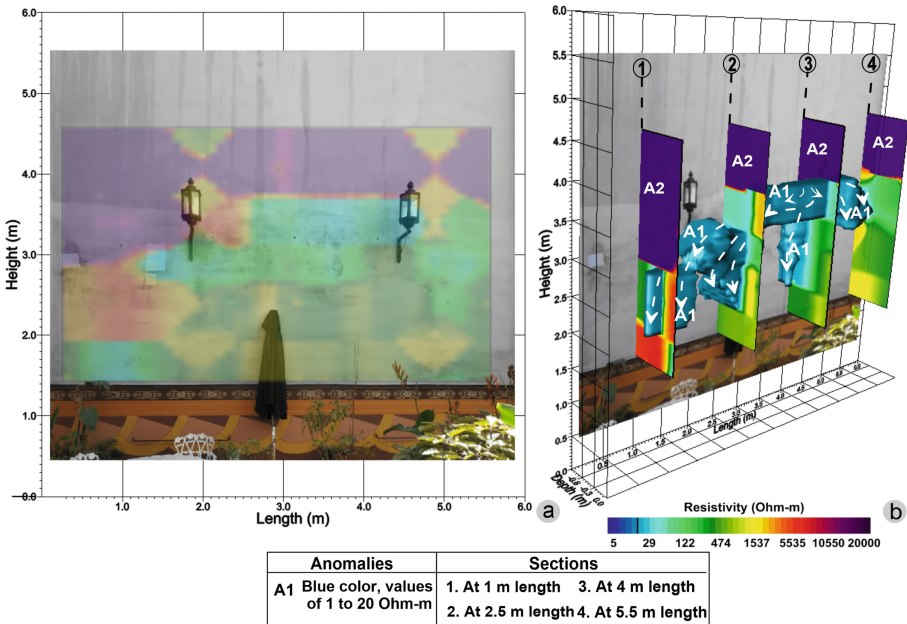
The tridimensional model (Fig. 11) configures the mean with a high amount of humidity and defines the origin of the water. The 3D model has configurated more precisely the zones where humidity propagates. Also, the zone with none is up to 4.2 m in height (Fig. 11b).

**Fig. 11.** The 3D model obtained from the horizontal and vertical 2D sections is a) a 3D model with an image of the wall overlap. b) a Tridimensional model with vertical sections located on 1, 2.5, 4, and 5.5 m. It is possible to see the volume with a high content of humidity and some arrows representing the flow of it in the interior of the wall.

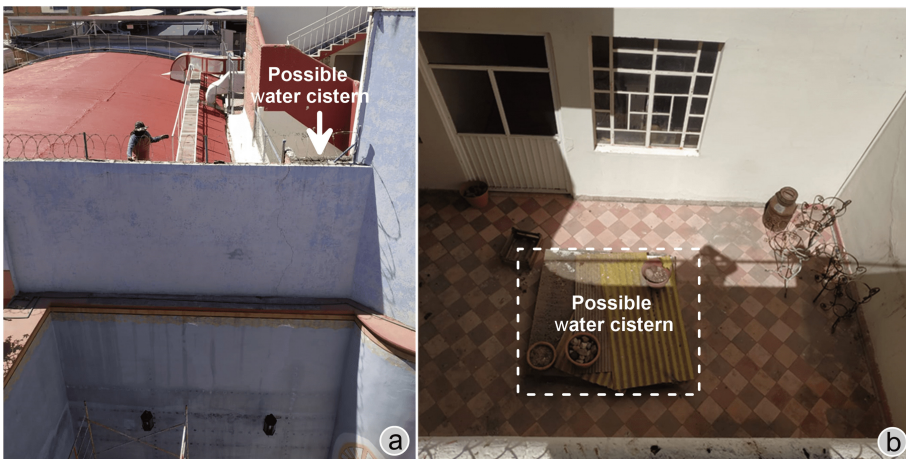
It reinforces the idea of water filtration due to a resilient source for the image obtained from the yard next to the wall, where is observed a possible tank on the second level (Fig. 12). The tank may present damages as cracks or fractures that could be generating filtrations to the wall of interest; due to the wall being of mud, the water of the tank filtrates with no resistance and flows to the lower levels of the wall, as the tridimensional model shows (Fig. 11b).

**Fig. 12.** Location of the possible water cistern on the adjacent house a) Photography from the rooftop of Terán House. b) Photography from the roof of the adjacent parking lot. In the pointed line, it is possible to see some blades that could be covering the water cistern located on the second floor of the adjacent building of Terán House.
