# Flat Roofs Characterization in Barcelona's Historic Center

Còssima Cornadó<sup>(✉)</sup>, Ainhoa Varela, Sara Vima-Grau, Marta Domenech, and Pere-Joan Ravetllat

Department of Architectural Technology, ETSAB Barcelona School of Architecture, Universitat Politècnica de Catalunya – BarcelonaTech, Barcelona, Spain  
cossima.cornado@upc.edu

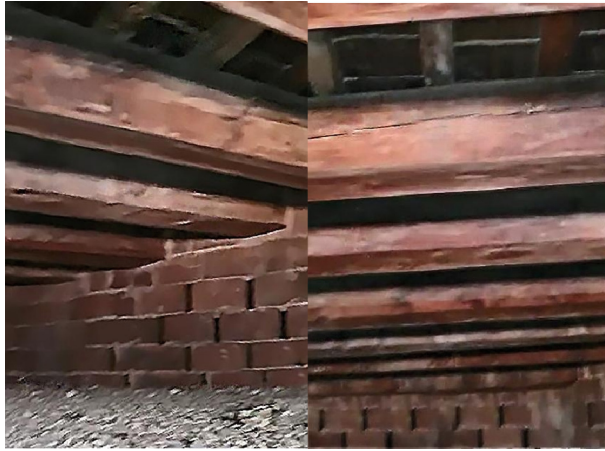
**Fig. 3.** Interior of the air chamber of one of the decks visited. Source: own elaboration.

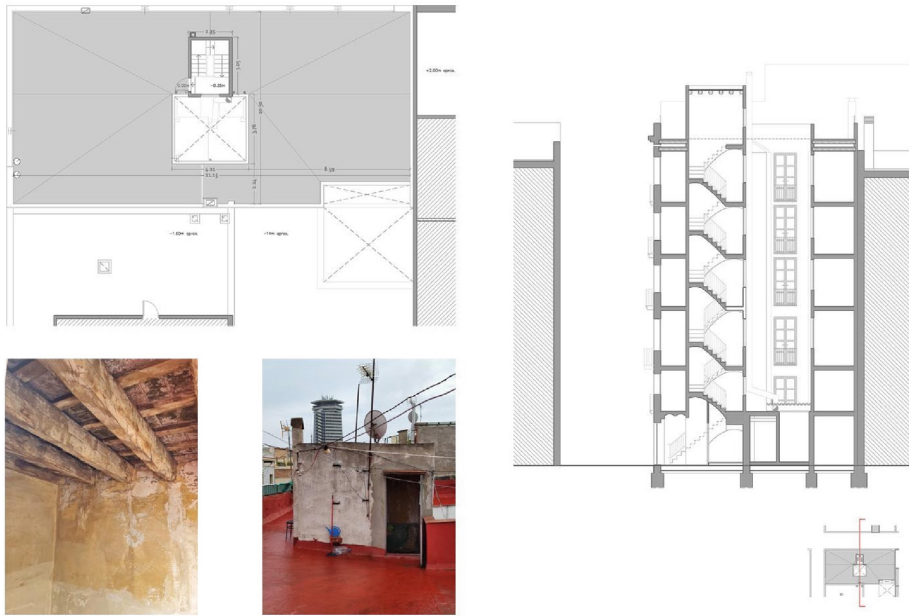
The current state of the roofs selected as case studies was then analysed (Fig. 5), identifying the present damage, the interventions carried out and the geometric characteristics that influence their functionality.

**Fig. 5.** Example of one of the surveys carried out

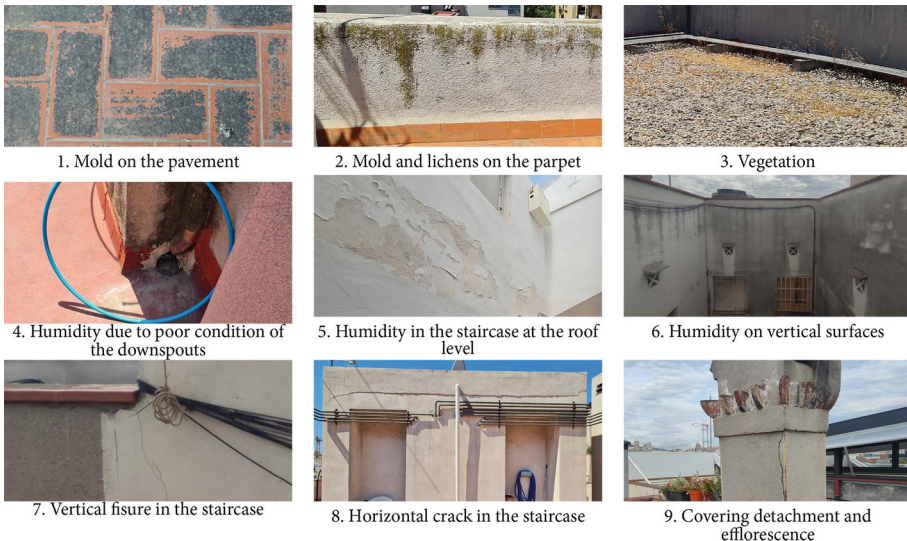
The main problem detected in the roofs was the waterproofing. This can cause mould problems due to water stagnation (1, Fig. 6). In the same figure, number 2 shows the

presence of lichen on the parapets; in most cases, this damage has been solved with a new stucco coating and the installation of a ceramic coping with a ceramic double drip edge (2, Fig. 7) [12]. Another of the main water-related shortcomings is the presence of humidity in the dwellings in contact with the roof and in the stairwells at the height of the roof slab (5 of Fig. 6). In order to repair them, the main techniques used have been the placement of waterproof sheets on the original paving (3 and 6 of Fig. 7), the use of waterproof paints as can be seen in number 5 of the same figure [10, 11] and the placement of ceramic perimeter flashings in those roofs that lacked them (8 of Fig. 7) [12]. This same strategy has been used for specific interventions to seal cracks or repair damage in existing drains (1 and 7 of Fig. 6).

**Fig. 6.** Most frequent damages

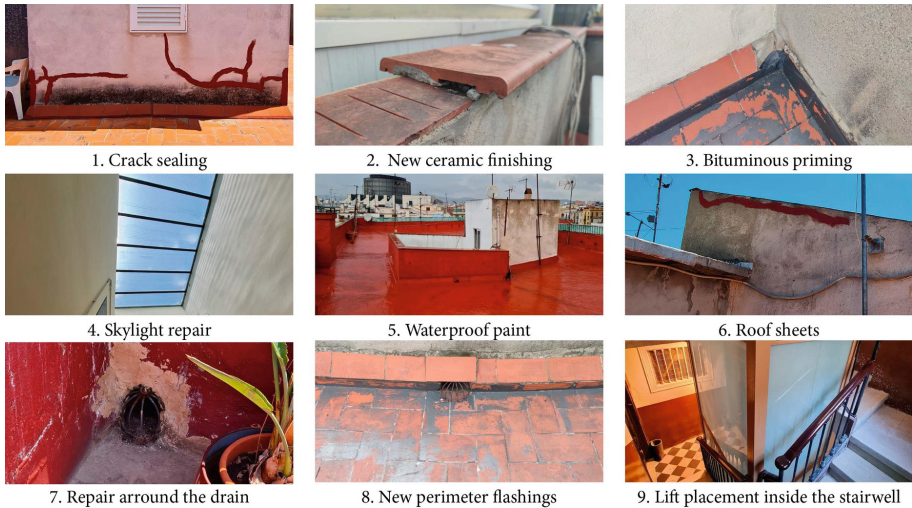
**Fig. 7.** More frequent interventions

As regards the improvement of comfort conditions, one of the most recurrent interventions is the replacement of the stairwell roof with a skylight or the repair of existing skylights (4 Fig. 7), in order to achieve better natural lighting and ventilation in these small spaces [10]. In terms of improving thermal conditions, one of the most commonly used strategies has been the incorporation of thermal insulation under the air chamber and a waterproof sheet over the original ceramic finish covered by new “rasilla” (thin ceramic brick) finish [11]. Finally, in terms of total roof replacements, studies [10, 11] illustrate that the most commonly used strategies in this respect are the total replacement of the roof with a new conventional or inverted roof.
