Vulnerability Assessment of Historical Churches in Banat Seismic Region, Romania

Iasmina Onescu¹(✉), Anna Lo Monaco², Mihai Fofiu¹, Nicola Grillanda³,
Marius Mosoarca¹, Michele D'Amato², and Antonio Formisano⁴

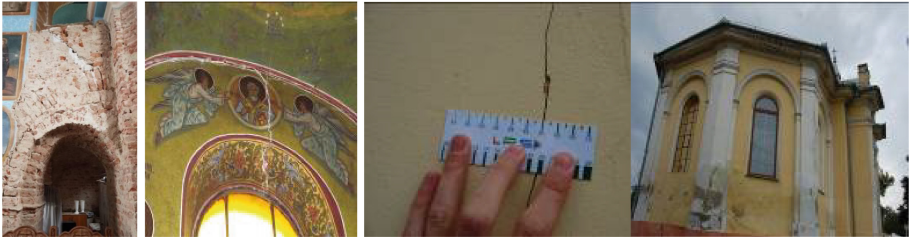
Almost all buildings present vertical cracks on the exterior facades, in the proximity of the openings. In some cases, during on-site inspection, there were observed cracks in the masonry vaults and arches. In some cases, some cracks between the tower bell and the longitudinal walls were noticed. In general, the cracks were caused by the different settlements and are presented in Fig. 4. Other decays were observed at a non-structural level, such as damaged plaster and paintings, superficial plaster cracks. A synthesis of the construction details and observed damages is presented in Table 2.

Fig. 4. Damage and cracks observed on the investigated churches.

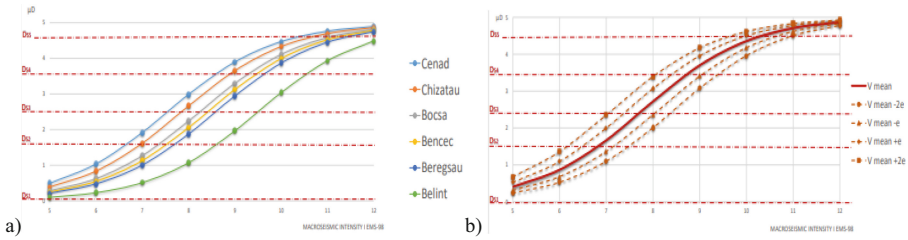
Fig. 5. Only structural assessment: a) Individual vulnerability curves; b) mean vulnerability curve for all six churches.

The results indicate a medium seismic vulnerability for all six churches, in the range of damage states D2-D3 for the probable macroseismic intensities VIII and IX EMS-98. This indicates the possibility of appearance of moderate to severe damages to non-structural elements, but only slight to moderate damages to the structural ones.

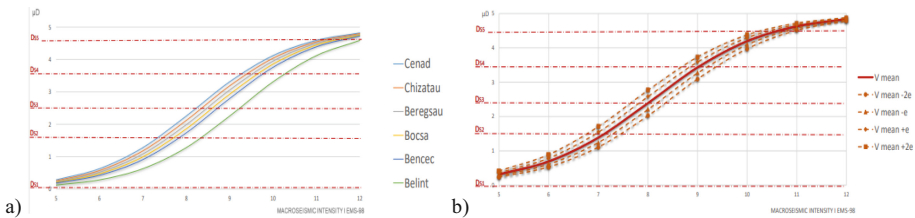
Fig. 6. With cultural value: a) Individual vulnerability curves; b) mean vulnerability curve for all six churches.

The results indicate a slight change of vulnerability in comparison with the assessment without the consideration of the cultural value. The medium seismic vulnerability of all churches decreases by 5% when the cultural value is considered. This happens because the consideration of the cultural value tends to bring all the vulnerability indexes in the same range, as all the investigated buildings are very similar in terms of architectural-artistic, urbanistic and socio-economic values. So, from a structural point of view, there is a higher vulnerability difference between the investigated churches, but from a cultural point of view, all the churches are quite similar in terms of vulnerability, as presented in Fig. 7.

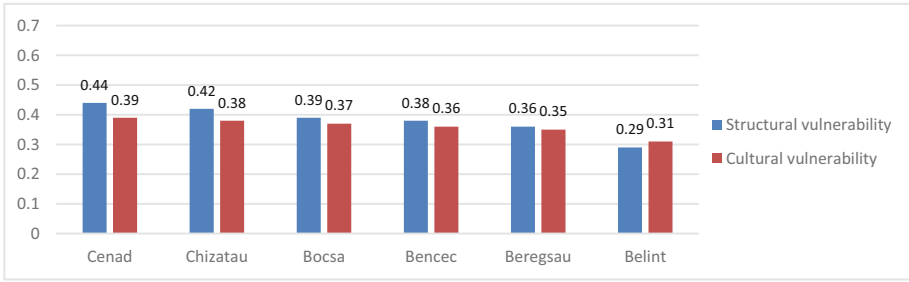
Fig. 7. The results ordered in a top of the most vulnerable churches according to empiric methodology.

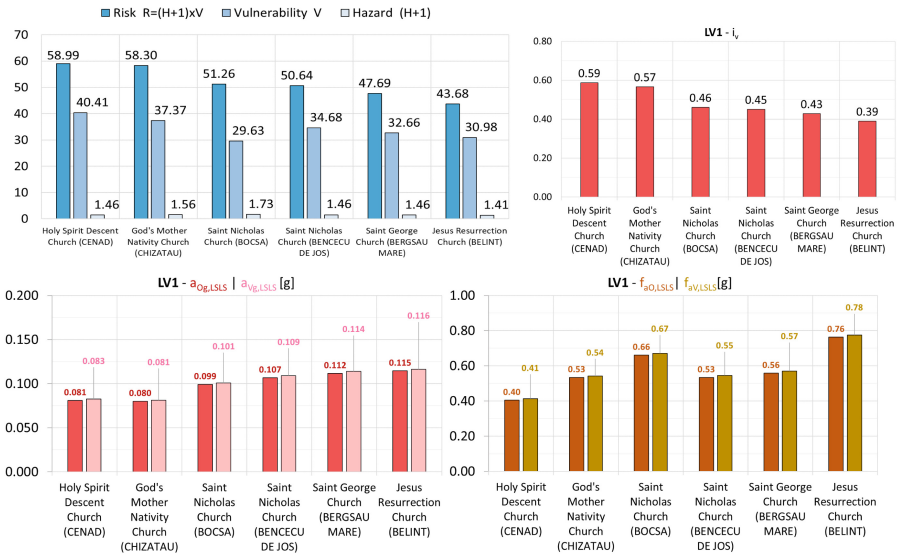
Fig. 8. The results following LV0 and LV1 methodology.

The results obtained following both LV0 and LV1 analysis are presented in Fig. 8, indicating a good correlation between the 2 Levels of Valuation. The results indicate the church of Cenad to be the most vulnerable, while the least vulnerable seems to be the

church in Belint. The obtained horizontal acceleration at LSLS is $a_{Og,LSLS} = 0.080 \text{ g} \div 0.115 \text{ g}$, while the obtained vertical acceleration at LSLS is $a_{Vg,LSLS} = 0.081 \text{ g} \div 0.116 \text{ g}$. The expected a_g on rock soil ($T_R = 225$ years) is 0.15g for the churches in Chizatau, Belint and Bocsa and 0.20 g for the churches in Cenad, Bencecu de Jos and Beregsau Mare.

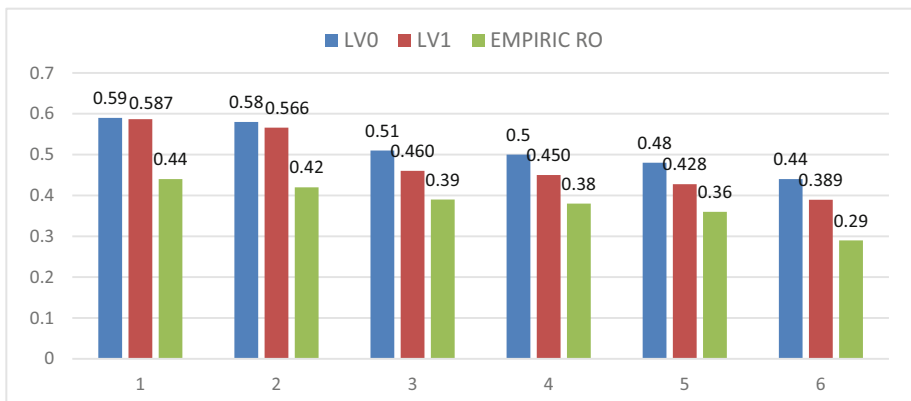
The comparison of the results obtained following Romanian and Italian procedures indicated a good correlation of the vulnerability classification, all methods indicating the Church in Cenad as the most vulnerable one, followed by the Church in Chizatau, the Church in Bocsa, then the one in Bencec, the Church in Beregsau and the less vulnerable is the Church in Belint. The empiric vulnerability assessment methodology adapted for Banat area, proposed by the Romanian authors tends to underestimate with 15% the seismic vulnerability of the investigated churches. None of the investigated churches satisfies the LSLS verification (Fig. 9).

Fig. 9. Comparison of results
