Monitoring the Combined Effects of Induced Earthquakes and Climate Change on a Heritage Building in Groningen

Abstract. Heritage buildings are often subjected to loading conditions that they were not exposed to in their earlier life span. Induced earthquakes in non-seismic regions caused by energy exploitation activities, or strains in the ground that are caused by the climate changes, are new phenomena that alter the usual loading situations for historical buildings.

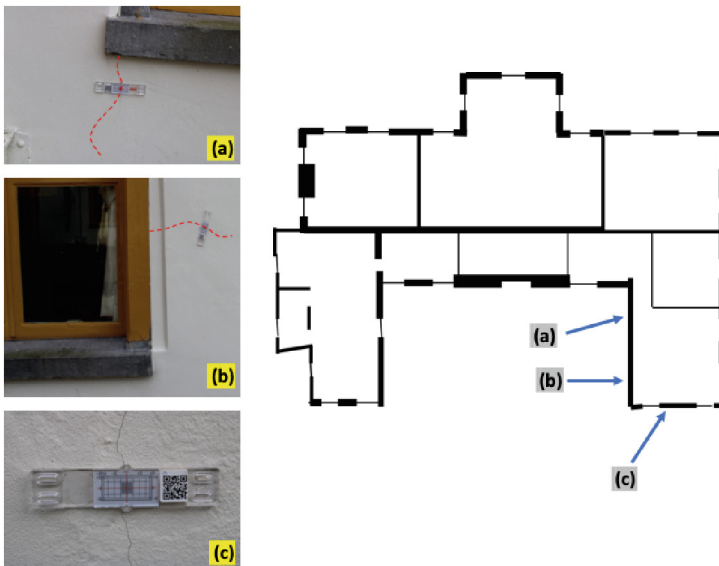
The structure received more cracks in mid-August 2018. In search of the reason of these new and surprising cracks, an investigation on the monitoring data started. The shape and location of these cracks, shown in Fig. 2, did not resemble earthquake-related cracks because most of them were in vertical direction, with a larger width close to the base and smaller widths in higher elevation, while diagonal X-shaped cracks, the standard sign of in-plane masonry response to lateral earthquake loading, were not observed in the structure. The existing cracks reminded more the type of cracks caused by soil movements rather than by seismic loads. After the end of restoration, the manifestation of new cracks in the summer of 2018 in the most problematic part of the structure, i.e. the façades of the NW wing, was puzzling given the relative limited seismic activity in that period. However, after monitoring results have been combined together with finite element analyses and observations in the field, it was possible to reach a plausible explanation for the old (prior to 2015 and in 2015) and the new (summer 2018) damage in the building, as discussed further in this paper. More details are given in [8 and 13].

Fig. 2. Minor cracks appeared in August 2018 (left) and their locations on the plan view (right).

The structure has light floors and a light timber roof, while the bearing walls are relatively thick. In-plane cracks would not be expected in this structure during such small earthquakes. One possible explanation is that the soil parameters such as shrinking of water-sensitive soil layers and/or response of piles, in combination with a small distant earthquake, caused settlements and/or increased the stress levels on foundations. In other words, the soil effects might have superimposed with the earthquake motion and caused the small cracks. Nonlinear finite element analyses have also been run for supporting this scenario, as presented in [8 and 13].

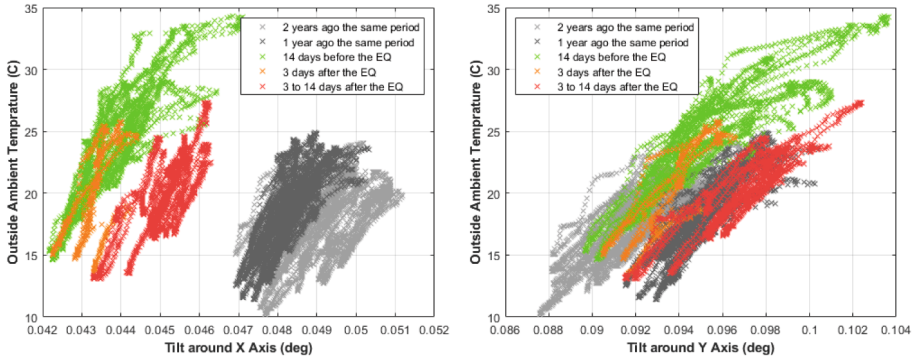
The tiltmeter data, in combination with the accelerometers data from 8th of August 2018 earthquake (see Sect. 2), indicate that the foundation of the NW wing and the soil beneath have played an important role in the cracks that appeared in August 2018. It is difficult to explain the exact contribution of soil-related parameters since fundamental

Fig. 4. Tilt angles recorded ± 15 days from the earthquake and last two years before.

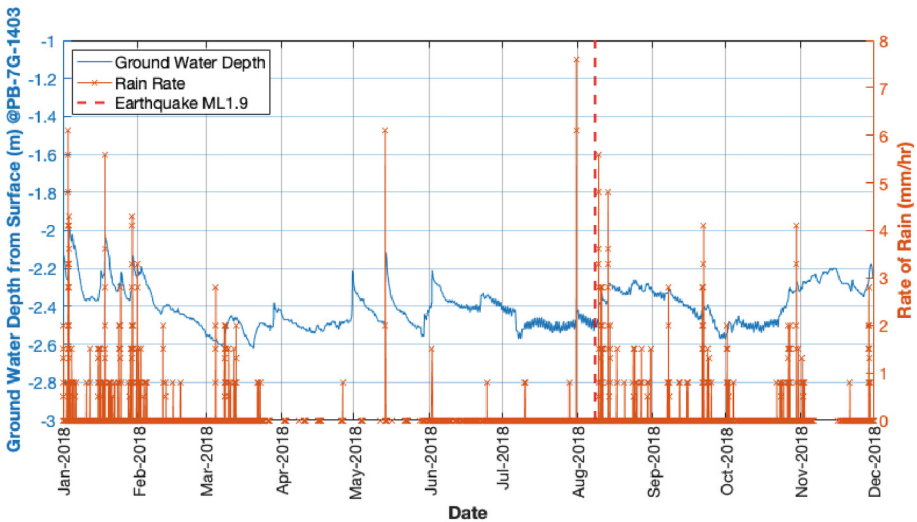
Figure 5 reveals a very dry period from mid-March to mid-August in 2018, reported as a disastrous period for the farmers in the region due to the extremely dry soil. It was also witnessed in soil drilling works that the clay layers were hard and dry due to lack of rain for a very long period. As seen in Fig. 5 the start of the rainy period coincides with the earthquake (in fact, a couple of days later). When other rainy periods in the data are examined, tiltmeter data are found mostly insensitive to the rain. Furthermore, the out-of-the-ordinary movement (i.e. change in tilt baseline) in the tiltmeter data starts right after the earthquake, proving that the movement is related to the earthquake motion too.

Fig. 5. Ground water depth from the surface and the rate of rain in 2018 in the monitoring well 600 m south of the site.
