Problems Associated with the Use of Pyritiferous Fill at Ballymun Youth Facility, Dublin

A. Brian Hawkins and Matthew Stevens

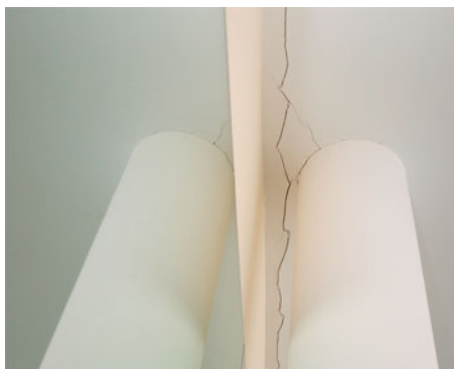
The 3rd August 2006 snag list did not include the pronounced upward bend and crack in the ceiling of the Gym adjacent to the mirror wall (Fig. 6). However, it is clear that in the area where the Gym adjoins the original building, as the floor rose it forced the dry lining upwards into the ceiling and, as a consequence, a crack developed parallel to the internal wall. Evidence of the rise in the dry lining of this wall is indirectly recorded in the snag list as *Make good wall at top of socket*. A photograph taken in February 2008 (Fig. 7) shows 4–5 mm of upward rise at the position of the fixed electrical socket.

Fig. 7 Dry lining displaced relative to plug, February 2008

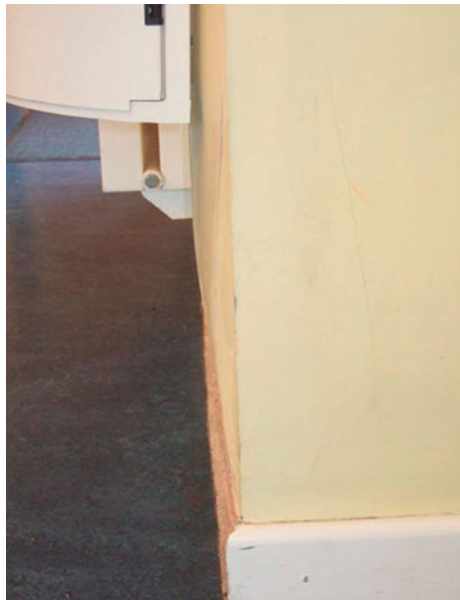
Fig. 9 Bulging and cracks in corridor (November 2007)

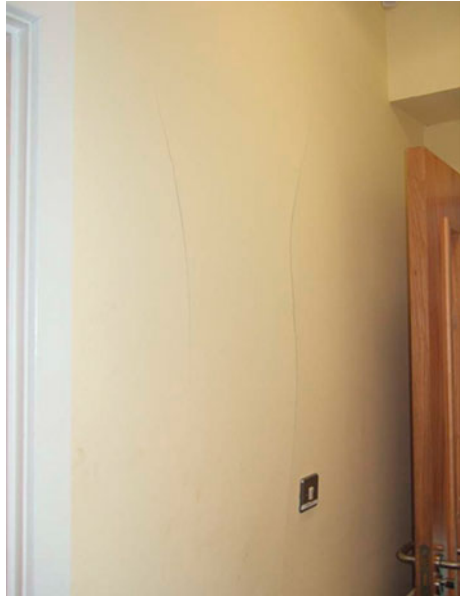
Fig. 10 Bulging in part restricted by electric points; Youth Information Room (November 2007)

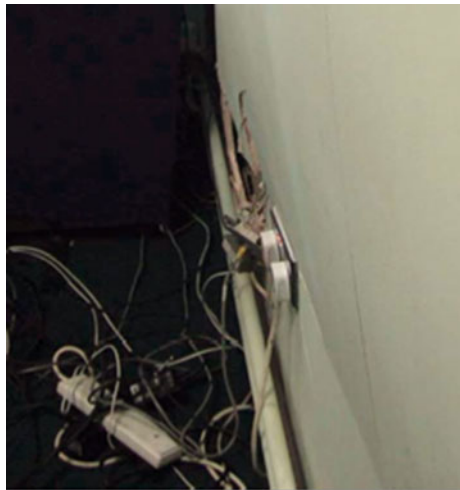
Fig. 11 Door frame displaced by bulging plasterboard; Youth Workers' Office (November 2007)

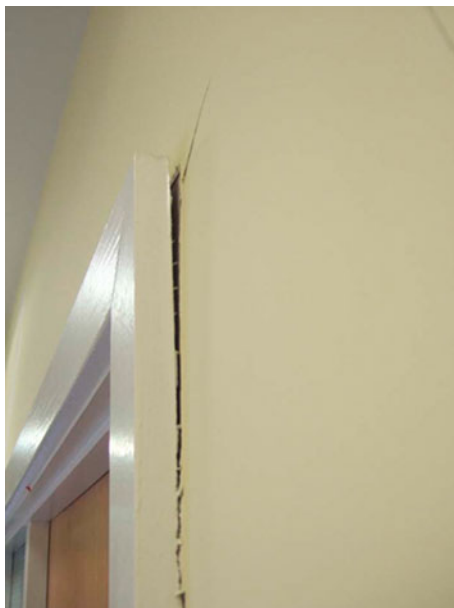
Fig. 12 Cracking in plasterboard which has bulged and displaced the skirting board (November 2007)

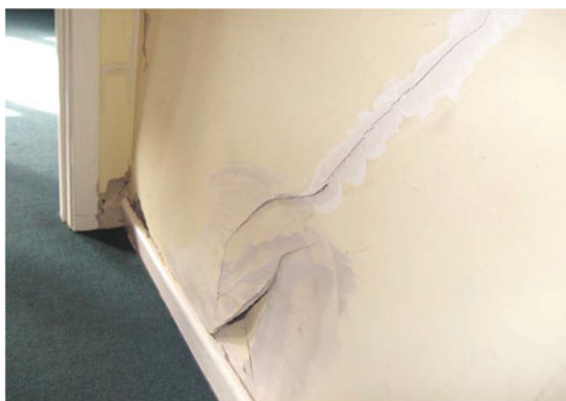
Fig. 13 Severe crack in the plasterboard in the entrance lobby (November 2007)

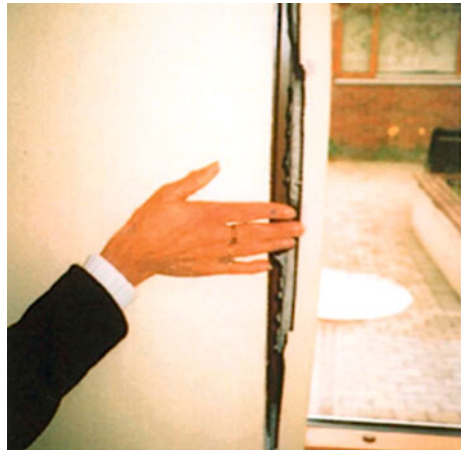
- (c) Severe cracking of the lining to the east of the window and arching of the cill in the corridor to the Gym (Figs. 14 and 15);
- (d) A 5–6 mm rise in the floor relative to the threshold at the doorway from the lift area into the courtyard (Figs. 16, 17 and 18);
- (e) Spider cracking in the floor of Store 1 (Fig. 19).

Fig. 15 Gap developing as window cill arches, between corridor from the Gym and the courtyard

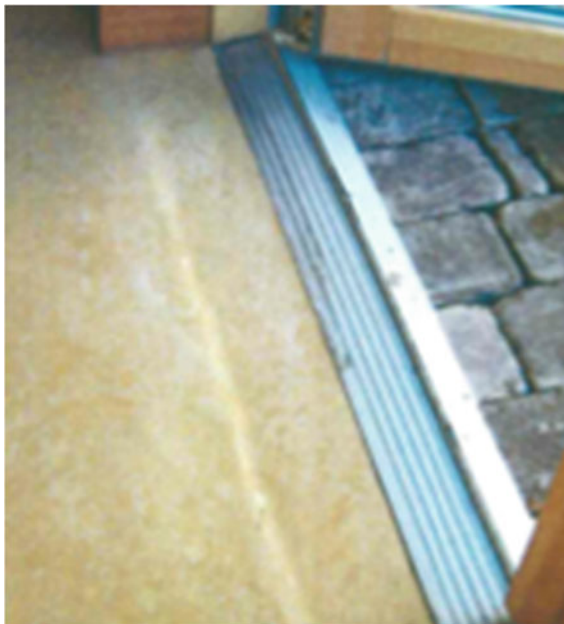
Fig. 17 Rise of floor against the threshold into the stairwell (November 2007)

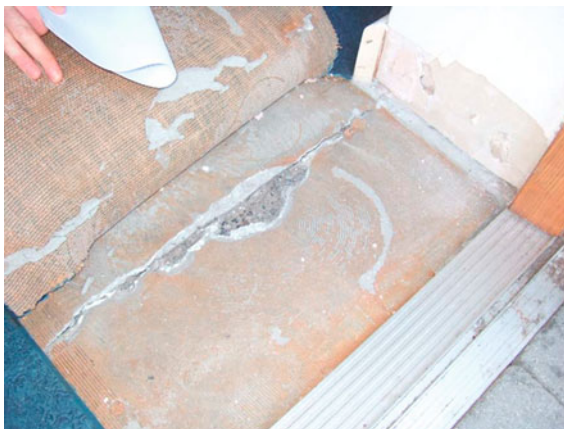
Fig. 18 Detail of height difference shown in Fig. 17

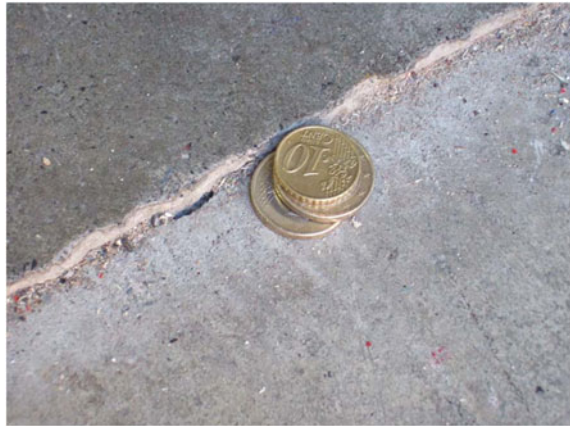
Fig. 19 Cracking of the floor slab in Store 1 (November 2007)

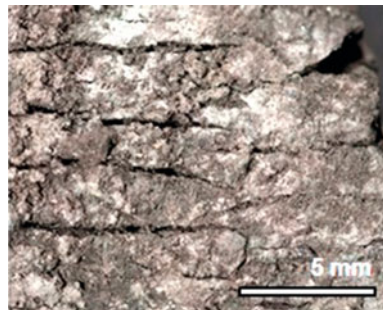
Fig. 23 Cracks opened by crystal growth

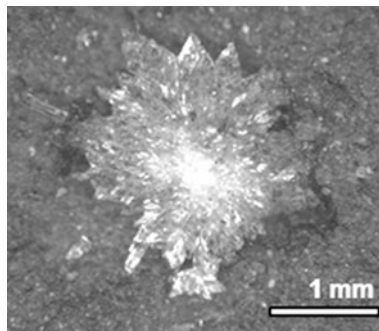
Fig. 24 Typical selenite crystal formed in a dilating crack

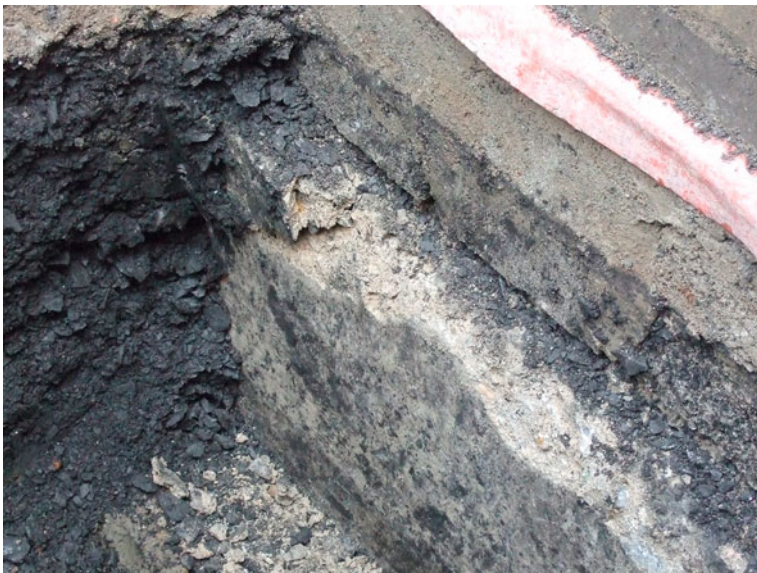
When TPs 11 and 12 were dug in May 2008, it was noted that some of the concrete showed signs of deterioration and some gypsum crystals were present on the surface of the concrete. As a consequence, on 3rd July 2008, the upper parts of the pits were re-opened and a number of samples were cored from the support beam and mass concrete pillars. Figure 28 shows the poor state of the upper part of the beam in the corner of the courtyard (TP 11) where more than 25 mm of the concrete at the top external corner of the beam could be removed with finger pressure.

Fig. 28 Deterioration of concrete at the top of the beam, TP 11, and the nature of the dark deleterious fill adjacent to it

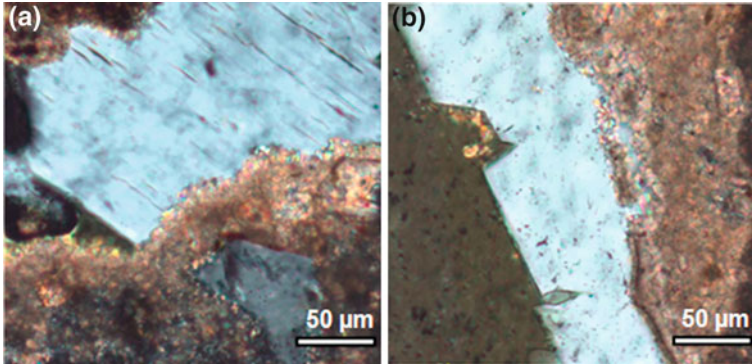
Fig. 29 Growth of gypsum crystals on surface of concrete

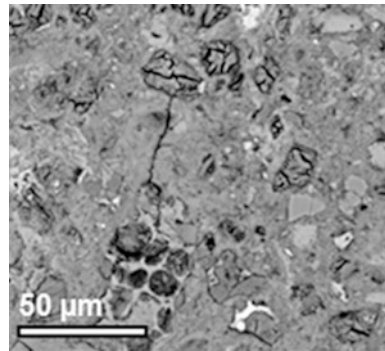
Fig. 30 Abundant ettringite-filled voids, note crack in concrete

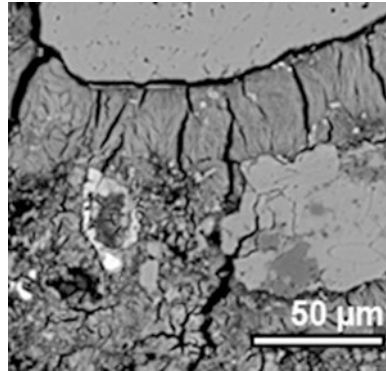
Fig. 32 Fibrous thaumasite in crack around quartz particles, note crack in concrete

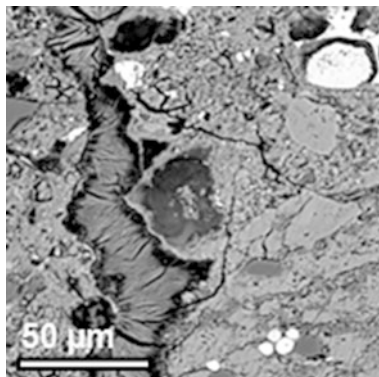
Fig. 34 Crack filled with thaumasite and ettringite, note crack in concrete

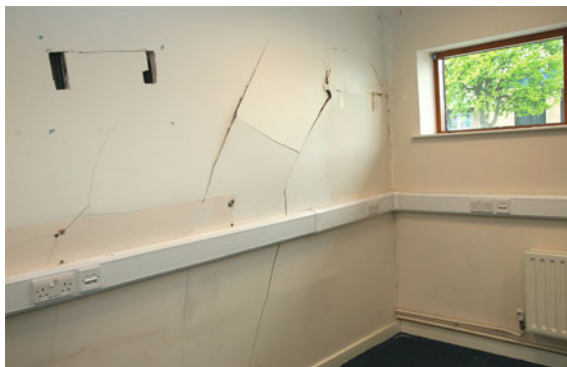
Fig. 36 Distortion of plasterboard in office

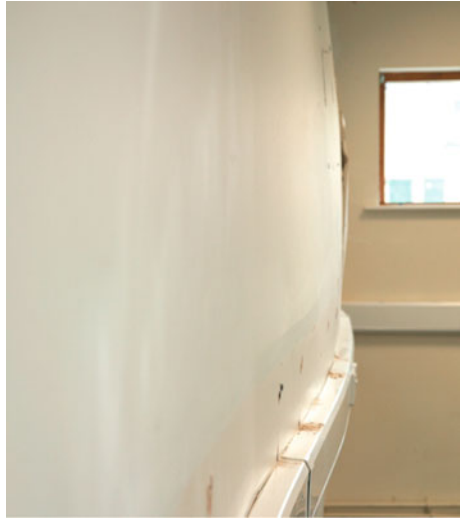
Fig. 37 Distorted electric service duct

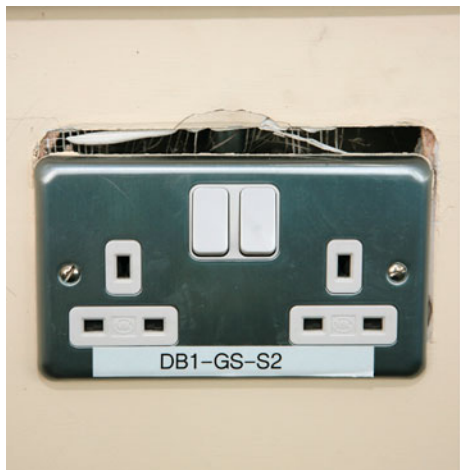
Fig. 38 Plasterboard pushed away from plug

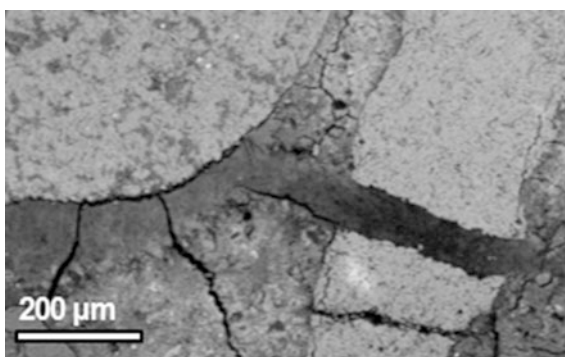
Fig. 44 Thaumasite in beam

In view of the extent of sulphate penetration into the concrete/concrete blocks a decision was made to scabble the ground beams where the concrete was exposed during the remedial works. In part this was to ensure that sulphates did not extend as far into the beams as the steel reinforcement. After the outer 1–5 mm had been removed by scabbling, the concrete was coated with a Fosroc product to inhibit further moisture entering into the cementitious material and thus minimise the potential for any future development of sulphate.

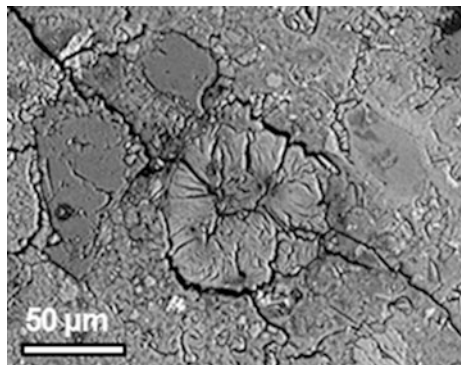
- (a) Samples 1 and 2 had sulphate values of $>4\% \text{SO}_4$ up to 6 mm into the concrete.
- (b) The concrete chippings in core 4 had $>4\% \text{SO}_4$ extending up to 11 mm into the concrete.
- (c) In concrete blocks examined from Zone 3, thaumasite was seen to fill pores up to 6.1 mm into the block (Fig. 45).

Fig. 45 Thaumasite filling void 6.1 mm from concrete surface
