# The Effect of Pyrite-Related Heave: A Structural Engineer's Perspective

Paul M. Forde

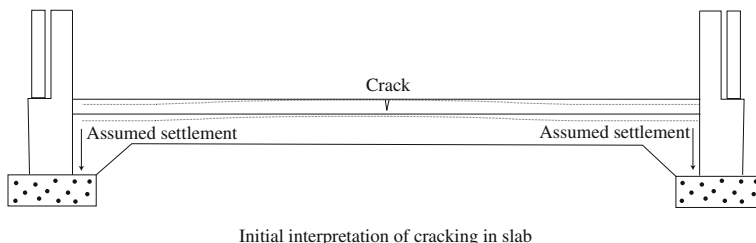
Initially the problem was misdiagnosed as settlement of deep sections of fill against rising walls (Fig. 1). In the first houses, it was recommended that grout

**Fig. 1** Initial interpretation of cracking in the ground-bearing floor slab

should be pressure-injected into any voids in the fill. However, when cracking recurred in the same houses, it was clear that a different cause was responsible and it would be necessary to review the previous conclusions.

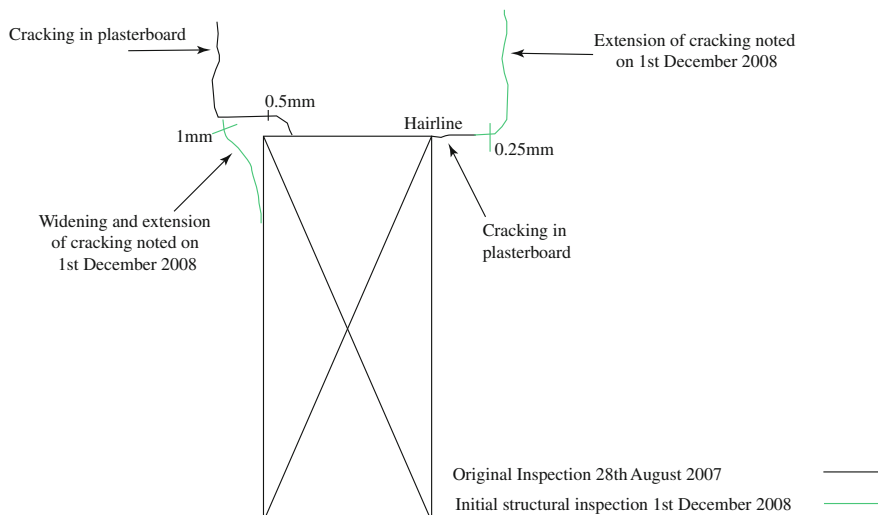
It is also worthwhile to mark and date crack termination points (see Figs. 2 and 3). Any evidence of previous repairs should also be noted, particularly repairs that do not appear to have been successful i.e. where damage has re-appeared.

**Fig. 2** Damage recorded in an internal wall of a house indicating progression over an interval of 15 months

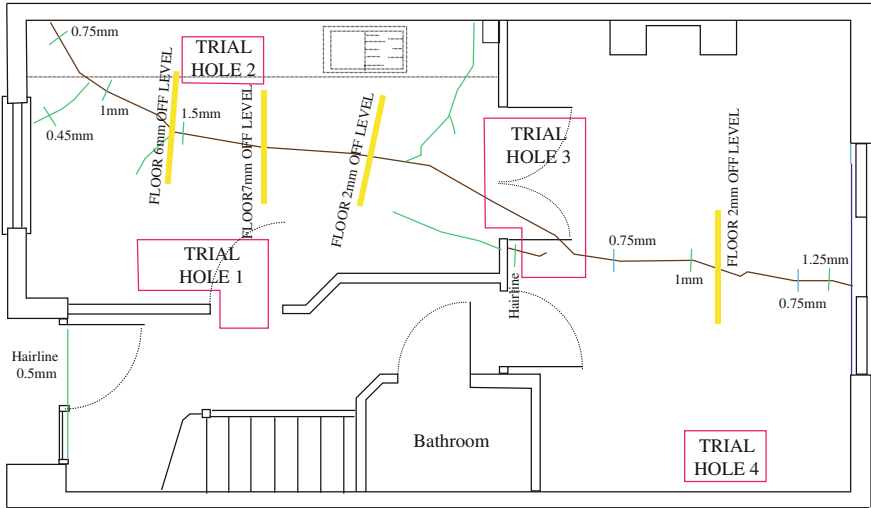
**Fig. 3** Damage recorded in a floor slab during four visits over an 8 month period. Progression in the width and extent of cracking is highlighted. The locations of four exploratory trial pits are also shown

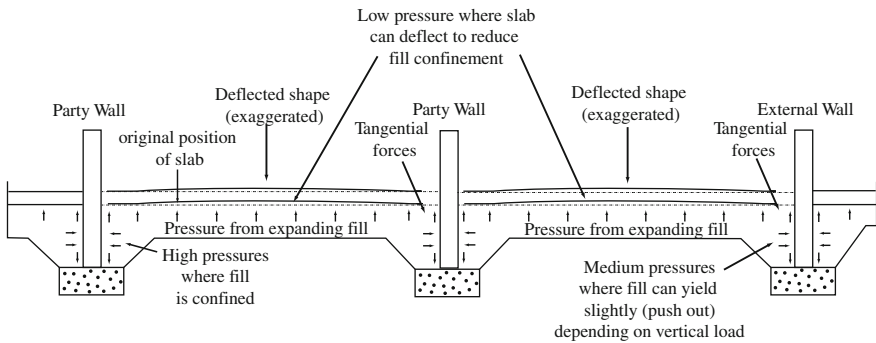
Where the stone infill is very confined, such as adjacent to party walls and internal rising walls, very large forces are developed which cause the walls to be lifted and the formation of horizontal cracks in the rising walls. Where the stone infill is less confined, such as at external walls where outward movement can occur, the forces generated by the expanding stone infill can be relieved or partially relieved.

**Fig. 4** Section through terrace showing notional sub-floor behaviour

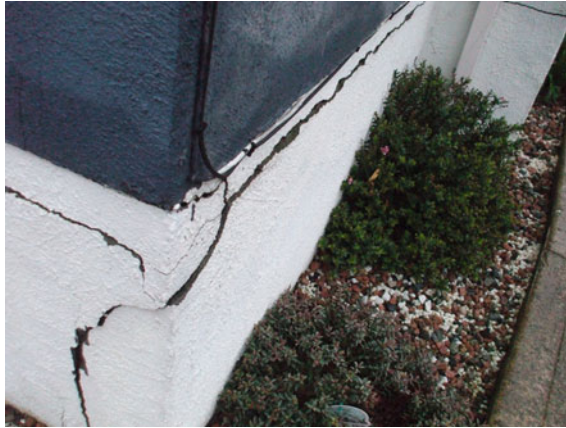
Continuing lateral pressure causes outward stress on the external rising walls and this can lead to cracking and lateral displacements (Fig. 5). The movement is not always obvious, but during the remedial works evidence of the lateral pressures exerted by the fill was found in numerous properties.

**Fig. 5** Cracks created during lateral displacement of a rising wall

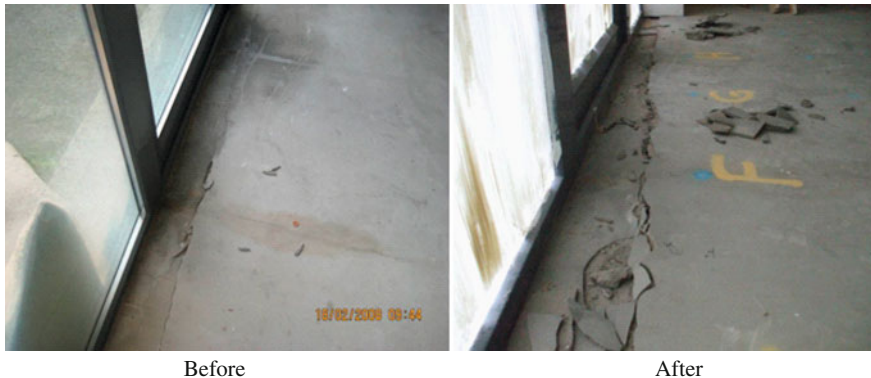
In some properties, sudden apparent rises were noted in the ground floor slab within a number of days after the removal of the ground floor slab in the adjacent property i.e. on the other side of a common party wall.

**Fig. 6** Effect on the ground-bearing floor slab after the removal of fill in an adjacent property

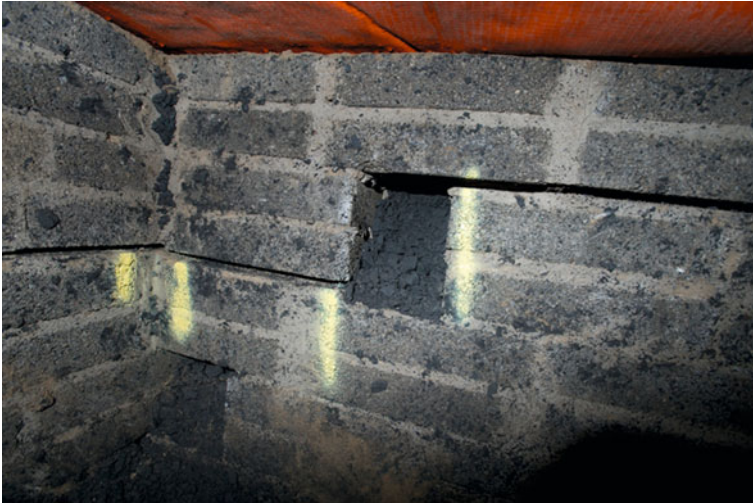
During the removal of the defective stone, horizontal cracking and gaps in the rising wall joints below ground floor level were often observed. These frequently extended through the full thickness of the rising walls and some cracks/gaps continued around the full periphery of the property. Where they passed through the internal rising walls, in some cases the aperture was in the order of 20 mm (Fig. 7).

**Fig. 7** Horizontal gaps (up to 20 mm) observed in a rising wall immediately after the fill was removed in a localised trial pit (the balance of the fill beneath the floor slab was still in place at this time)

- (a) break the mortar bond;
- (b) lift the house by 20 mm, and
- (c) hold the house up in its raised position.

These cracks/gaps were observed to close almost immediately after the slab and fill were fully removed and the forces that caused the building to rise were relieved, allowing the walls to return to their original positions.

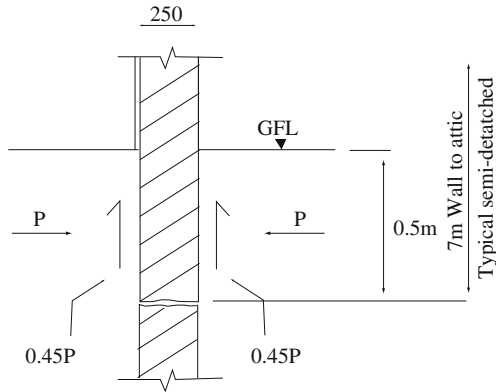
Remedial works undertaken to date have confirmed that the interaction between the swelling stone, the sub-structure and the superstructure is complex and is likely to depend on many factors relating to the fill, its environment, the form of construction and time. Most structural engineers who have not experienced these processes would be very surprised at the pressures that can be developed in the fill if it is in a confined state. These pressures can be sufficient to fully lift a house and hold it in its raised position, as outlined above. The most basic calculation will show that this is possible with swelling pressures in the order of 100–200 kPa where the coefficient of friction between the stone and the blockwork is taken at, say, 0.45 (Fig. 8).

**Fig. 8** Sample calculation of pressure required to lift a party wall

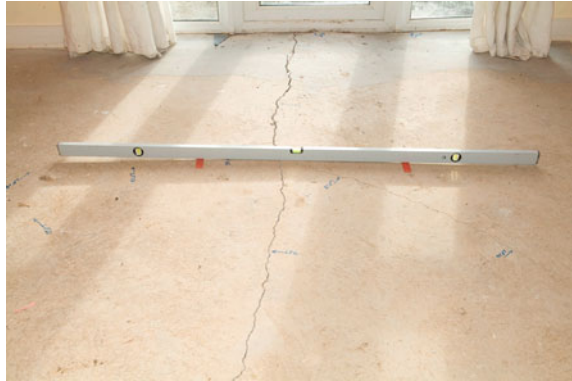
**Fig. 9** Crack up to 7 mm wide across a floor which has risen 30 mm within a distance of 2.5 m

Concrete ground-bearing floor slabs have risen and cracked. In standard houses, rises of around 25–30 mm across a normal width house are common, with crack apertures of up to 7 mm. A typical example of a crack extending through a sitting room is shown in Fig. 9.

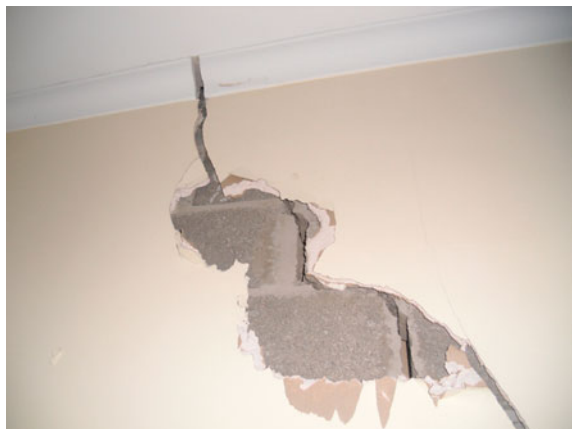
Cracking is common over door heads and where the internal wall, constructed on the floor slab, abuts the external wall founded on a strip footing (Fig. 10).

**Fig. 10** Cracking through plaster and blockwork of internal wall

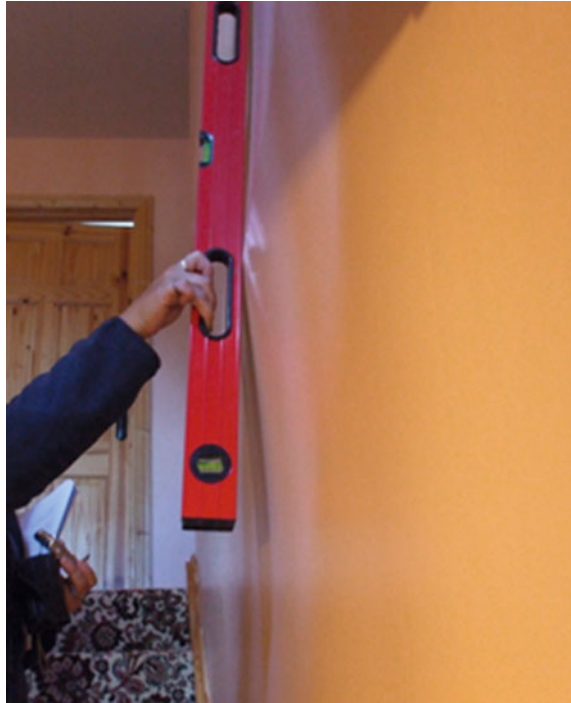
**Fig. 11** Bowing of a stud wall pushed upwards by the rising floor slab

Many of the internal walls in the affected buildings were constructed as plasterboard stud walls. Where the plasterboard rests directly on the floor slabs, the upward pressures cause distinct bowing (Fig. 11).

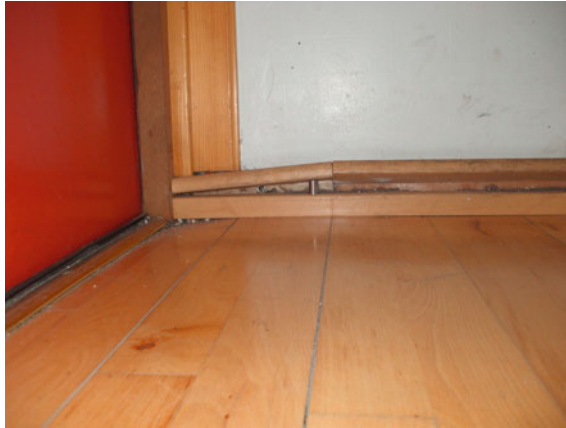
A typical example of the twisting and bowing of timber skirtings is shown in Fig. 12. Door architraves are also frequently distorted by the pressure from the swelling stone.

**Fig. 12** Displacement of timber skirting

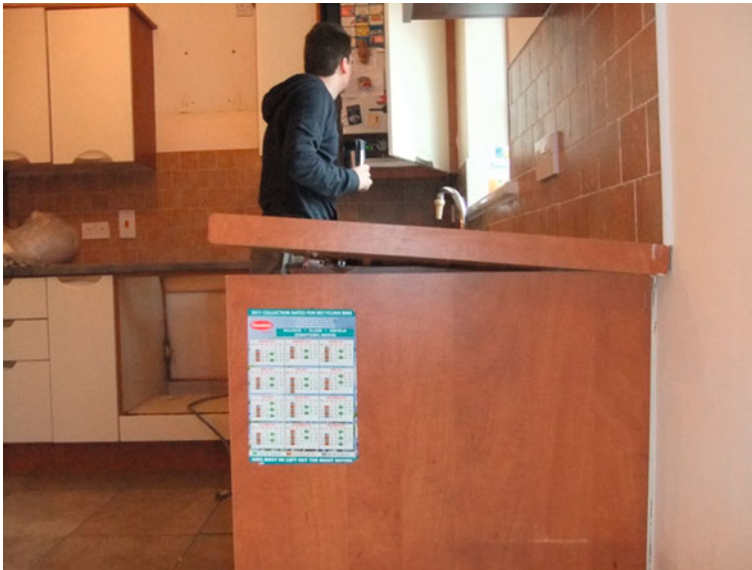
The rising/arching of the floor slab causes significant stress on fittings, particularly in kitchens where units may be damaged and worktops lifted/distorted. Figure 13 shows the effect on a worktop under stress from the rising floor but restrained by the wall tiles.

**Fig. 13** Kitchen work top prised off its base

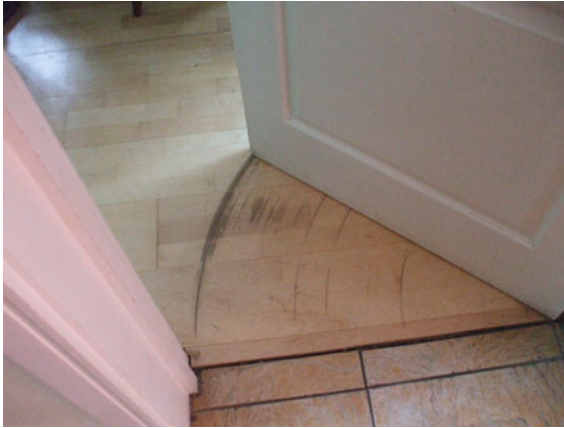
There are many examples of doors binding against the rising ground floor slab (Fig. 14) or external paving (where the same pyritic stone has been used externally). In other situations, the door frame is forced upwards by the rising floor while the architrave in the centre does not rise, hence the door “catches” in the middle (Fig. 15).

**Fig. 14** Bottom of door binding against floor

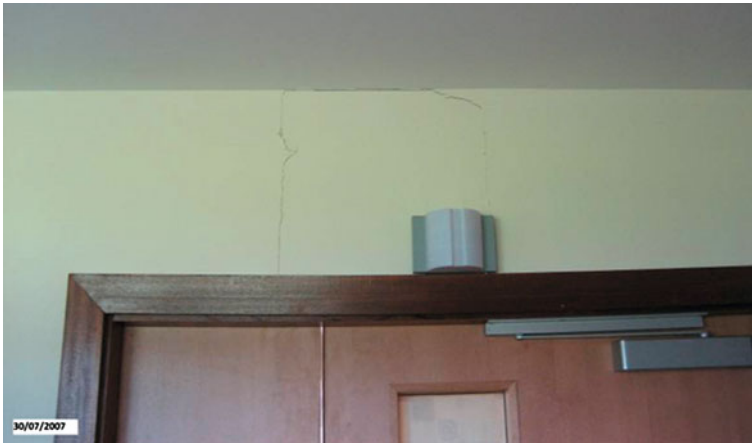
**Fig. 15** Top of door binding against architrave

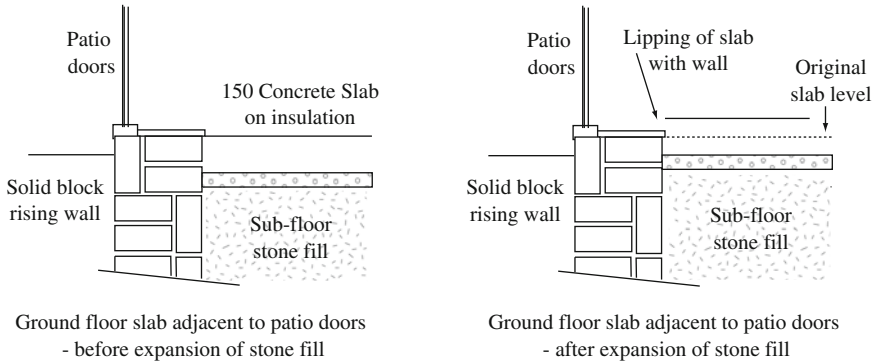
Significant lipping can occur in the ground floor, generally at external doors/patio doors where the ground floor slab rises relative to the door threshold (Figs. 16 and 17).

**Fig. 16** Ground floor slab adjacent to patio doors, *before* and *after* expansion of the stone fill

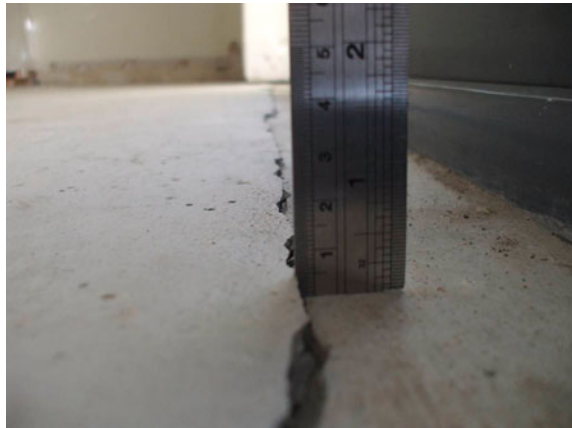
**Fig. 17** Typical lip at the location of a patio door (7 mm in this case)

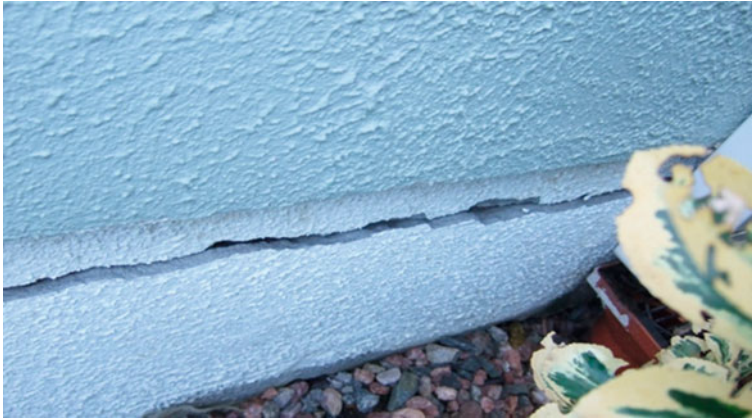
weakness in the wall, such as where the damp proof course has been placed. In some instances this is accompanied by differential outward movement across the crack (Fig. 18).

**Fig. 18** Cracking and displacement of external wall (plinth)

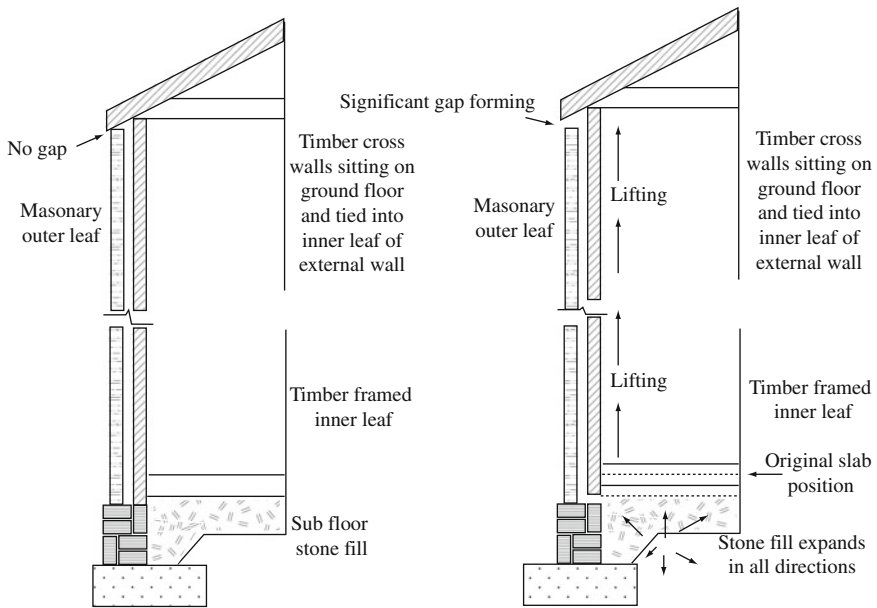
Significant horizontal gaps and cracks in the external leaf of cavity constructions have been noted. These develop where the inner leaf has been pushed up relative to the external leaf, notably in timber-framed houses. On one particular project this resulted in a gap of 40 mm at soffit level within 5 years (Figs. 19 and 20). In other situations a similar rise at the underside of cills has been observed.

**Fig. 19** Sketch indicating external wall *before* and *after* the internal leaf has been pushed upwards by the expanding fill

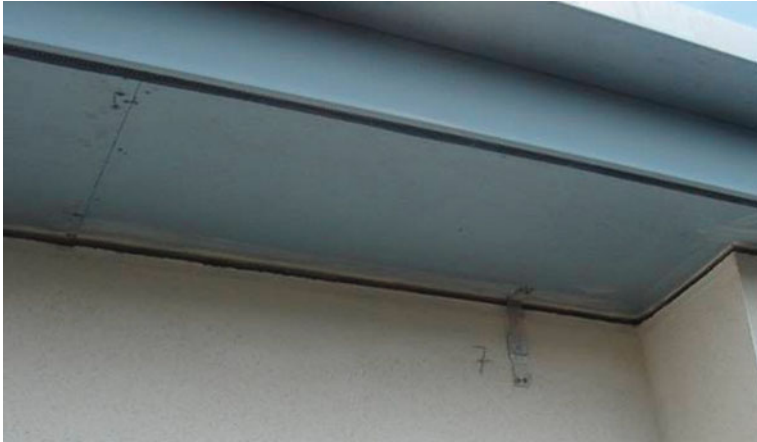
**Fig. 20** Gap of some 40 mm which developed at eaves level within 5 years of construction

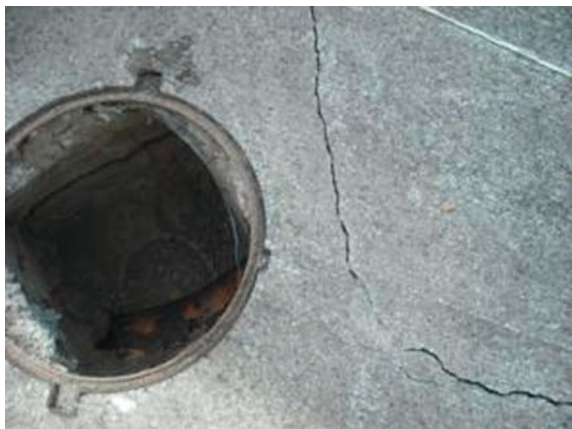
areas. Possible damage to underground services from swelling stone is also a concern. Horizontal gaps have been observed in many manholes and service chambers (Figs. 21 and 22).

**Fig. 21** Pavement cracking near manhole

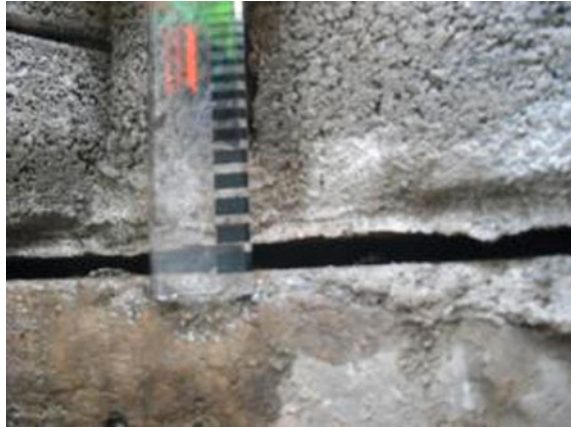
**Fig. 22** 12 mm gap near top of manhole
