An Overview of Some Recent Large Landslide Types in Nahanni National Park, Northwest Territories, Canada

Courtney Jermyn and Marten Geertsema

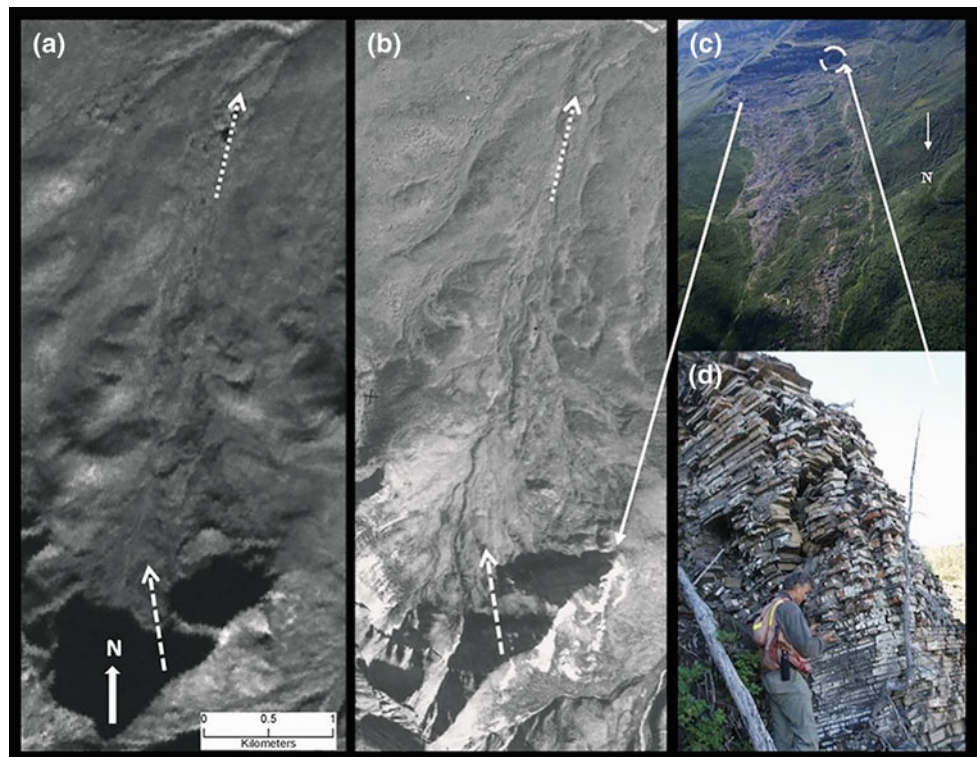
We identified in the Tlogotsho Plateau, long-runout earth flows on low-gradients (typically less than 7°), mainly on north-facing slopes. The Grizzly landslide covers 7 km^2 and traveled approximately 4 km (Fig. 59.2a–c). The upper portion of the slide displays both rotational and translational

movement in jointed sandstone and siltstone along a shale rupture surface (Fig. 59.2d). The middle to lower portions of the landslide involved flowing and minor sliding of cohesive soil on a gradient of 3° . The landslide can thus be classified as a rock slide—earth flow. Based on aerial photos, satellite imagery, and field work observations, this slide was first active prior to 1949 and achieved its current form and extent over 10 years ago (Fig. 59.2a, b). The long runout of this and other similar slides may be caused by undrained loading of cohesive earth material generated by the rock slide. Similar landslides have been described by Geertsema (2006) in northern British Columbia.

Fig. 59.2 Imagery of the rock slide-earth flow in the Tlogotsho Plateau (photos taken by Dr. Marten Geertsema and Courtney Jermyn). *White dashed lines* represent rock slide movement and *white dotted lines* signify earth flow movement. **a** ASTER ortho-image: shadows on north-facing slopes obscure exposed bedrock. **b** 1:40,000 scale, cropped 1949 air photo; A12295-182. **c** Oblique photo illustrating rock slide-earth flow features. **d** Jointed siltstone located at the base of a rotational rock slide (location identified by the circle in photo c)

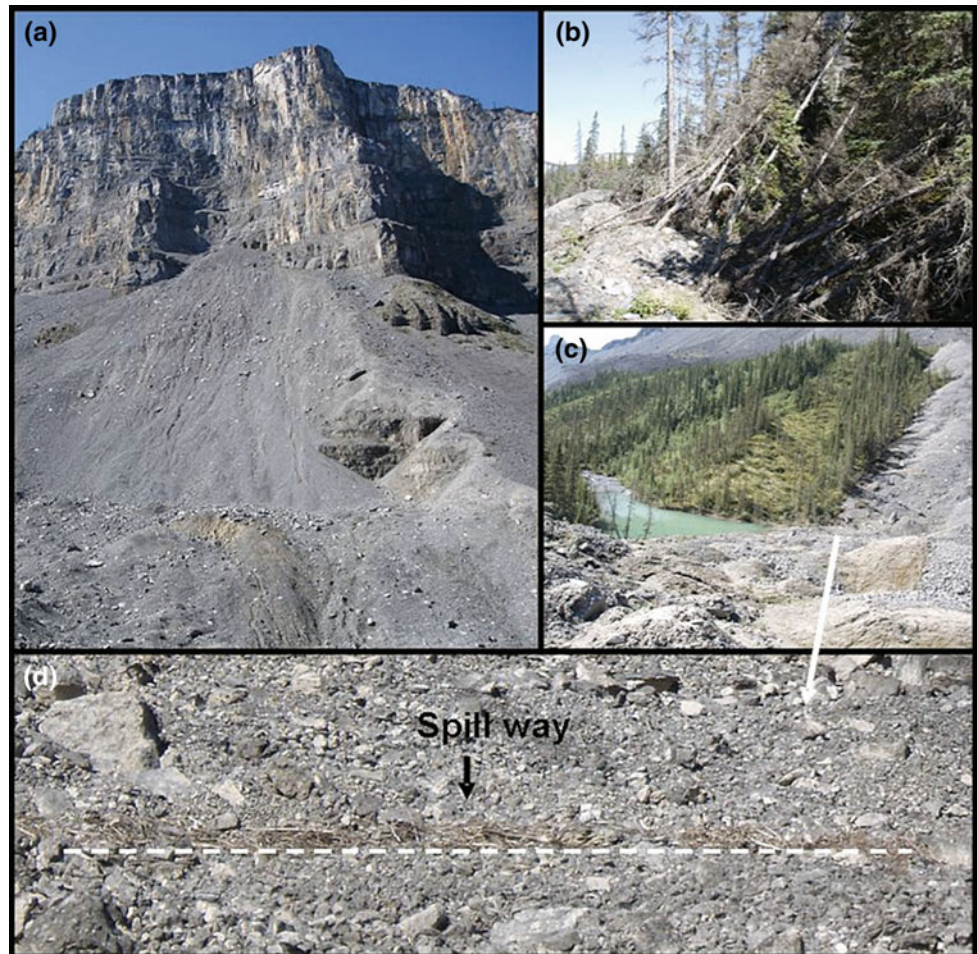
This rock slide is located on an unnamed river within a canyon incised in the Ram Plateau. The landslide was likely triggered by a rock fall from the steep, limestone cliff face (Fig. 59.3a). The failed rock rubble moved down slope, entrained lake sediments and ran 20–25 m up the opposite side of the valley (Fig. 59.3b, c). The lake is located on the south side of the landslide deposit and was originally 4 m higher than at present (Fig. 59.3c). We determined the previous highest level of the lake from the presence of a spillway marked by accumulation of woody debris and lateral margins formed in the rock debris. The rock slide was not visible on 1949 air photos indicating that the failure post dates 1949. In addition, the absence of vegetation and

Fig. 59.3 Ram Plateau rock slide 1: **a** rock slide failure surface; **b** uprooted trees caused by run-up of debris during the rock slide event; **c** landslide-dammed lake; **d** spillway (photos taken by Dr. Marten Geertsema and Courtney Jermyn)

disturbance of the landslide deposits and fresh preservation of the spillway (Fig. 59.3d) suggest this failure was recent. Due to cloud cover over the failed region in the image, it was not possible to determine if this rock slide pre- or post-dated the imagery.

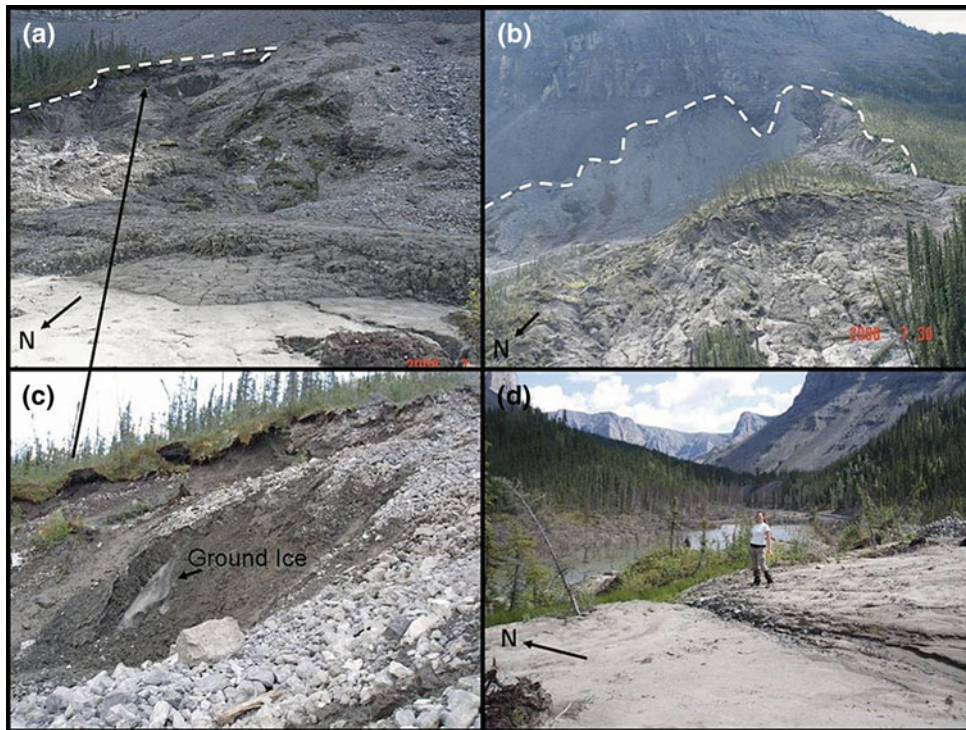
We located an active complex landslide south of the rock slide in the canyon on the Ram Plateau (Fig. 59.4a–d). Based on field observations, it appears that riverbank erosion exposed fine-grained glacial lake sediments, causing an earth slide—earth flow that dammed the river (Fig. 59.4a, b, d). The flowslide exposed permafrost (ground ice) and angular rubble in a talus slope (Fig. 59.4c). The exposed permafrost thawed resulting in retrogressive flows. The ASTER scene did not provide additional information about the failure because of strong shadows. Field observations

suggest the failure post-dates the ASTER scene acquired in 2000 because retrogressive thaw flow activity was ongoing during our visit.

Fig. 59.4 Ram Plateau earth slide-earth flow (flowslide). *Dashed line* delineates headscarp: **a** earth flow movement within a complex landslide; **b** rotational earth slide movement within a complex slide;

c ground ice exposure; **d** landslide-dammed lake. Photos taken by Dr. Marten Geertsema

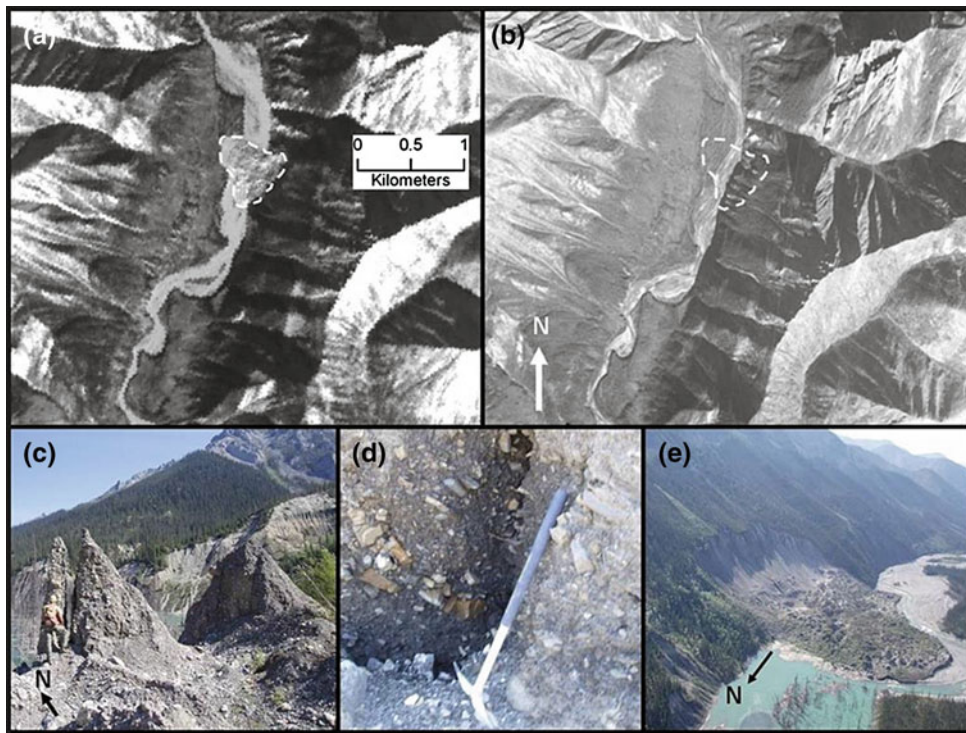
During field investigations we identified a translational debris slide (Fig. 59.5a, c, d, and e). The displaced material is matrix-supported diamicton containing sub-rounded to angular clasts (Fig. 59.5d). A landslide-dammed lake was located on the north side of the deposit, and based on strandlines on the shore, the lake was 10 m deeper than at the time of our field visit (Fig. 59.5e).

The slide dates post 1949 as it was not present in the 1949 air photos but was identified in ASTER scenes scanned in the early 2000s. In the field we identified large conical mounds of debris (molards), up to 12 m in height, across the entire deposition zone (Fig. 59.5c). The molards gave the landslide a blocky texture in the ASTER scene.

Fig. 59.5 Wrigley Creek debris slide: **a** ASTER scene (*white dashed line* identifies the debris slide); **b** 1949 air photo A12319-230: 1:40,000 scale. The image pre-dates the landslide. The air photo has a higher resolution than the ASTER scene. Geomorphological detail is comparable in the two aerial images. Because the air photo pre-dates

the landslide event, gully formation in the headscarp region is visible. The presence of gullies suggest that the material is glacial in origin (*white dashed line* identifies the debris slide); **c** molards; **d** failed diamicton; and **e** view of the landslide-dammed lake. Photos taken by Dr. Marten Geertsema and Courtney Jermyn

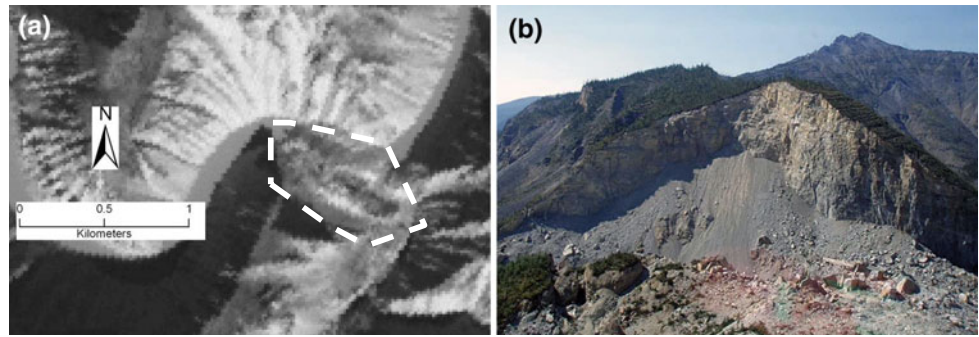
Fig. 59.6 **a** ASTER image of Rock slide, Cathedral Creek, **b** Oblique photo of Rock slide face, Cathedral Creek

A large rock slide occurred at the confluence of Cathedral and Clearwater creeks (Fig. 59.6a, b). The movement occurred along a dipping bedding plane. The landslide dammed the two creeks forming two lakes. The lake along Clearwater creek was approximately 5 km in length (Parks Canada 2012). Through correspondence with David Murray from Parks Canada in 2005 and reinstated by Parks Canada (2012), the failure occurred in the winter of 1996–1997, which followed a series of earthquake events in the region that year. In the summer of 1997, a portion of the natural dam, caused by the landslide, breached causing an outburst flood that dropped the lake along Clearwater creek 15 m; raising the level of the South Nahanni River in Deadman Valley by more than 4 m. Although no one was injured as a result of the flash flood, groups of canoeists camping downstream had to pack up quickly to avoid the event. The stability of the dam is unknown (Parks Canada 2012).
