Post-earthquake Assessment of a Masonry Tower by On-Site Inspection and Operational Modal Testing

Antonella Saisi and Carmelo Gentile

Keywords Diagnosis · Ambient vibration testing · Historic masonry structure

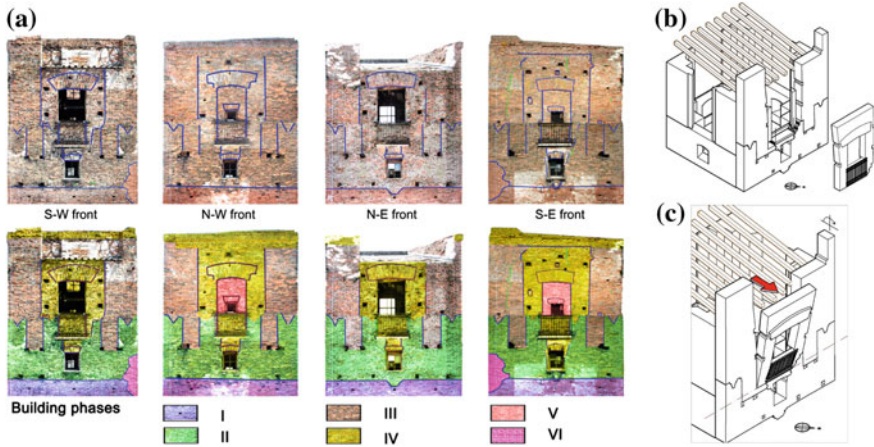
Fig. 4 Reconstruction of the building phases (a), recognizing of the weakly restrained masonry portions (b) and (c) of the possible overturning mechanisms due to seismic actions

As previously pointed out, an accurate on-site survey of all fronts of the tower was firstly performed using a mobile platform (Fig. 1). This preliminary survey is aimed at providing details on the geometry of the structure and identifying critical areas and irregularities, where more refined inspections are needed. In the meantime, the historical evolution of the structure should be known to explain the signs of damage detected on the building and to hypothesize possible seismic out-of-plane behaviour of weak restrained masonry portions (Fig. 4).

On the contrary, the top of the tower (i.e. the upper portion about 8.0 m high, Fig. 3) shows damage related to the detachment of the several construction phases, worsened by the natural decay (Fig. 4). In fact, settlement of the interventions and of the opening infillings coupled with the highly disordered masonry and mortar erosion causes lack of horizontality of the joints of the crowing and the development of cracks as well (Fig. 8). Critical areas are the infillings between merlons (Figs. 4 and 9), supported only by few courses of thin masonry due to the unusual

layout of the scaffolding holes. The extension of the scaffolding holes over the base of the infillings weakens the local and overall stability (Fig. 9) so that the prevention of local instability of such masonry portions should be one of the intervention priority on the tower. Figure 4 shows an example of the detailed survey of the masonry textures aimed at recognising the structural discontinuities and the boundaries of the weakly restrained portions. Based on this investigation, the first evaluation of out-of-plane seismic behaviour for each recognised masonry portion not effectively linked was carried out (Fig. 4c). This procedure, implemented according the most recent technical literature and the Italian seismic code, gives an overview of the seismic vulnerability related to the building transformation over time and the effect of local damage.

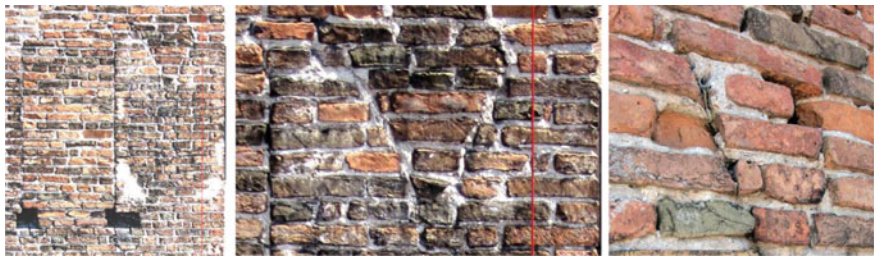
Fig. 5 Probable merlons embedded in the masonry texture

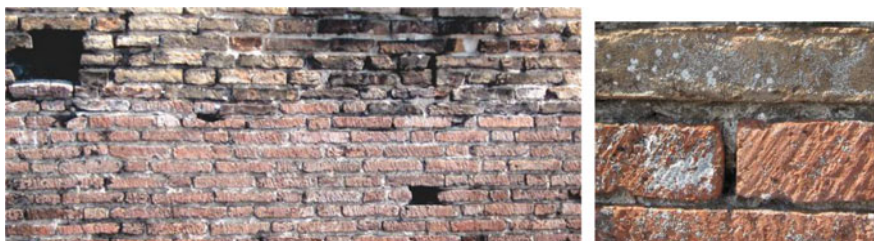
In the XVI century, the *Gabbia* tower was used as open-air jail, hosting a hanged dock on the S-W front (Figs. 1 and 3). Scanty information is available on the building evolution but the observation of the masonry texture reveals passing-through discontinuities at the top. Traces of past structures are visible on all fronts (Fig. 4) and the presence of merlon-shaped discontinuities (Figs. 4 and 5) suggests modifications and further adding at the top of the tower above the crenelation. Moreover, at about 8.0 m from the top, a clear change of the brick surface workmanship (the bricks of the lower part are superficially scratched) could reveal the first addition (Fig. 6); in the same region concentrated changes of the masonry texture suggest local repair.

Fig. 6 Change of the surface workmanship at about 8.0 m from the top of the tower (the bricks of the lower portion are superficially scratched)

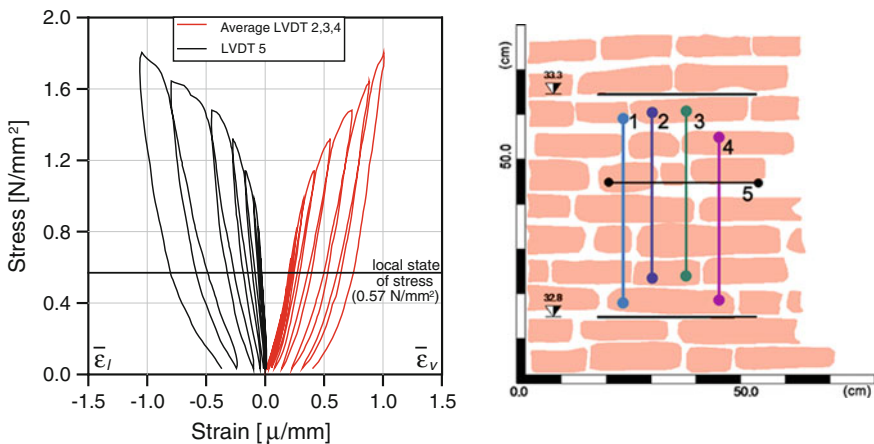
Excepting the upper part of the tower, visual inspection did not reveal evident structural damage but only superficial decay of the materials (mainly of the mortars, due to the natural ageing and the lack of maintenance). In the lower part of the tower, the corners exhibit rare thin cracks and the masonry section appears of solid bricks and lime mortars. Subsequent pulse sonic tests and double flat jacks confirm the soundness and the compactness of the masonry of such building portion. Results from pulse sonic tests suggest compact solid brick section, with high velocity values, ranging between 1100 and 1600 m/s. Double flat jack test carried out on the N-E side at about 32.8 m from the ground level (Fig. 7) revealed that the Young's modulus is larger than 3.00 GPa. Similar information result from the laboratory tests on sampled bricks and mortars.

Fig. 7 Results of the double flat jack test and superficial texture of the investigated area

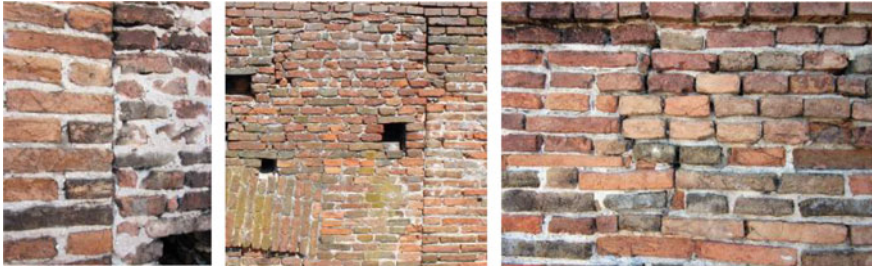
Fig. 8 Typical discontinuities on *top* of the tower and lack of horizontality of the masonry courses

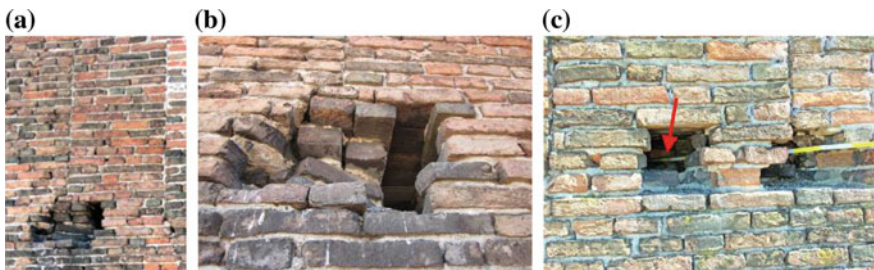
Fig. 9 Details of the infillings between the supposed merlons on the N-W front: **a, b** *left side* infilling; **c** *right side* infilling

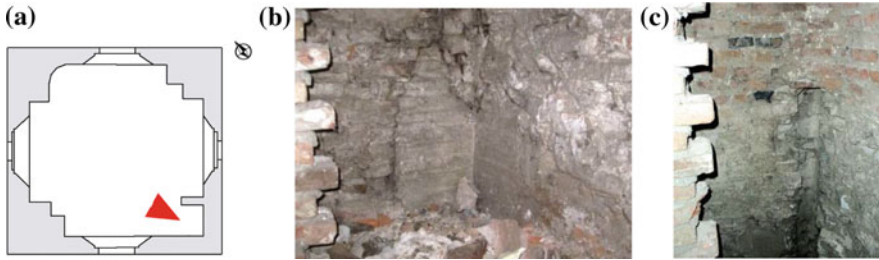
It is important to remark the change of the masonry sections and of the plan layout on *top* of the tower (Levels 3 and 4 in Fig. 3), where the continuous side wall of the nearly squared plan turns into corner masonry piers and un-toothed infillings. The decrease of resisting section is especially significant for the piers on North and South corners at level 4. As shown in Fig. 10, the corner pier at South is partially dismantled, showing an embedded pipe at the edge and the merlon shape. The lack of any mortar encrustation in the merlon surface suggests a weak connection in the other piers at the same level, as well.

Fig. 10 Details of the South corner at level 4 (a): **b** the corner is partially dismantled with a probable infilled merlon and **c** with an embedded pipe at the edge

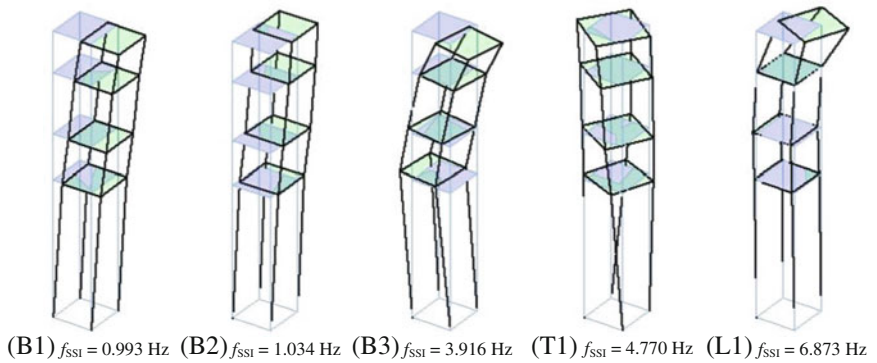
- (d) the last identified mode is local (L) and only involves deflections of the upper portion of the tower (Fig. 13L1). The mode shapes seem dominant bending, with significant components along the two main planes of the tower. The presence (and generalized detection) of a local vibration mode provides further evidence of the structural effect of the change in the masonry quality and morphology (including un-toothed opening infillings and discontinuities) observed on top of the tower during the preliminary visual inspection. On the other hand, both visual inspection and OMA confirm the concerns about the seismic vulnerability of the buildings and explains the fall of small masonry pieces from the upper part of the tower, reported during the earthquake of May 29th 2013.

Fig. 13 Vibration modes generally identified from ambient vibration measurements (SSI, July 31st 2013, 16:00–17:00)

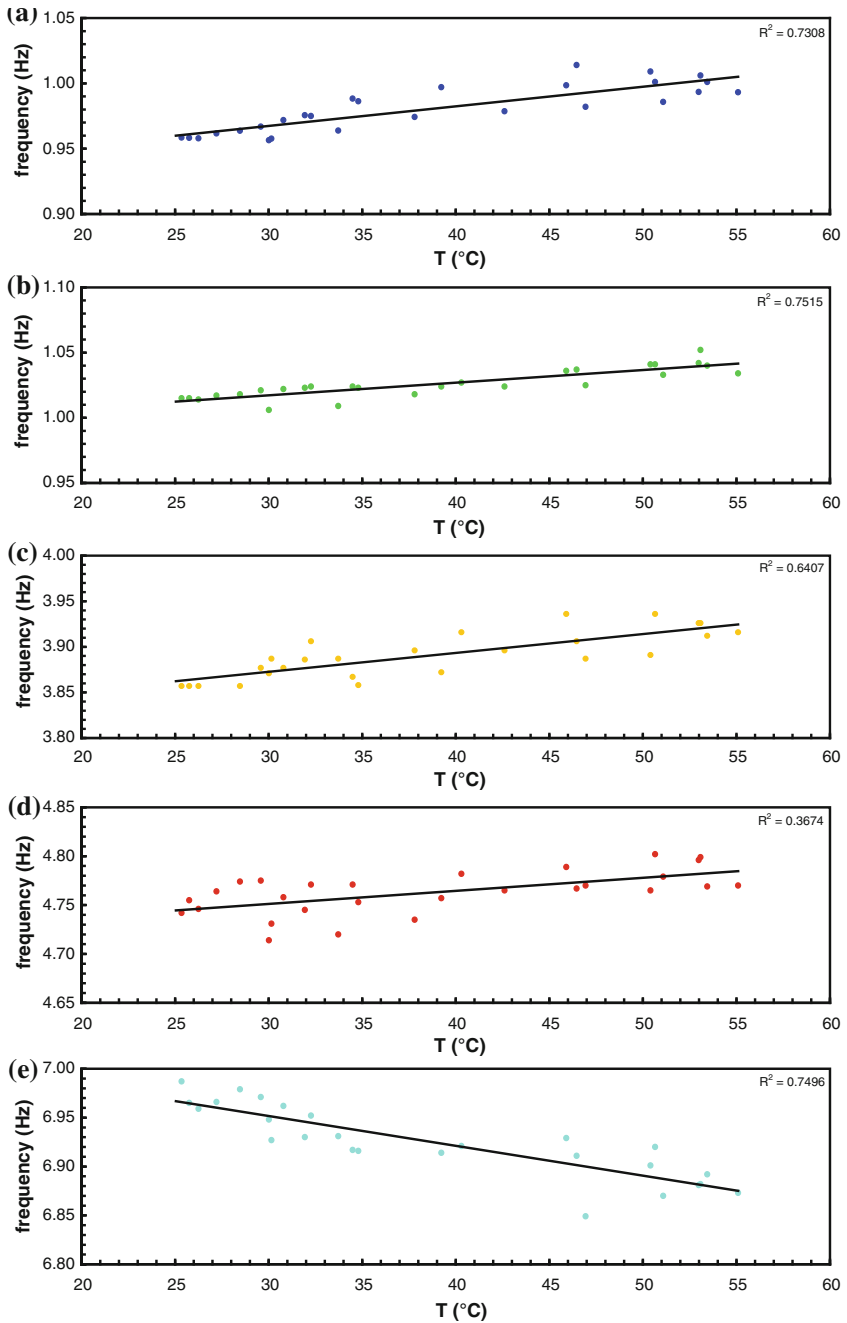
Fig. 15 Frequency (SSI) variation versus measured outdoor temperature (S-W front): **a** mode B1; **b** mode B2; **c** mode B3; **d** mode T1; **e** mode L1

Unlike the global modes, the natural frequency of the local mode L1 (Fig. 15e) decreases as the temperature increases and the coefficient of determination assumes a high value ($R^2 \cong 0.75$). This result suggests that the thermal expansion of materials in a very inhomogeneous area of the structure causes a general worsening of the connection between the masonry portions; hence, further evidence seems to be provided, again in agreement with the main observation of the visual inspection, of the poor state of preservation of the upper part of the tower.
