8.1 General

8.1.1 Hardware Return from Space

8.1.3 Recent Investigations Using Retrieved Materials

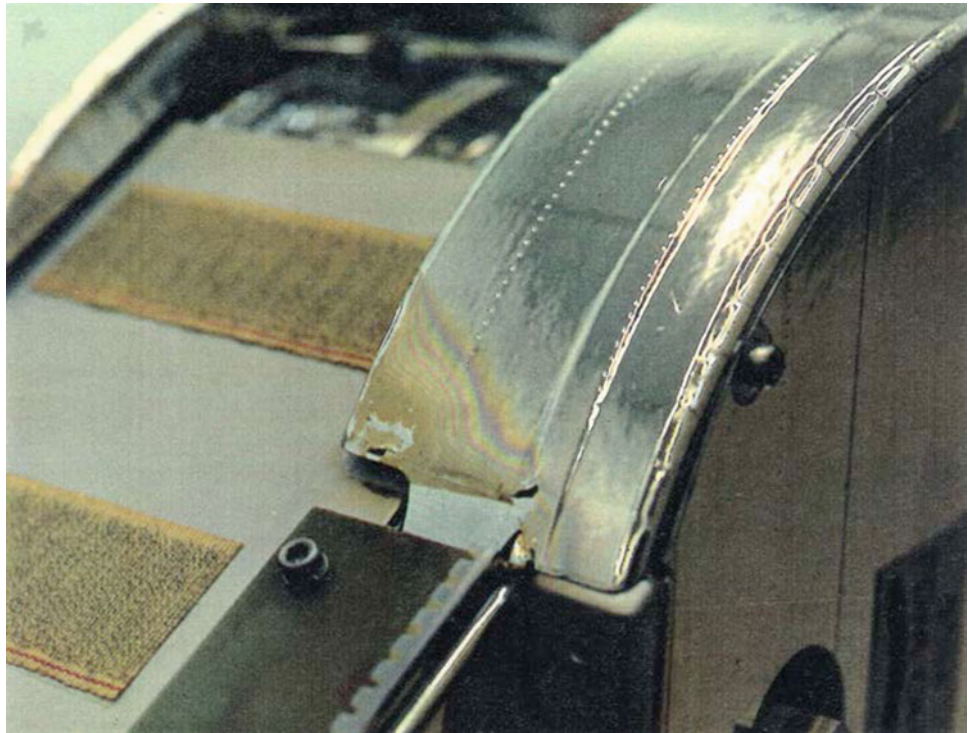
Fig. 8.3 Thermal cover showing ‘fringe pattern’ of condensed contaminant on exposed Kapton tape (returned from Hubble Space Telescope)

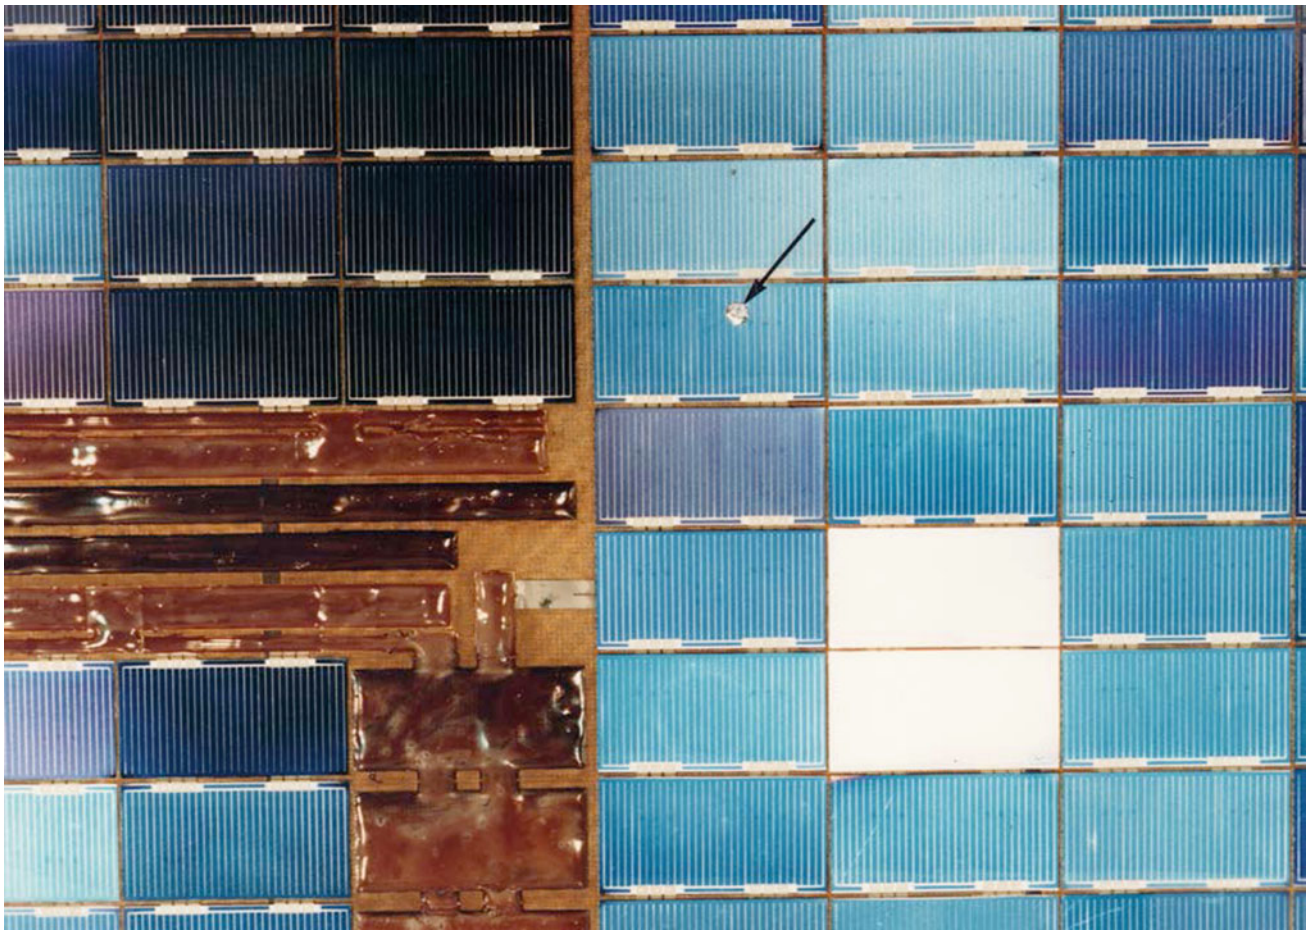
Fig. 8.4 Part of the HST solar array showing the ATOX protection silicone coatings to have become darkened after exposure to the Sun's radiation. One micrometeoroid impact is also visible (*arrowed*) (see also Fig. 4.63)

whilst black paints tended to bleach. The white paints with an inorganic base and a silicate binder were found to be more stable than any of the organic-based paints. Spacecraft adhesives, thermosetting resins, and lubricants are unaffected by the low dosage of radiation from space, and these are usually well protected by metallic foils or are present within electronic black boxes. Some inorganic glasses are quickly damaged by radiation, and even as little as 10^3 rad can cause a loss of transparency to some wavelength ranges (Dauphin 1993). Plastic glasses and optically transparent silicone coatings are also damaged by a general ‘yellowing’ during exposure to solar radiation as seen in Fig. 8.4.

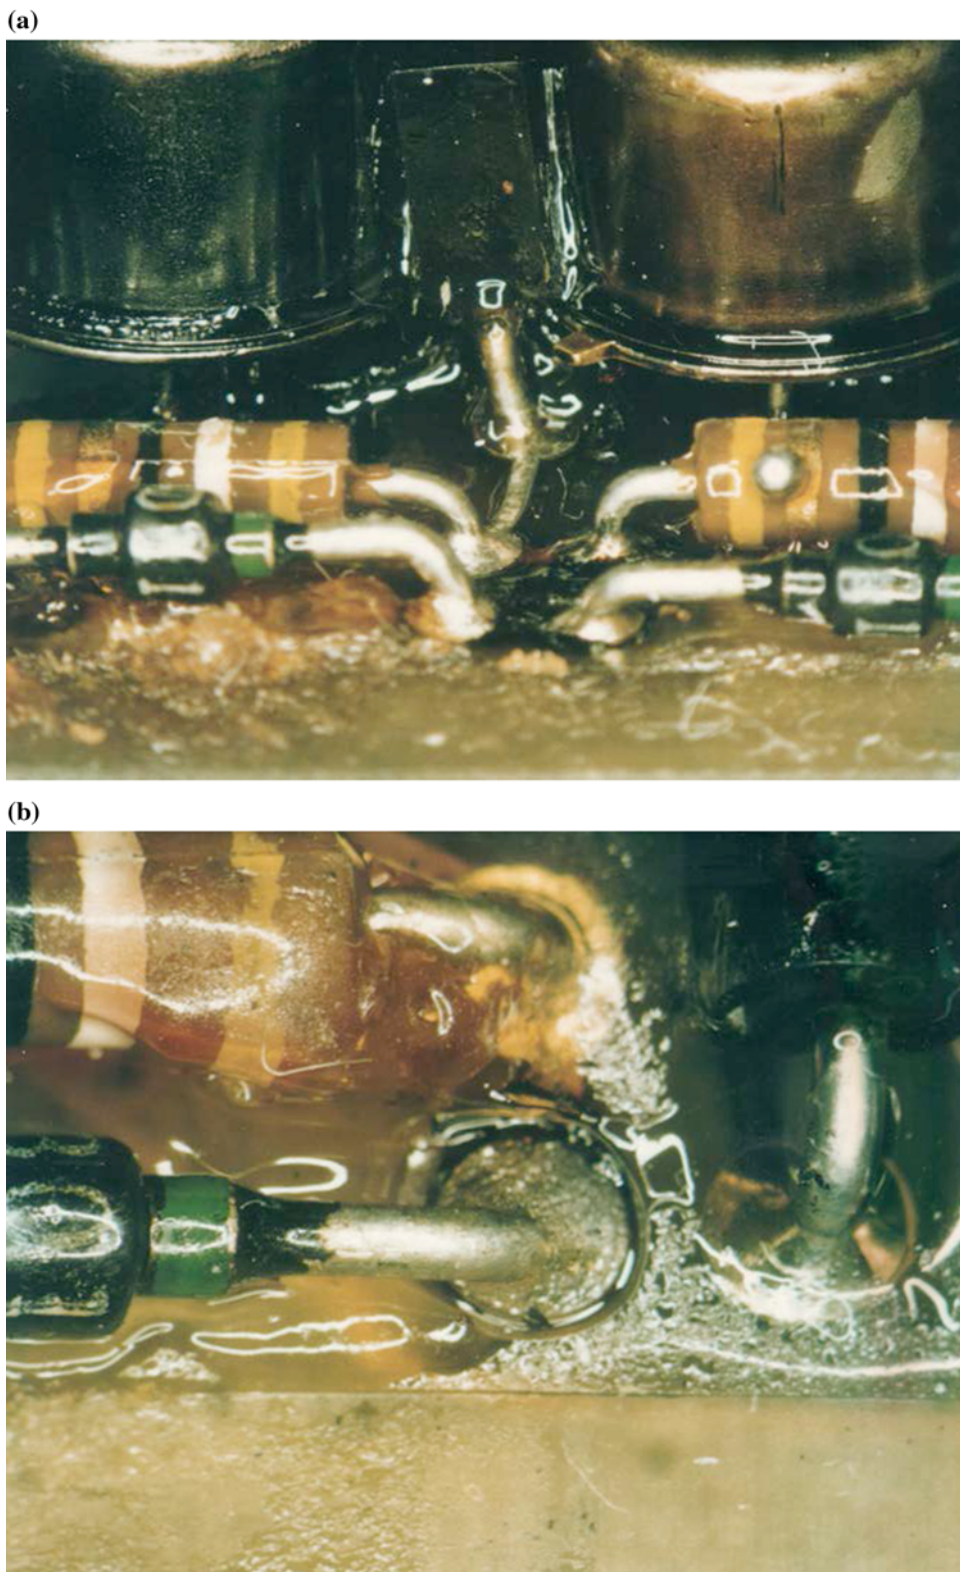
The cause of the SADE failure is thought to have resulted from the inadequate thermal management of the defective PCB assembly. Testing on the ground, in air, had not caused any pre-flight failures because the area surrounding the two power transistors could be kept below a critical temperature by means of heat lost by thermal conduction through the board and heat lost by thermal convection through the laboratory air. Under spacecraft conditions, the operating environment of vacuum excluded convection as a means of cooling and, after a period of high-temperature operation, the transistor solder joints melted (above 183 °C), so producing the final failure. By modifying the circuit such that both power transistors were physically attached to the metallic frame of the box, additional conductive heat loss was made possible and, to date, the present HST SADE unit is operating perfectly.

Fig. 8.6 Visual appearance of post-flight Hubble Space Telescope's SADE failed electronic circuit board. **a** View showing the two transistors, in the background, detailing the discoloration of the Solithane coating on the component bodies. **b** View showing a joint on a diode, detailing the melting of the coating causing it to draw away from the joint. Other areas of this pcb assembly are seen in Figs. 8.7 and 8.8

on-ground studies of the problem it was concluded that the failure was due to overheating of one of the SADE's assembled printed circuit boards (PCBs). A replacement model was built in which two power transistor devices were physically removed from the circuit and mounted via heat-sink caps onto the internal metallic structure of the SADE (Haines et al. 1995). This modification resulted in a device junction-to-structure thermal resistance of 30 °C per watt and ensured that even under the worst case conditions, the maximum transistor junction temperature would be less than 85 °C.

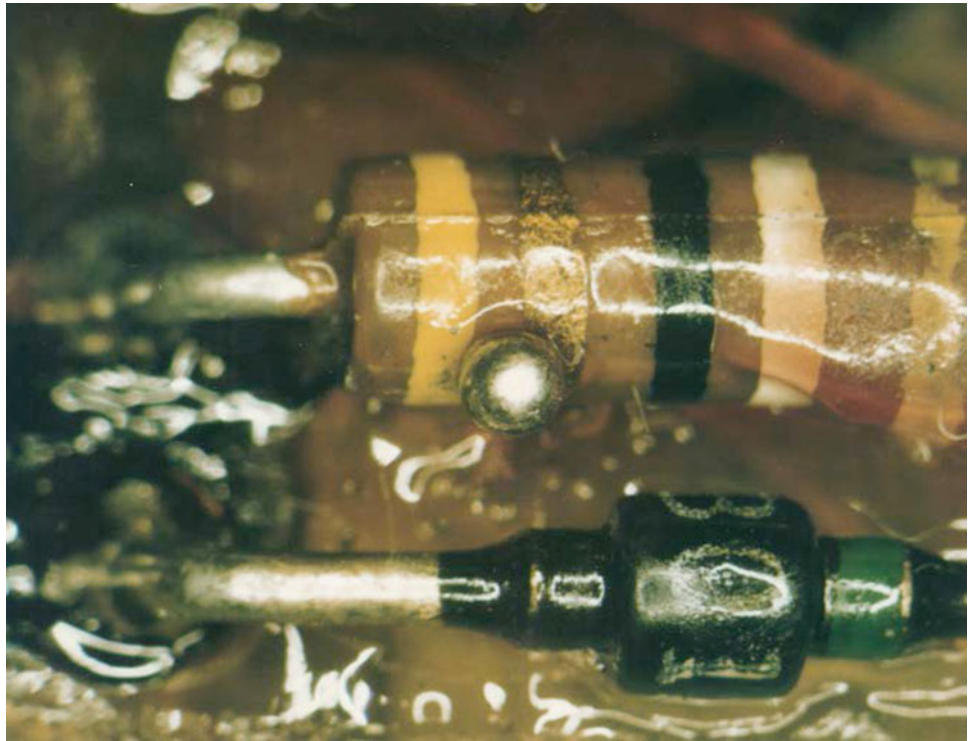
Fig. 8.7 View showing a solder sphere attached to a resistor adjacent to one of the diodes

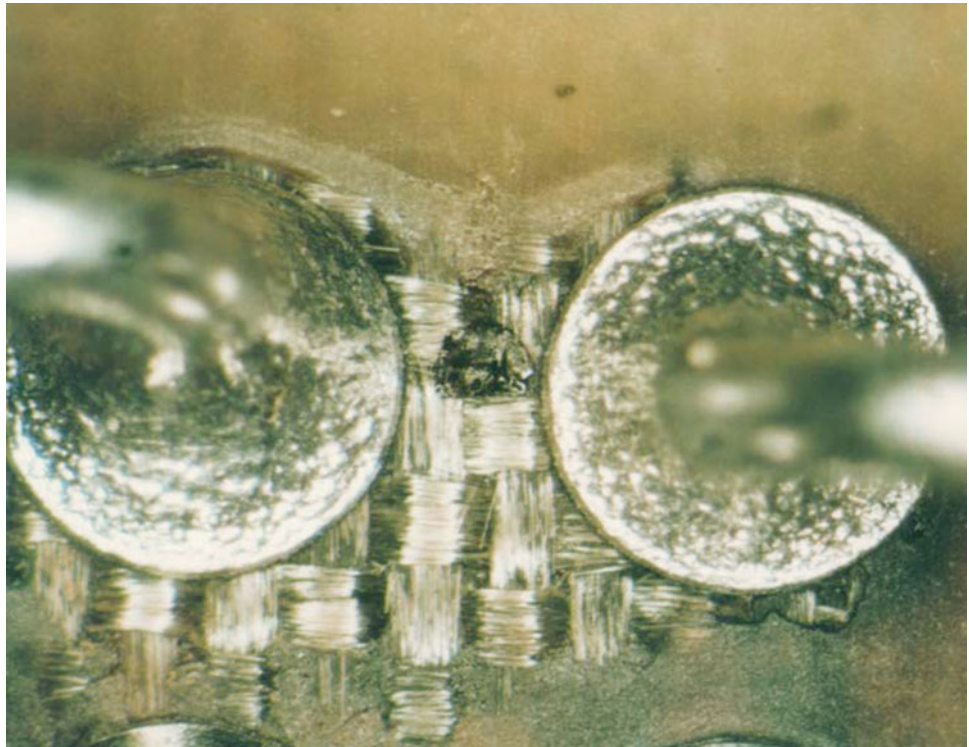
Fig. 8.8 Detail of the damage to the board substrate, some solder splash between the pad terminations, and the granular appearance of the solder

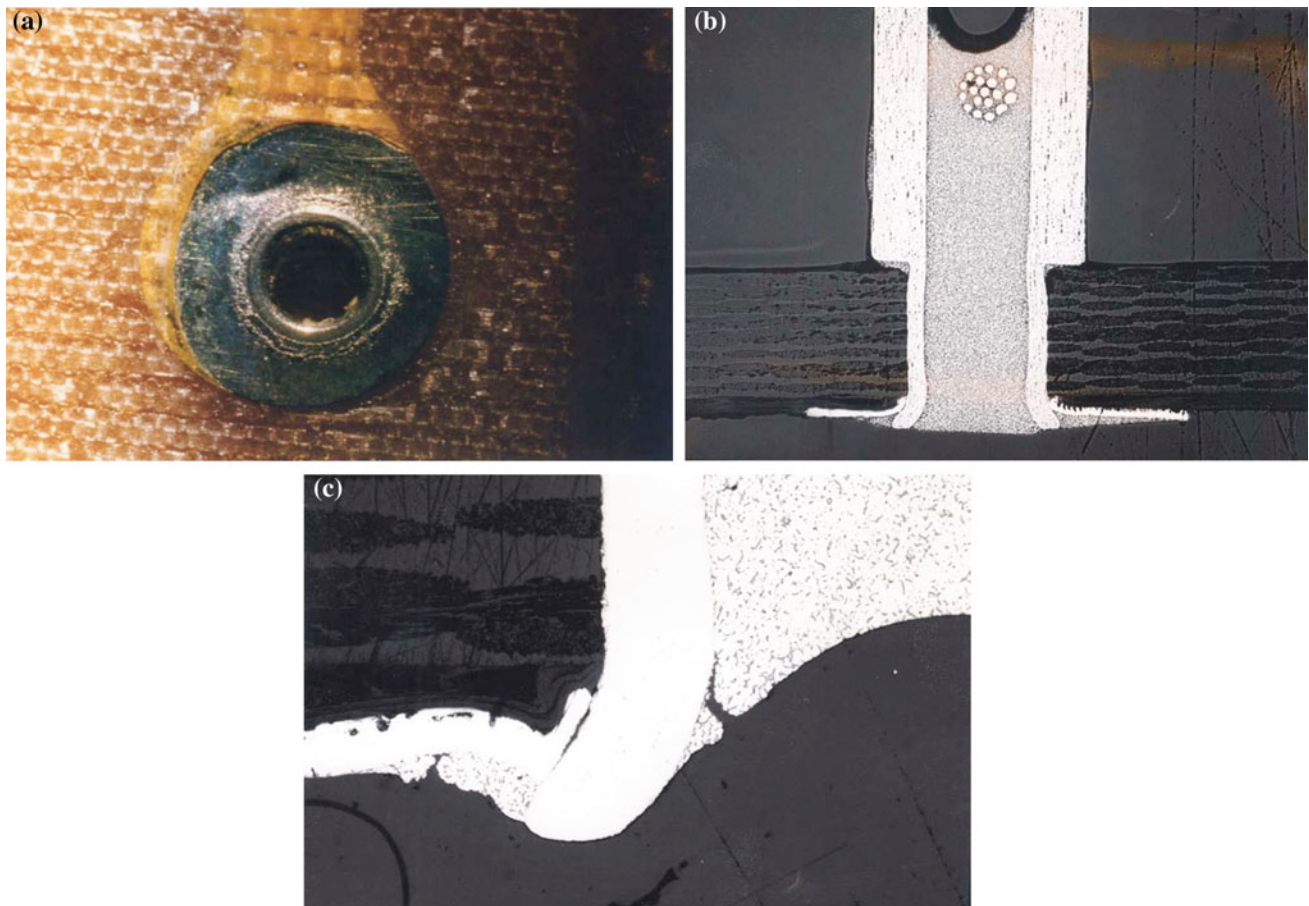
Fig. 8.10 **a** Detailed view of the soldering side of a terminal pin attached to the 'tag board' on HST following approximately 21,000 thermal cycles between -100 and $+90$ °C. Some circumferential cracks are visible and a little 'orange peel' effect ($\times 12$ magnification). **b** Microsection through the solder joint shown in **a**; the PCB has a

thickness of 1.65 mm. **c** Only at a magnification of $\times 100$ can the shallow thermal fatigue cracks and surface roughening be detailed, but the majority of the joint's circumference shows no cracking (de Rooij 1995)

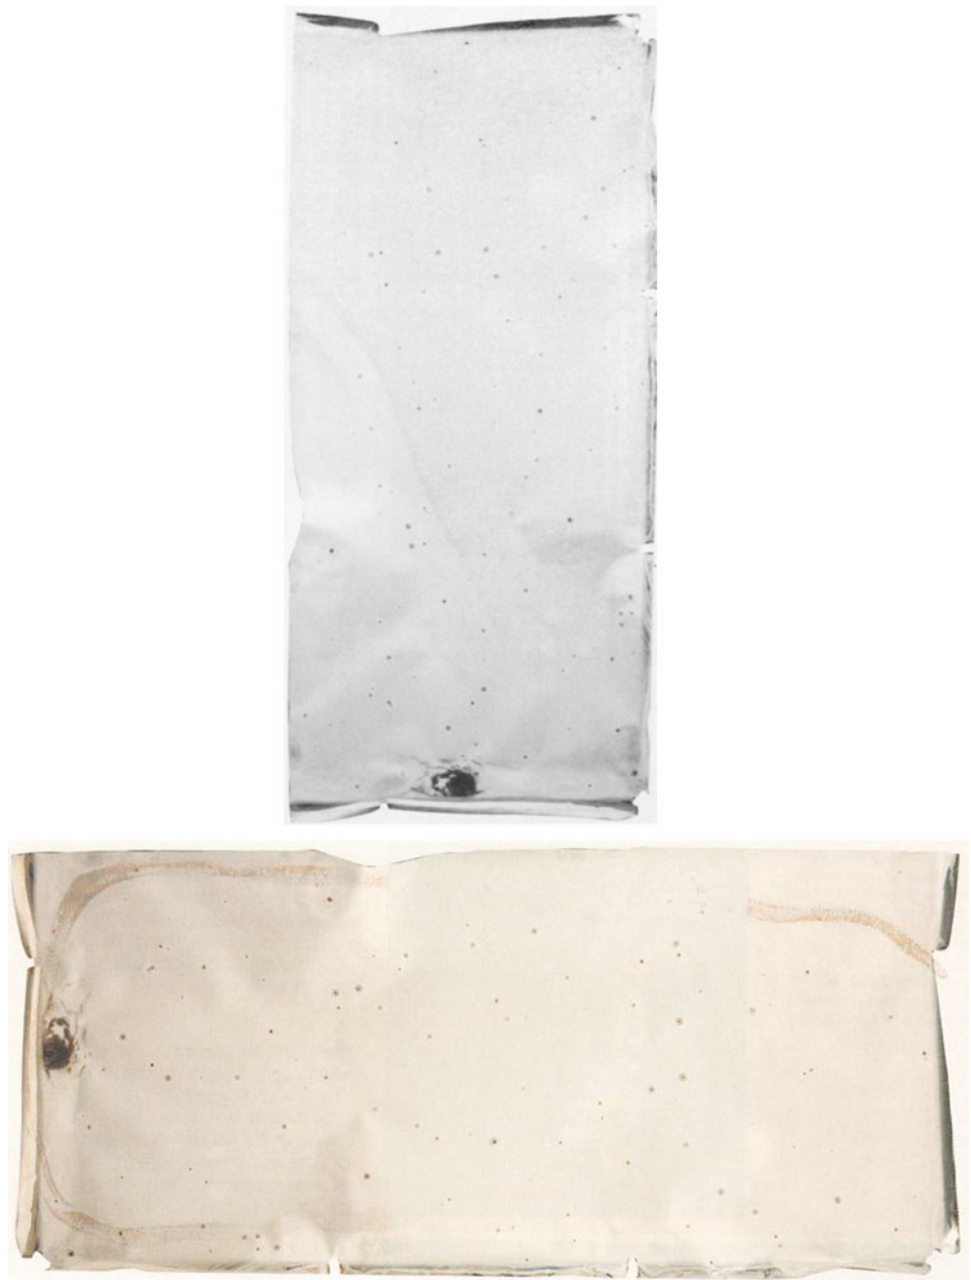
and thermal systems. 68 months after launch, the spacecraft was recovered and returned to Earth. At least 34,000 impacts were recorded on all the space-exposed surfaces; some are illustrated in Figs. 8.13 and 8.14. Particles were noted to have pierced aluminium screens 0.8 mm thick but that multilayer materials of teflonized woven glass were less damaged (Durin et al. 1993). Solar cells with various cell covers showed that polymer cell covers provide very little protection. When the crater impact diameters were about 100 μm , 2–4 % degradation in short-circuit current was observed—with smaller impact sizes, no measurable changes in efficiency were observed. If the cell itself was damaged, the loss in current was proportional to the size of the damaged area (Gruenbaum and Dursch 1993). Similar impact holes were seen on the returned HST array (Fig. 8.4) and detailed in Fig. 8.15, but here they accounted for an insignificant loss of power. The Eureka spacecraft was retrieved in 1993 after almost one year in LEO. With a total area of 140 m^2 the observed impacts included 73 penetrations of the outer layer of the thermal blankets which covered most parts of the spacecraft’s external body, and more than 2000 impacts on the front face of the solar arrays. The size of recorded impact features ranges from about 30 μm to 6.5 mm (Drolshagen et al. 1996). One impact on Eureka’s painted scuff plate is shown in Fig. 8.16. The ESABASE meteoroid and debris tool was used to predict particle flux for the Eureka mission (for details of the model see Berthoud 1994). Figure 8.17 shows that there is a good comparison between Eureka measured and modelled fluxes and LDEF measured flux in terms of particle diameter.

Fig. 8.13 Part of the LDEF surface covered with impact records

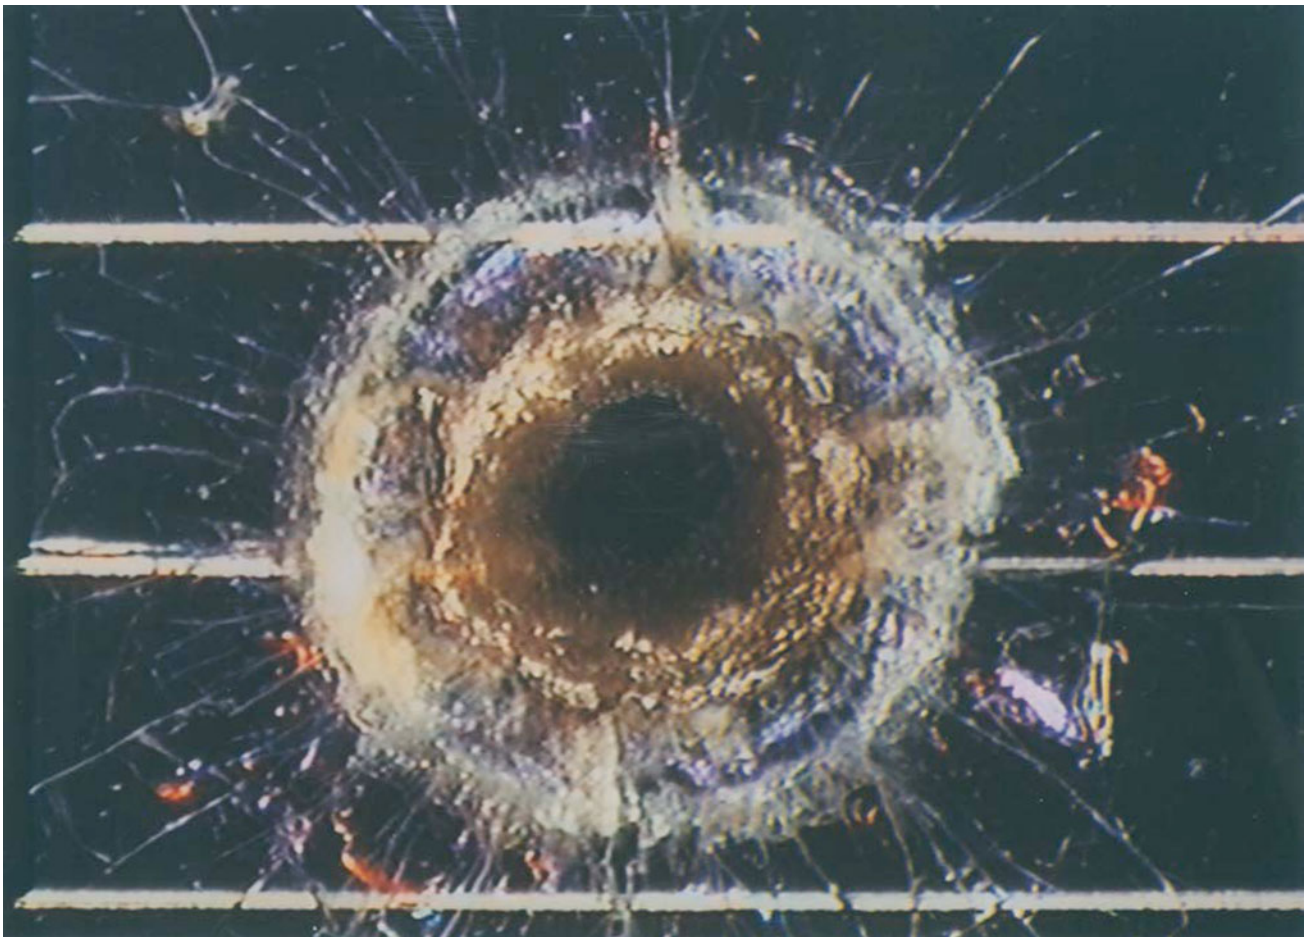
Fig. 8.14 Detail of micrometeoroid impact on solar cell

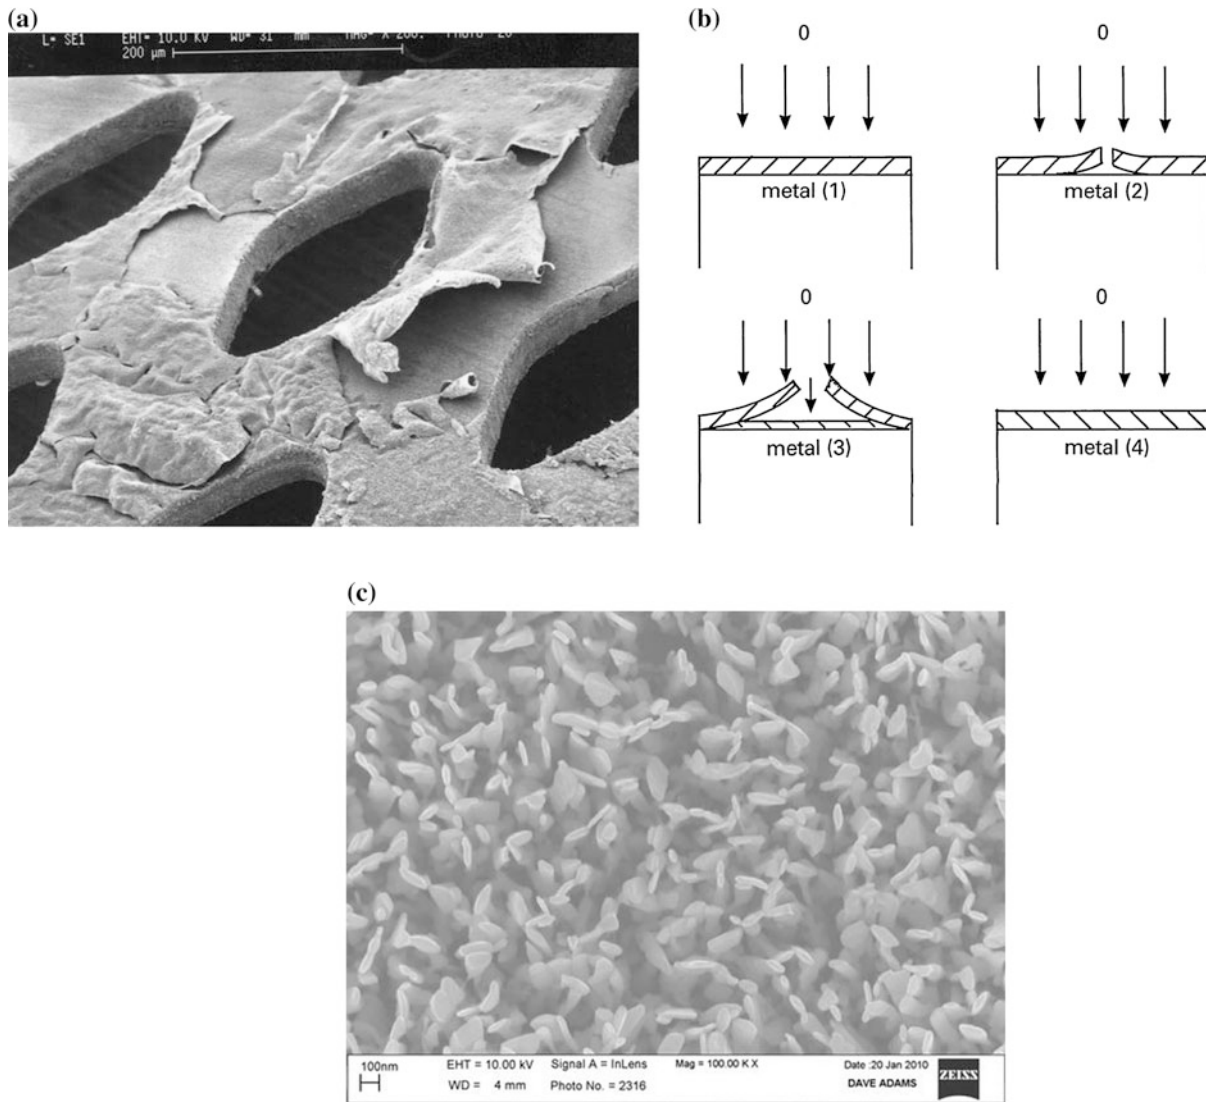
Fig. 8.21 Degradation of silver mesh solar cell interconnectors due to atomic oxygen (Courtesy of A. de Rooij): **a** Silver oxide flakes after atomic oxygen attack during STS flight. Cross-sections revealed the silver interconnector to have thinned from an original thickness of 34 to 29.5 μm . **b** Flaking of oxide layer due to internal stresses and

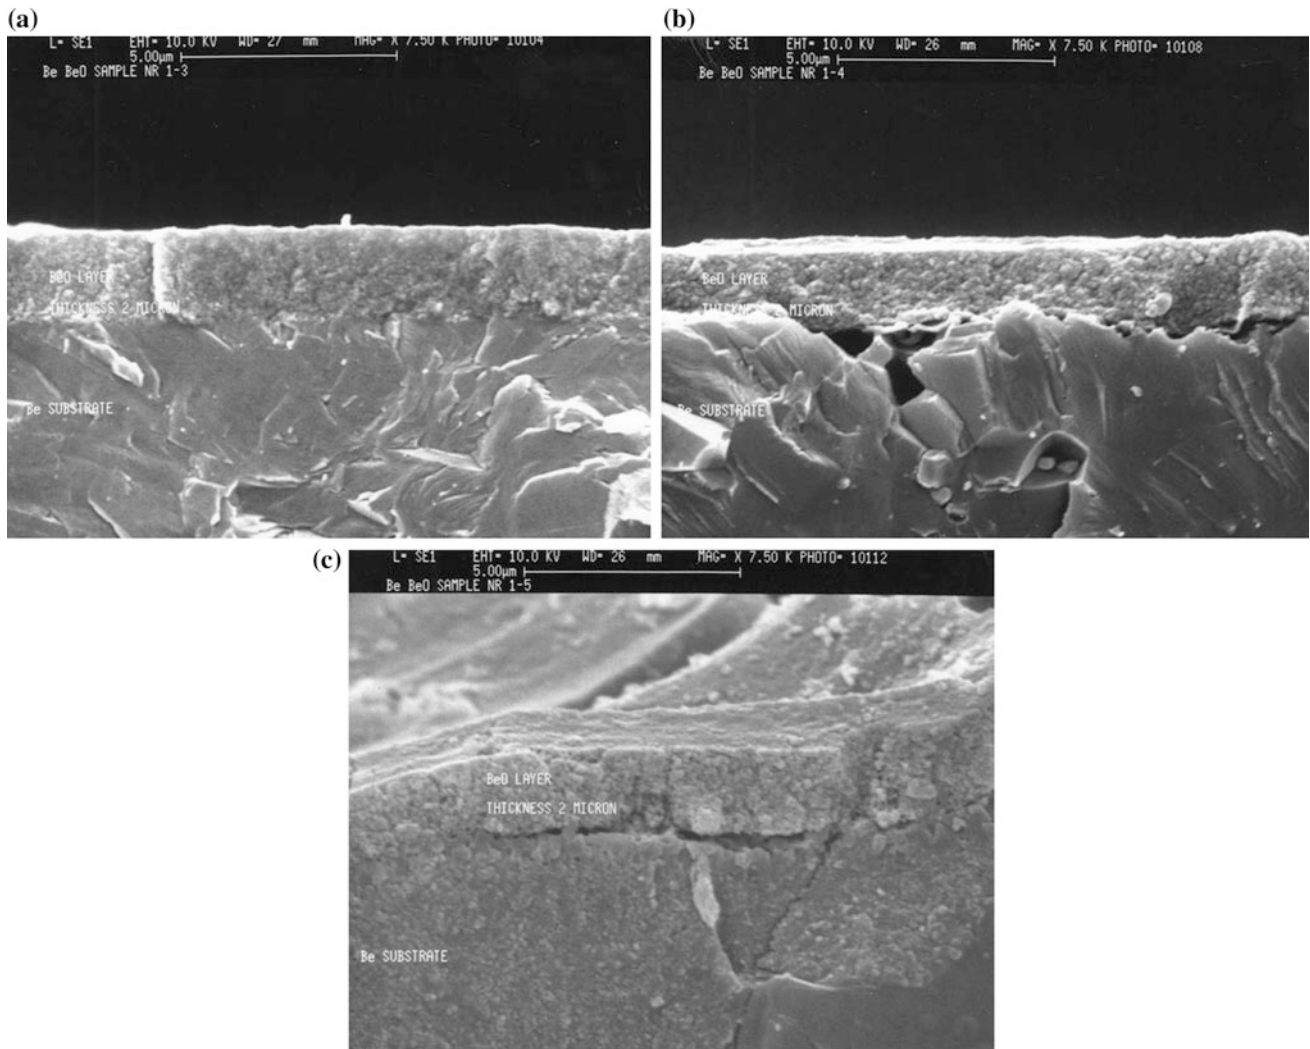
Fig. 8.28 Anodized beryllium, thin (2 μm) coating, showing fractured sections after: **a** 200 thermal cycles (-150 to $+100$ $^{\circ}\text{C}$), **b** thermal cycling plus 600 $^{\circ}\text{C}$ nitrogen exposure/8 h, and **c** all exposures, plus 1000 $^{\circ}\text{C}$ nitrogen/8 h and salt spray/192 h

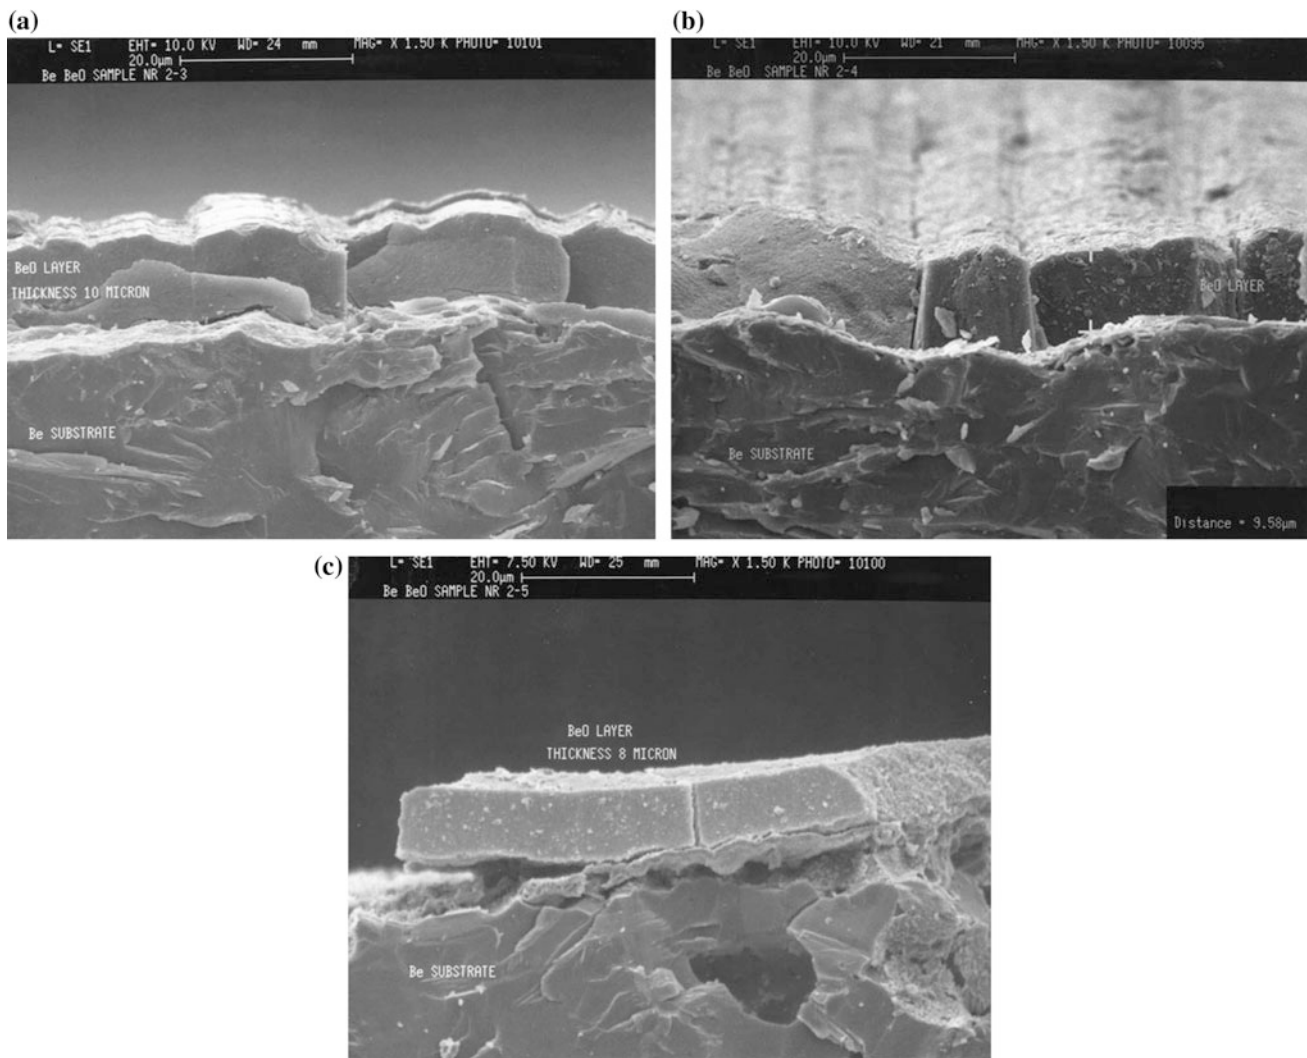
Fig. 8.29 Anodized beryllium, thick (8–10 μm) coating, showing fractured sections after: **a** 200 thermal cycles (-150 to $+100$ $^{\circ}\text{C}$), **b** thermal cycling plus 600 $^{\circ}\text{C}$ nitrogen exposure/8 h, and **c** all exposures, plus 1000 $^{\circ}\text{C}$ nitrogen/8 h and salt spray/192 h

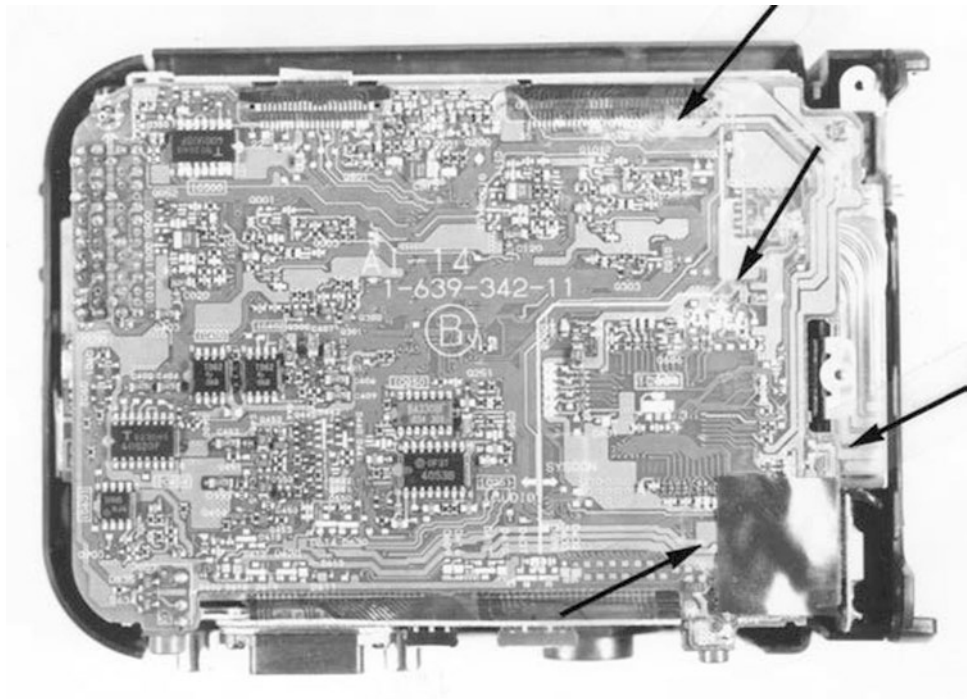
Fig. 8.36 Colour photomicrograph of corrosion products seen on failed video camera electronic circuit (approximately $\times 50$ magnification)

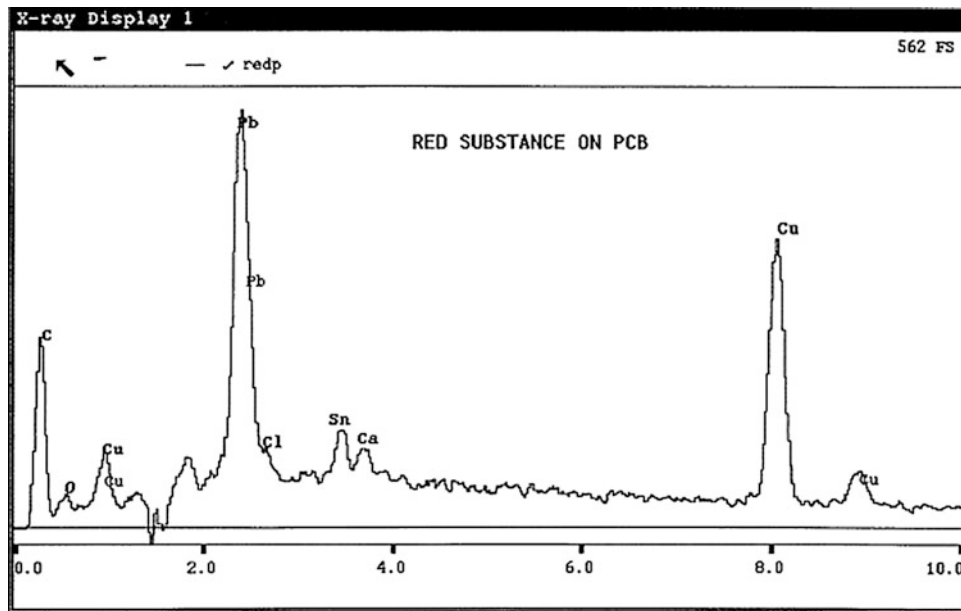
Fig. 8.39 EDAX analysis of *red* product showing much copper and lead. This is similar to 'red plague', the corrosion product of copper to form red cuprous oxide

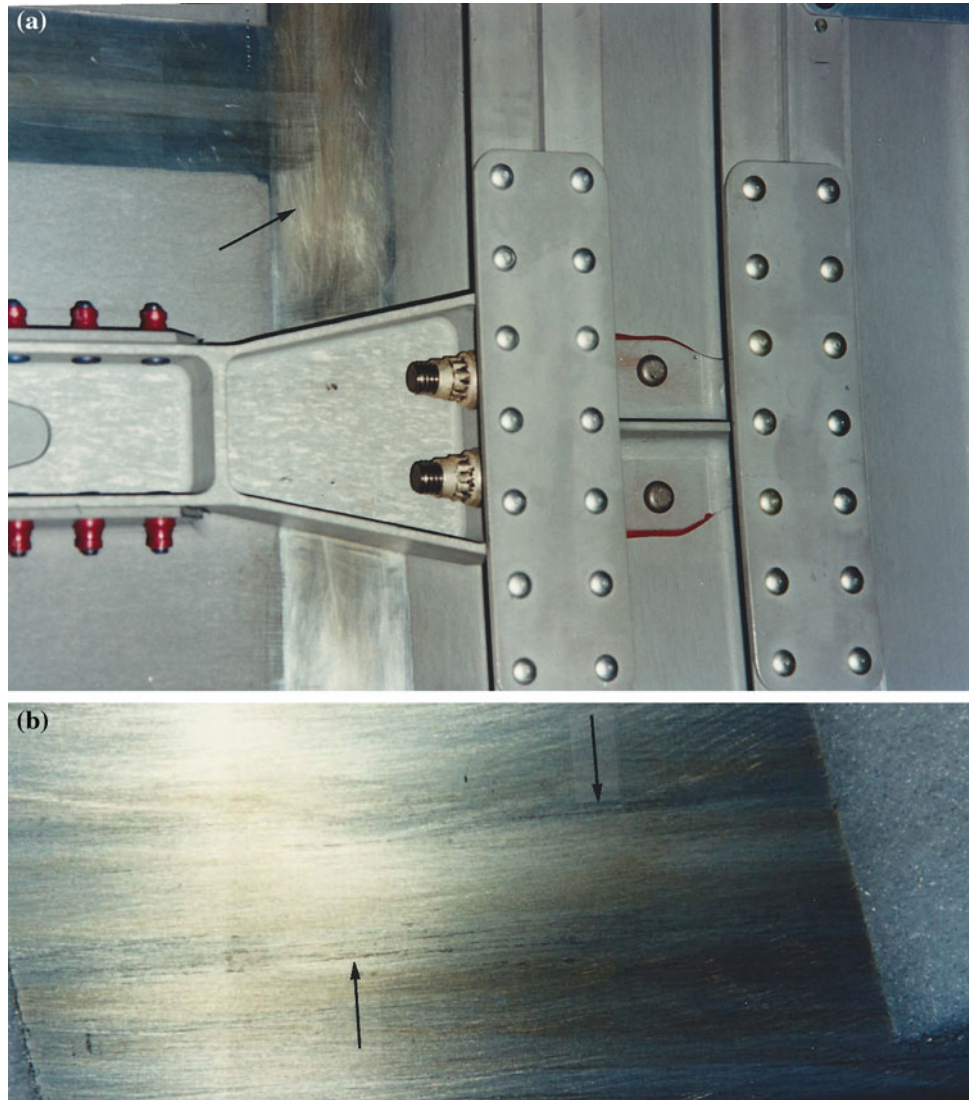
Fig. 8.43 **a** General view of heat exchanger and the right-hand region of corrosion. **b** The corroded aluminium and brown corrosion product appears to result from flux residue

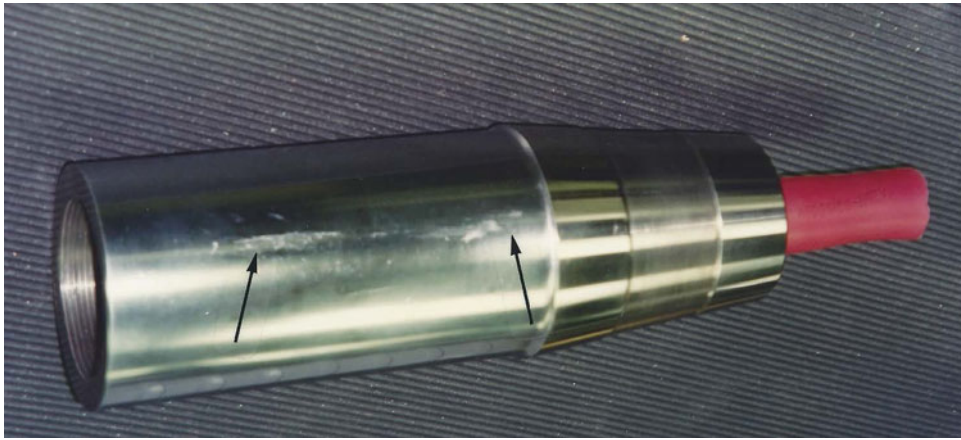
Fig. 8.48 Chromium-plated main module trunnion (approximate diameter 80 mm) removed after flight and ground handling. An extensive deposit of aluminium alloy is seen to adhere to this bearing surface. It was determined to have been transferred from an

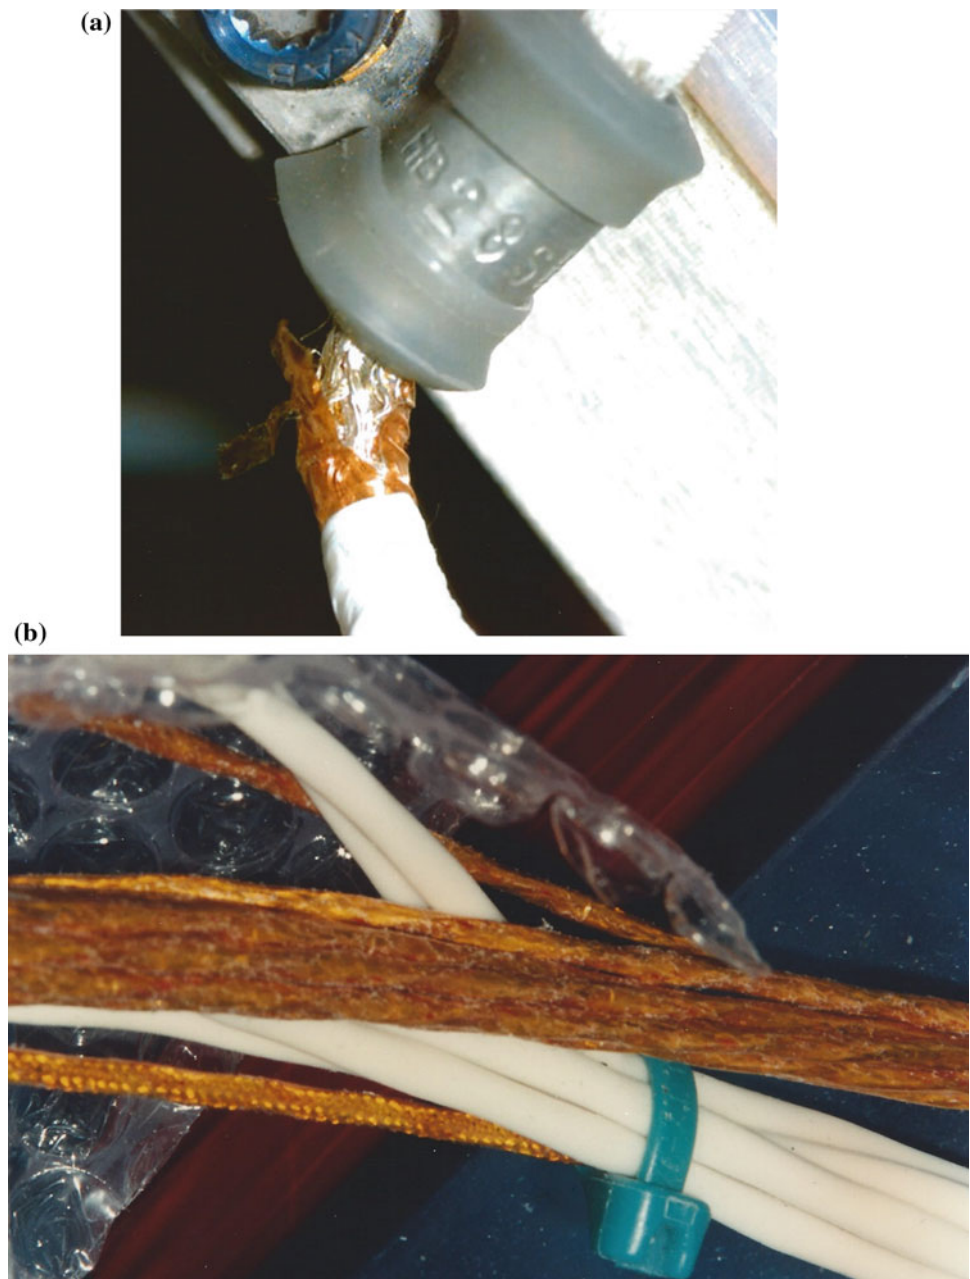
Fig. 8.51 Several wire bundles containing spliced wire joints made with Solder Sleeves. These wire interconnections would not be permitted for vacuum applications due to the entrapped solder flux and its residues (seen as a *yellow-brown* layer beneath the sleeving)

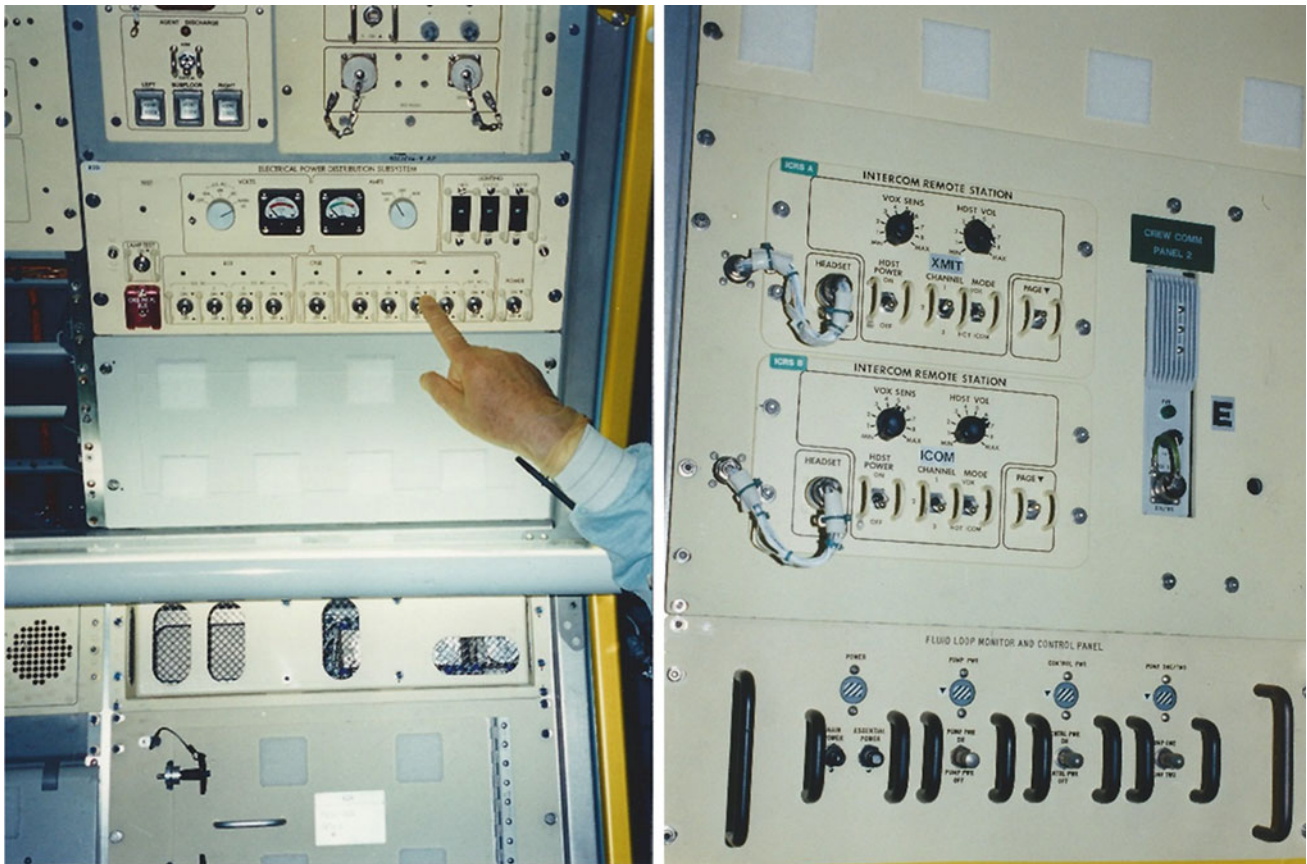
Fig. 8.53 The switches in the left photograph are inadequately protected against accidental contact by an astronaut working under micro-gravity conditions (see also Fig. 3.1). Covers are necessary, on the right-hand rack location protection is given by *bars* that protrude above the switches themselves

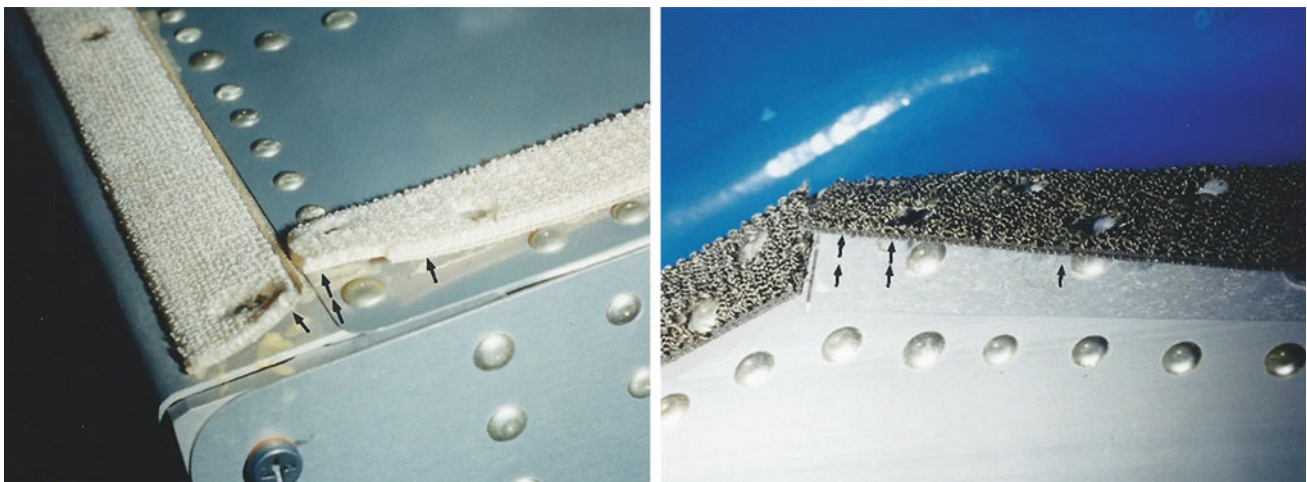
Fig. 8.54 General views of de-bonded Velcro tape. These defects were frequently seen. They result from an inadequate amount of adhesive—a continuous film might be preferable

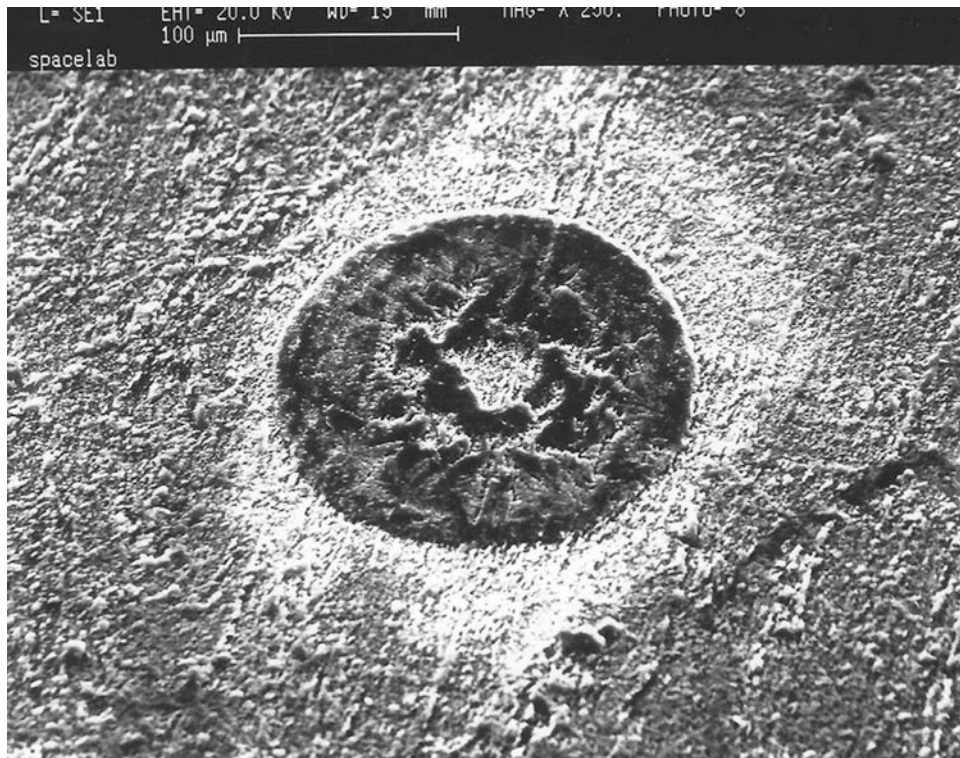
Fig. 8.56 Another hold down button from Spacelab; here a micrometeoroid hit is displayed. This remarkably small impact crater has a diameter of about 180 μm
