Assessing Deterioration of an In-field RC Bridge Deck by AE Tomography

M. Fukuda, K.C. Chang, H. Nakayama, H. Asaue, T. Nishida, T. Shiotani, T. Miyagawa, K. Watabe, and T. Oshiro

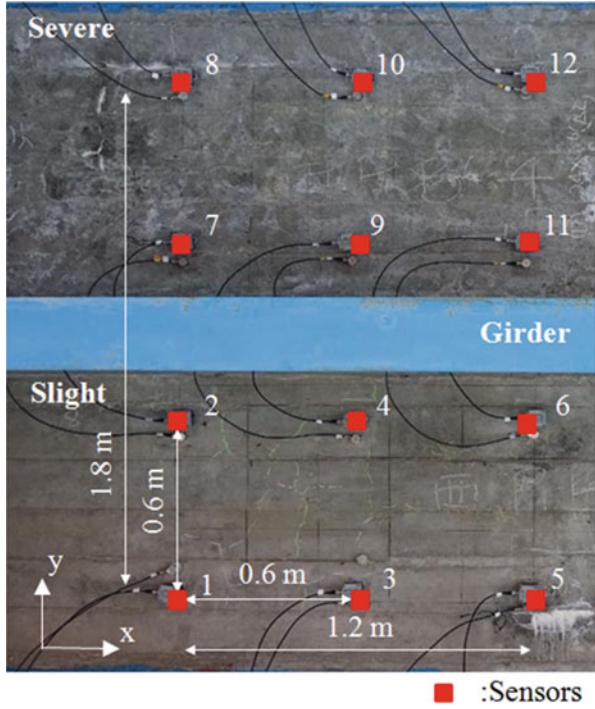
Fig. 1 Target RC deck and sensor layout

The surface condition of the target RC deck is shown in Fig. 1. This RC deck is supported by steel girder and has been served for 40 years as a part of a highway in Nara Prefecture, Japan.

AE measurement system is AMSY-6 MB19 by Vallen Systeme GmbH. Twelve AE sensors of 30 kHz resonant frequency (VS30-V by Vallen Systeme GmbH) were installed on the bottom surface of the highway bridge deck, 6 on the panel severely deteriorated (upper panel in Fig. 1) and 6 on another panel slightly deteriorated (lower panel) by visual inspection. AE activities under normal traffic loadings were monitored from 10:08 AM, 24th Dec., 2014 to 9:28 AM, 26th Dec., 2014 and a total of 29,438,265 AE events were acquired. Most of AE data obtained in-situ measurements are secondary AE induced by traffic loads. The relationship between the AE peak amplitude and LUCY (Location Uncertainty, defined in VisualAE[®]) [4] is shown in Fig. 2. It shows that as the peak amplitude increases, the number of AE events and LUCY decrease. Herein, the threshold was set as 60 dB for peak amplitude and 0.3 m (half of sensor spacing) for LUCY, i.e., AE events with peak amplitude smaller than 60 dB and a LUCY larger than 0.3 m are filtered out for further analysis.

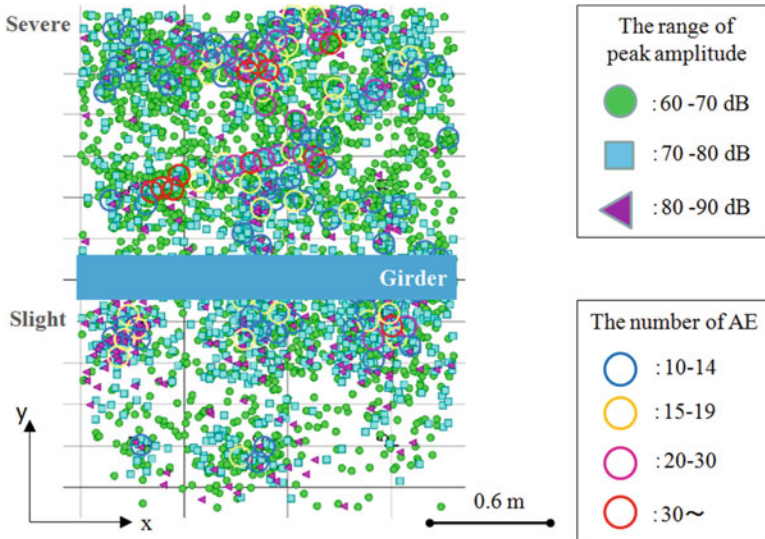
Fig. 3 AE source locations

AE source locations are shown in Fig. 3, where the AE peak amplitudes are labeled as follows: 60–70 dB in green circle, 70–80 dB blue square, and 80–90 dB in purple triangle. Also, the numbers of AE events clustering in a circular area of 0.1 m in diameter are marked in hollow circles as follows: 10–14 events in blue, 15–19 events in yellow, 20–30 events in pink, and more than 29 events in red. It is observed that AE activities were denser and generally of smaller peak amplitude in the severely deteriorated panel than the slightly deteriorated panel.

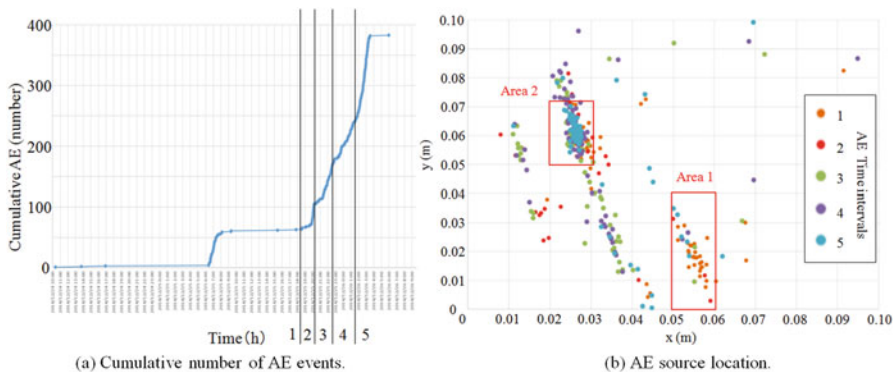
Fig. 4 AE events in a specific 0.1 m × 0.1 m area. (a) Cumulative number of AE events. (b) AE source location

1:30 to 9:28, 26th Dec. In this area, AE occurred from 6:00 to 9:00, 25th Dec. (in Interval 1 of Fig. 4a), calmed down once and then occurred continuously from 18:30, 25th Dec. to 3:30, 26th Dec. (intervals 2–5).

The AE sources location is shown in Fig. 4b. Amazingly the majority of the sources distributed in two belt zones. Let us take a closer look at Area 1 ($x = 0.05\text{--}0.06$ m, $y = 0\text{--}0.04$ m, Fig. 4b) and Area 2 ($x = 0.02\text{--}0.03$ m, $y = 0.05\text{--}0.07$ m). In Area 1, a large number of AE events were observed in Interval 1. In Area 2, AE events were observed continuously in all intervals and they extended towards upper-left side of this area. Although the frequency characteristics or other AE parameters have not been comprehensively studied yet, the rapidly increasing number (Fig. 4a) and spatial concentration (Fig. 4b) of AE events in Area 2 might imply a propagating internal crack, which released primary AE waves.

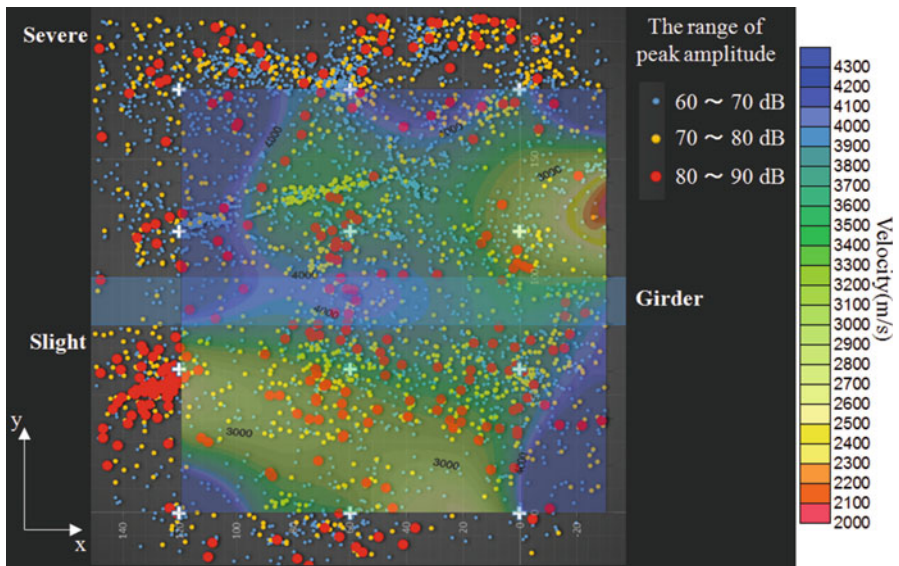
Fig. 6 Comparison of AE location and elastic wave velocity

Elastic wave tomography analysis (see [1, 2] for detailed algorithm) was also implemented using hammering impacts. Area of tomography analysis and hammering points are shown in Fig. 5. In the elastic wave tomography analysis, velocity distribution of surface or measured media is acquired. It is known that the velocities tend to be high when the media is uniform and sound. The elastic wave velocity distribution overlaid with AE sources location is plotted in Fig. 6. It is observed that AE of large amplitude occurred at moderate-velocity areas (3300–3800 m/s) and the boundaries of low-velocity areas (3300 m/s or lower); fewer AE occurred at high-velocity areas (4100 m/s and higher) and low-velocity areas.

their amplitudes are small because there are little defects causing internal frictions. It means that crack interface is mostly contact in this area. Therefore, this result indicates less defects area. In the low-velocity areas, which are regarded as highly deteriorated areas, AEs are inactive as well since the defects like cracks have fully developed and little new defects propagating. This area can be estimated as crack interface with less contact; AEs are difficult to generate because of less friction. The area is regarded as a defected area.

As for the moderate-velocity areas and the boundaries low-velocity areas, AEs are active and their amplitudes are large due to the propagation and frictions of newly developing defects. It is estimated that the results of velocity structures indicate edge of clacks. AEs are easy to generate in the area because clacks will make progress at this area. Fatigue damage by traffic load has been progressing during the measurement.

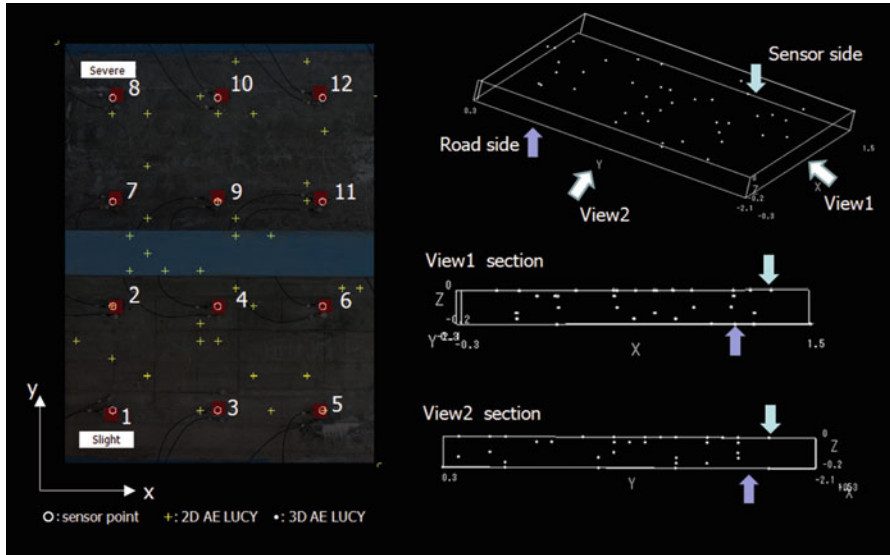
Fig. 7 AE source location detected by 2D and 3D tomography

A 3D AE tomography was performed, using the obtained AE events. The same area as that for 2D analysis as shown in Fig. 7 was considered, which is confined by the sensors No. 1, 5, 8, and 12. The area was discretized into $6 \times 8 \times 2$ meshes in the $X \times Y \times Z$ dimensions. Forty AE events that had large amplitude and were measured by at least four sensors at the same event were used for the 3D AE tomography analysis, to obtain 3D AE source locations and elastic wave velocity distribution. AE sources located by 3D AE tomography analysis are compared with those by 2D AE tomography analysis, as shown in Fig. 7. From these results, it could be said that similar source locations were identified in 2D and 3D analysis. 3D analysis is more powerful in that AE sources can be located inside the deck.

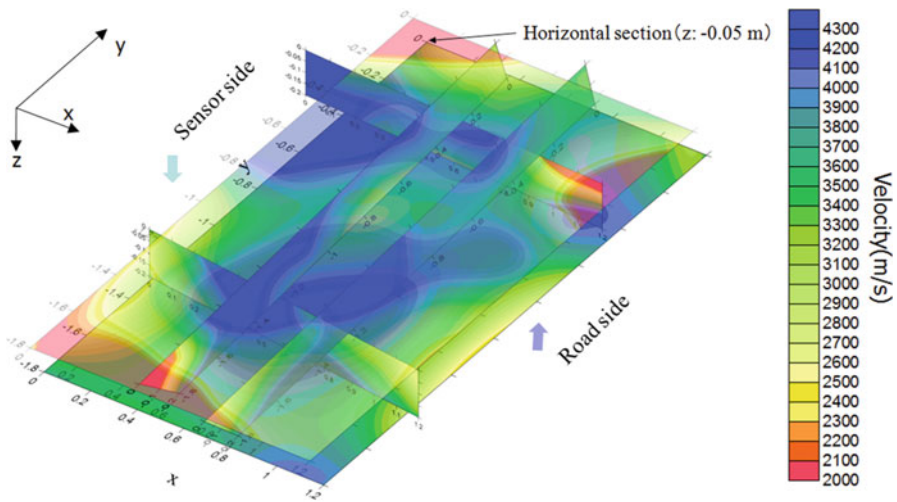
Fig. 8 Panel diagram of 3D analysis

3D elastic wave velocity distribution from 3D AE tomography analysis is shown in Fig. 8, where variations of the internal velocity can be observed. The elastic wave velocity distributions extracted at the horizontal planes $z = -0.05$ and -0.15 m are shown in Fig. 9. Near the bottom surface of the deck ($z = -0.05$ m), low velocity areas were observed and those areas were considered as deteriorated areas. On the other hand, at the plane $z = -0.15$ m, high velocity was observed in most areas, which indicated the internal deterioration was less progressed than the surface. The velocity distributions at cross-section of $x = 0.45$ m, 0.75 m and $y = -0.45$ m, -1.35 m, are shown in Fig. 10. It was observed that velocity distributions were not uniform in the concrete deck and low velocity (around 2000 m/s) areas were distributed below the depth of 0.1 m measured from the bottom surface (the sensor side). As mentioned above, 3D AE tomography analysis would be able to visualize the interior distribution of concrete quality, which is unavailable by both the 2D AE tomography analysis and conventional visual inspection.
