Large Area Nondestructive Evaluation of a Fatigue Loaded Composite Structure

Joseph N. Zalameda, Eric R. Burke, Michael R. Horne, and Eric I. Madaras

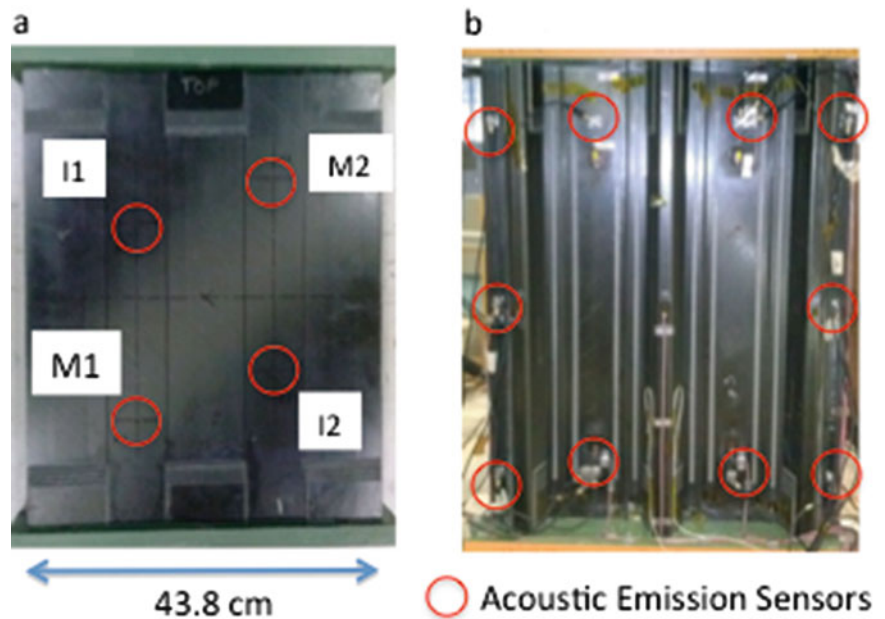
The hat stiffened composite panel flat side and stringer side with acoustic emission locations (stringer side) are shown in Fig. 4.1a and b respectively. The panel skin is 17 plies with a thickness of 0.32 cm. The hat flange is 11 plies with a thickness of 0.21 cm. Barely visible impact damage (BVID) were induced at four locations (I1, M1, I2, M2) on the panel skin on the hat stiffeners flange or right next to the flange. The BVID was used to simulate existing delamination damage and to serve as potential damage growth sites. Cyclic compressive loads were applied from $-20,000$ lb up to $-150,000$ lb at 2 Hz using the setup shown in Fig. 4.2. The sample was painted with a speckle pattern for high speed digital image correlation imaging. The high speed digital image correlation cameras required illumination using red light emitting diode (LED) lights. The LED lights were not a problem for the IR cameras operated in the mid IR waveband. The load was applied from the bottom while the top was held stationary. Passive thermography was used to track the damage on both the flat and stringer sides during loading using two IR cameras. Shown in Fig. 4.1b are the locations of the acoustic emission sensors in relation to the BVID. The acoustic emission sensors were used for real time detection of acoustic events indicating damage growth.

Fig. 4.1 Three stringer composite panel tested with impact and acoustic emission sensor locations. (a) Flat side, (b) Stringer side

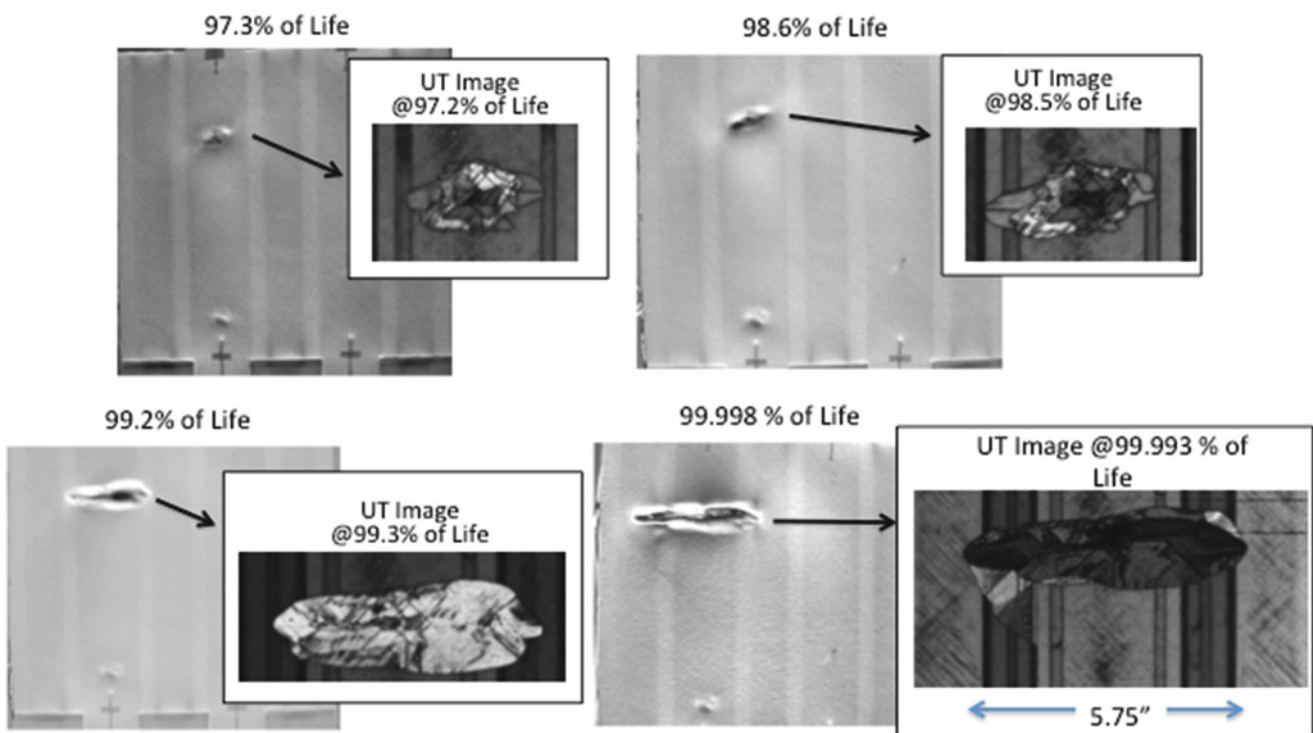
Examples of processed thermal images of the flat side are shown in Fig. 4.5. The processing technique used to improve defect contrast involves a delayed image subtraction [5, 12]. A moving buffer is required in the acquisition software in order for this processing technique to be implemented in real time. The delayed subtraction is given as:

Fig. 4.5 Comparison of processed thermography images to ultrasonic inspection results

over a number of cycles if desired. Also shown in Fig. 4.5 are the respective ultrasonic images obtained at intervals determined by the indication of damage growth from thermography and acoustic emission. The acoustic emission events are shown in Fig. 4.6a and b where the acoustic emission events are shown for different fatigue tests. The accumulated acoustic events for Fig. 4.6a were for approximately 50 s and for Fig. 4.6b were for 16.5 s. As the structure nears failure the accumulated acoustic events increases as a function of time as shown in Fig. 4.6a and b.

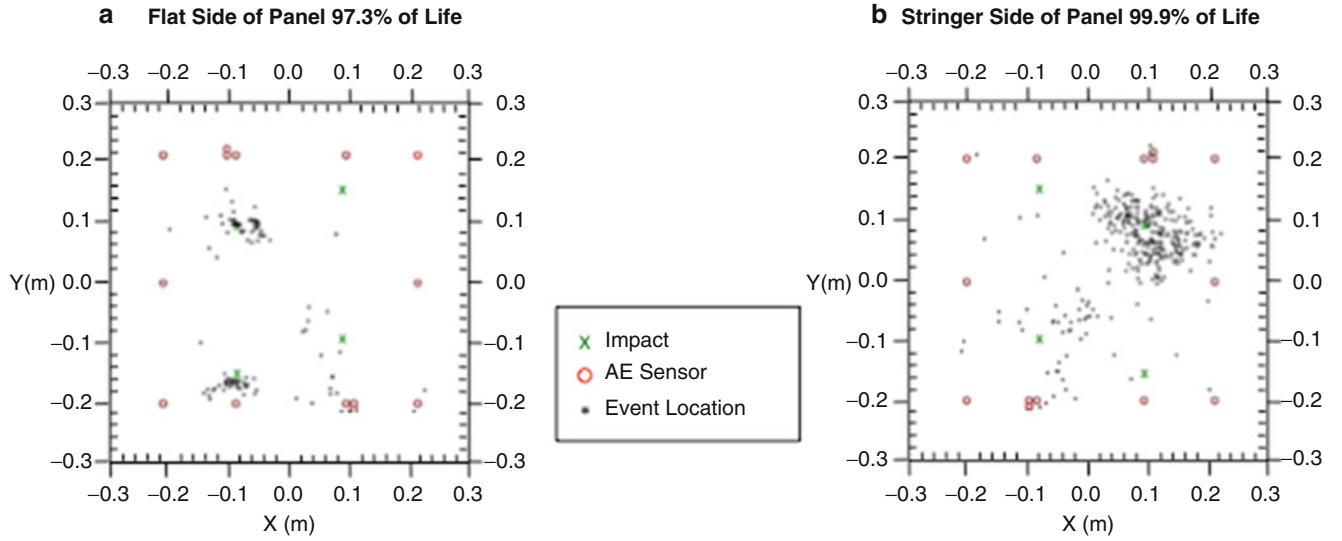
Fig. 4.6 Three-stringer panel acoustic emission event locations

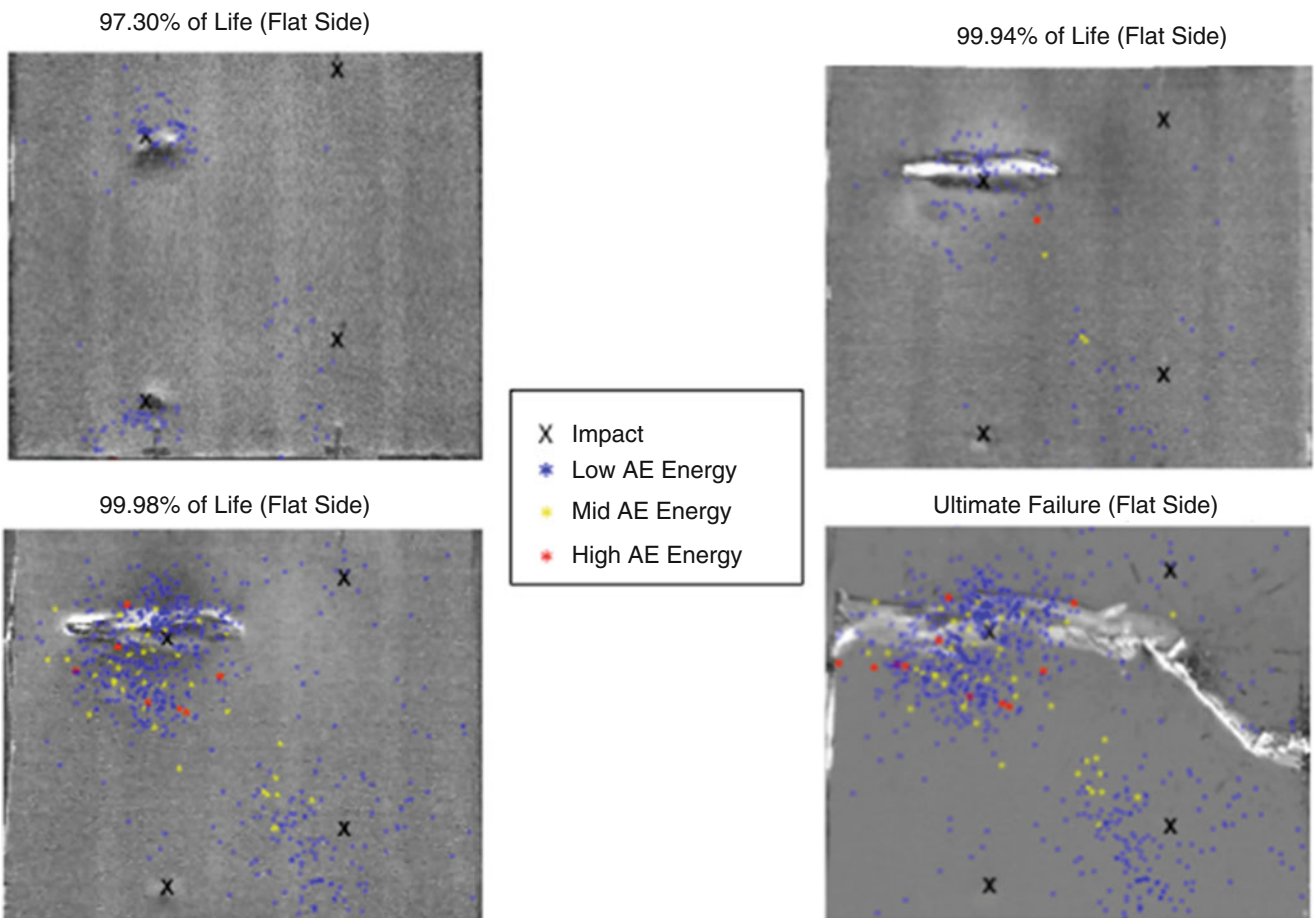
The mapped acoustic emission data as a function of remaining life are shown in Figs. 4.8 and 4.9 for the flat side and stringer side respectively. The impact locations (X) are also shown. Both the thermal data and the acoustic emission data were synchronized to the load and therefore the timing of the acoustic emission events are matched to the thermal image temporally. For a given location, the mapped indicator (star graphic) size and shading are based on the event energy given by:

Fig. 4.8 Mapping of acoustic emission data onto processed thermal imagery (Flat Side)

where the event indicator values of less than 13 (with a minimum size of 10) were given a low energy (opacity of 0.5), indicator values between 13 and 15 were designated as a mid energy event (opacity of 0.7), and greater than 15 was a high energy event with (opacity of 1.0). As the structure nears failure, the accumulated acoustic events and indicator values increase as shown in Figs. 4.8 and 4.9. Ultimate failure occurred at the location where the red high energy indicators and mostly yellow indicators are clustered. It is important to note the location of the acoustic emission events are prone to errors due to the progression of damage (fiber breaks, delaminations, matrix cracking) as the structure nears failure. These defects can affect the propagation of the acoustic emission signal in terms velocity and waveform mode conversions resulting in processing errors; however, overall the clustered locations are comparable to the thermal indications of the growing damage areas. In particular for the left image (thermal image from the stringer side) in Fig. 4.9, some of the clustered points tend to accumulate below the delamination on the right side. This clustering was due to a growing disbond between the stringer flange and the skin below the delamination. This disbond between the stringer flange and skin was determined, from the thermal data, to have caused ultimate failure.

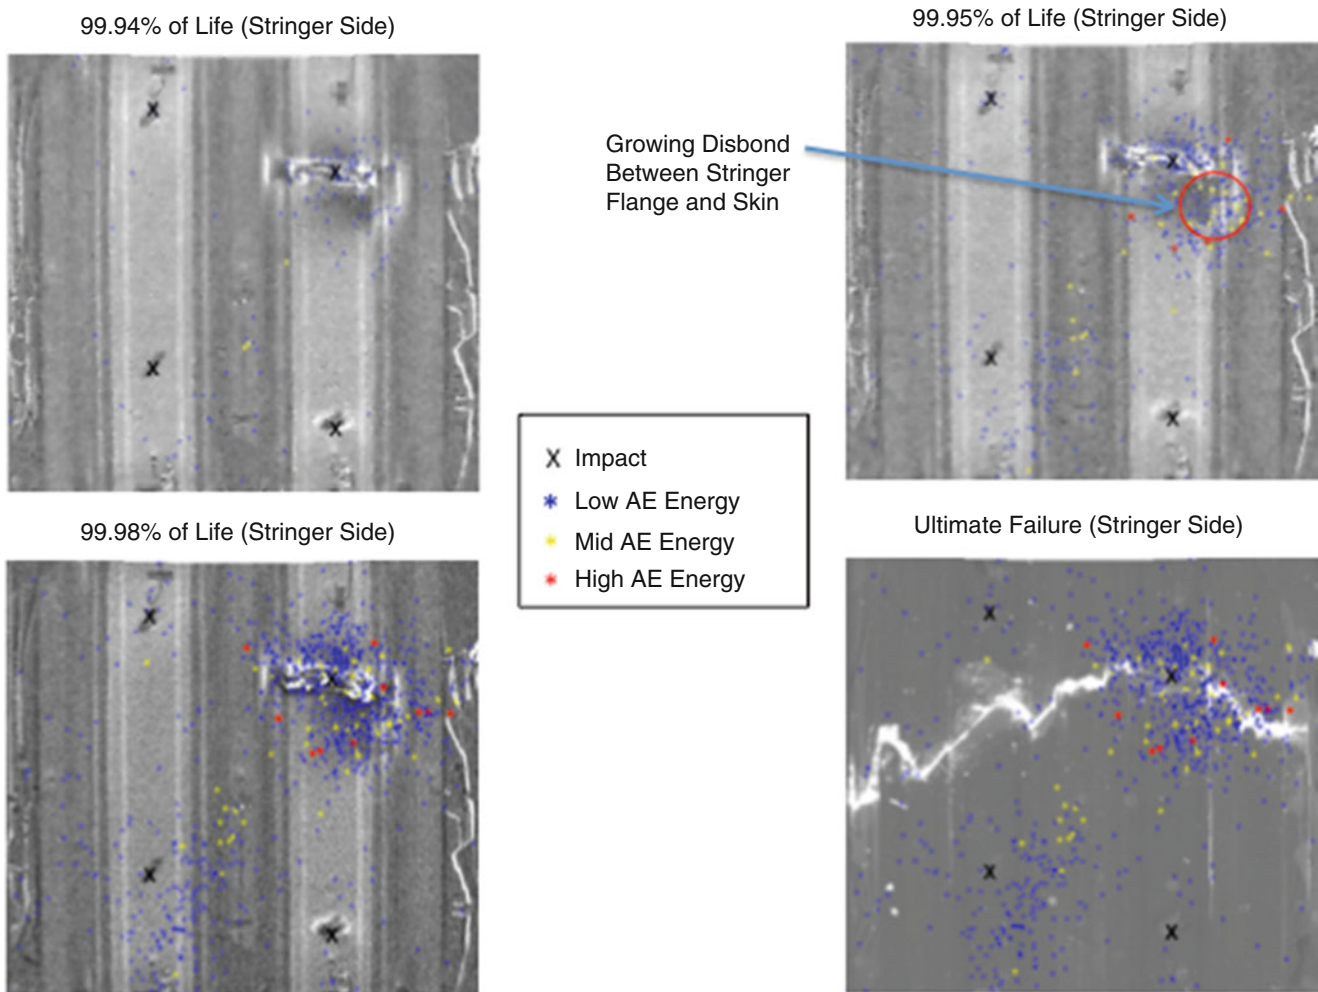
Fig. 4.9 Mapping of acoustic emission data onto processed thermal imagery (Stringer Side)
