# Periimplantitis as the Cause of Separation the Prosthetic Bridge Based on Implant

**Abstract.** The paper discusses the basic problems of the possible complications after implant-prosthetic treatment, with particular emphasis on periimplantitis. Presented are the results of materials science expertise for prosthetic bridge based on the implant, lost by sixty year old female patient as a result of perigraft tissue inflammation. The results allowed to assess whether the separation of the prosthetic system – in addition to biological factors – was influenced by mechanical factors, such as damage to restoration structures.

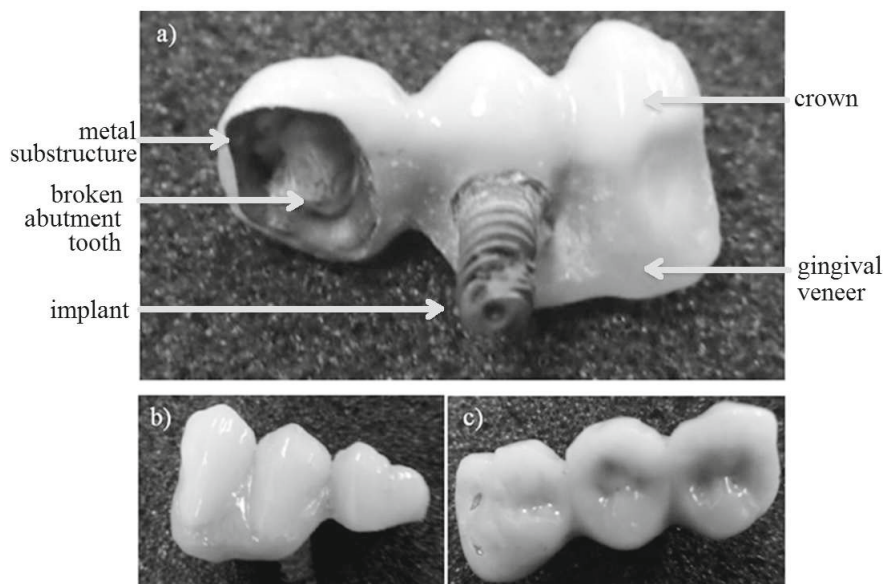
**Fig. 3.** Dental bridge after removal from the oral cavity of the female patient: (a) bottom view; (b) buccal view; (c) occlusal view

MC, determined by the manufacturer as being compatible with metal alloys having a coefficient of thermal linear expansion in the range of  $13.8 \div 14.9 \mu\text{m}/\text{m}\cdot\text{K}$ . Part imitating gum (Fig. 3) is made of acrylic. Based on an interview conducted by a dentist, it was determined that due to smoking tobacco patient is at risk group of biological complications.

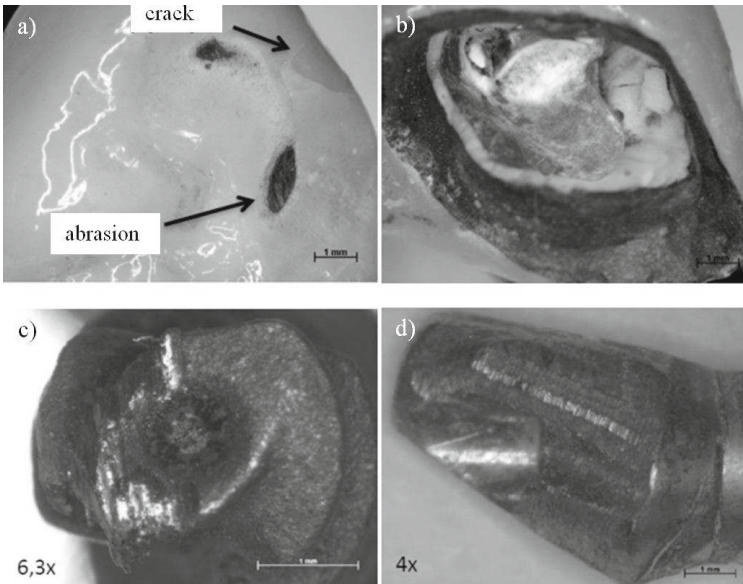
Based on preliminary observations using a stereoscopic microscope, it was found that the prosthetic system revealed signs of wear in the form of small cracks, and abrasions of the surface of ceramic crown. As a result of damages the exposure of the substructure material has occurred (Fig. 4a). There was also damage to the thread observed (Fig. 4c), probably caused by the destabilization of the implant and its movement in regard to the bone. On the abutment surface, the areas covered by corrosive changes were observed (Fig. 4d). It was also found that within the substructure of the crown based on the patient’s own tooth the remnants of that pillar have retained (Fig. 4b).

**Fig. 4.** Images from the stereomicroscope: (a) prosthetic crown; (b) tooth retained in substructure; (c) thread abrasion; (d) abutment with corrosive changes of the surface

Microscopic observations allowed a preliminary assessment of exploitative damages within the prosthetic crown, which could be caused by abnormal occlusion, and therefore the occurrence of occlusal parafunctions and adverse overloading of the implant. The reason for the appearance of defects could also be in mismatched shape of prosthetic crown to the antagonistic teeth. As a result, it could lead to the emergence of micro-cracks and loss of integration of the implant with the bone.

It was also noted the presence of adverse corrosive changes on the surface of the substructure and abutment, which could – by penetration of metal ions into the surrounding tissues – to have an effect of perigraft structures irritation. This

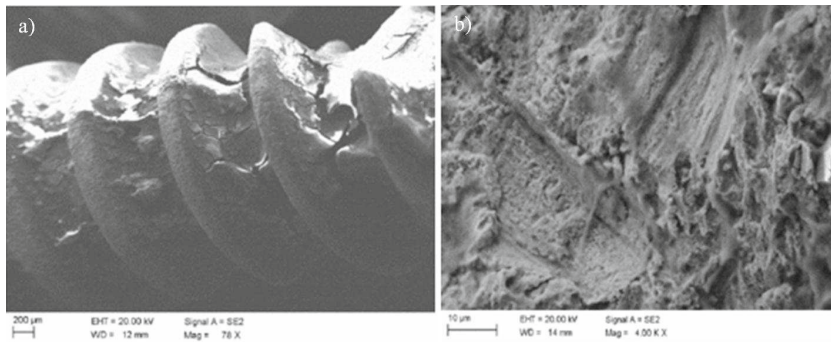
After cleaning the implant surface, observations were made by using a scanning electron microscope. Despite carefully conducted process of removing impurities from the implant surface it failed to remove all biological residues (Fig. 5a). It was also noticed that the porous surface structure of the implant has deformed (Fig. 5b).

**Fig. 5.** SEM image of the surface of the implant in magnification: (a) 78x; (b) 4000x

Observations with methods of light microscopy confirm that the materials used, despite the many years of being in the female patient's body, were characterized by structures typical for these specific material groups. It was also established that as a result of the periimplantitis course and loss of stability of the implant there has distorted the porous structure of the implant surface.

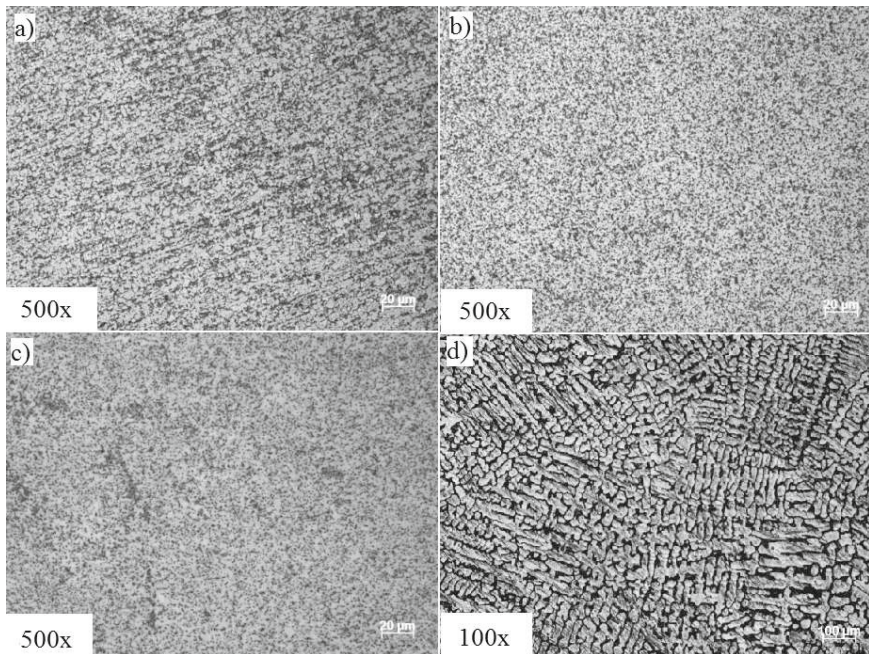
**Fig. 6.** The structures revealed in observations made by light microscope: (a) longitudinal section of the implant; (b) cross-sectional view of the implant; (c) longitudinal section of the abutment; (d) cross-sectional view of the substructure

On the basis of obtained images, it was found that the material of both the implant and abutment was characterized by fine-grained two-phase structure  $\alpha+\beta$  (Fig. 6a–c), typical for the alloys Ti6Al4V. In the case of the substructure material, observed was the existence of dendritic structure being characteristic

for the components made by casting, not subjected to metal forming. On the basis of observations and their comparison with the literature, revealed was the presence of intermetallic phase  $\gamma$  with increased content of Ni–Cr and molybdenum enriched interdendritic areas [7]. In addition, during the observations of microscopic cross-section of a prosthetic crown (Fig. 7) confirmed was the existence of a layered construction of veneering layer – on the surface of the substructure, it was clearly visible layer of opaquer (not translucent) with a thickness of approx.  $150\ \mu\text{m}$ .

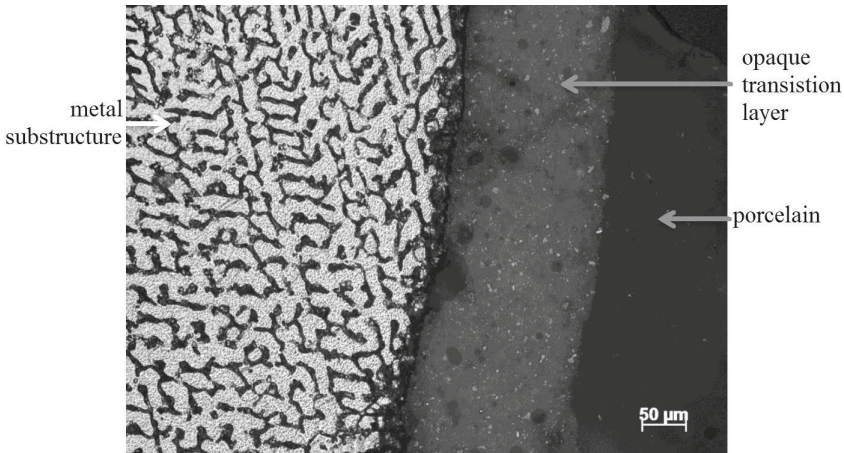
**Fig. 7.** Section through a prosthetic crown in 200x magnification (image from a light microscope)

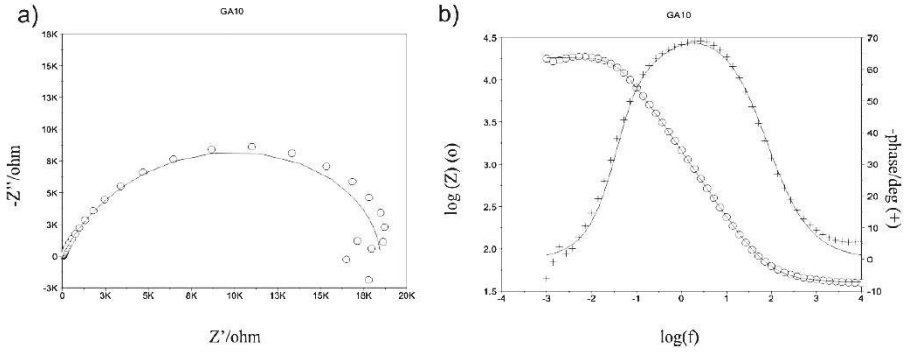
As a result of impedance examinations EIS the spectra of Bode (Fig. 8a) and Nyquist (Fig. 8b), were recorded, as well as characteristic parameters that describe the properties of the surface structure of the implant (Table 1).

Nyquist diagram indicates the occurrence of characteristic impedance response of thin oxide layers, which means that the implant surface has been

**Fig. 8.** Impedance spectra (a) Nyquist diagram (b) Bode diagram

passivated. On their basis, it was stated that the phase shift angle is approximately  $70^\circ$ , whereas the slope of the  $\log|Z|$  in the applied frequency range is close to value  $-1$ .

Characteristic of impedance spectra EIS and the results of assessment of resistance to pitting corrosion provide a basis to conclude that the Ti6Al4V implant has good corrosion resistance in assumed conditions. The basis of this reasoning is the phenomenon of transpassivation that occurred on the implant surface.

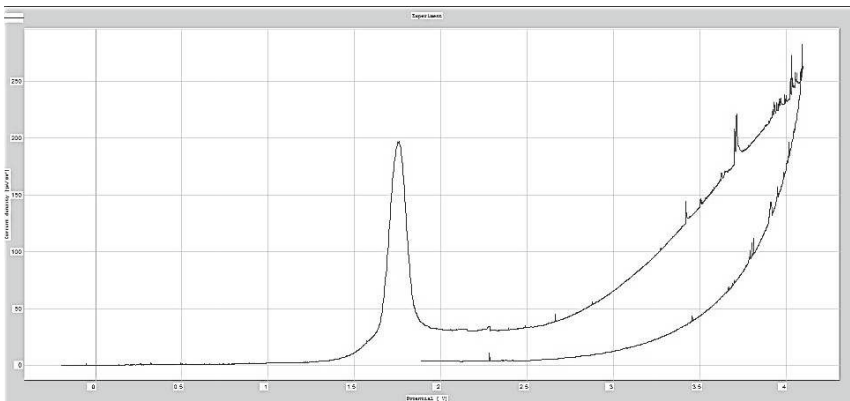
Before testing the resistance to pitting corrosion of the implant the opening potential was established, which amounted to  $E_{ocp} = -91$  mV. Then, starting from the value  $E_{start} = E_{ocp} - 100$ , using the rate of potential change of 1 mV/s, recorded was the anodic polarization curve (Fig. 9). Then the specific parameters were appointed:  $E_{cor} = -148.9$  mV,  $R_p = 456.5 \Omega\text{cm}^2$ ,  $I_{cor} = 11.85 \text{ A/cm}^2$ .

**Fig. 9.** Anodic polarization curve for implant of Ti6Al4V

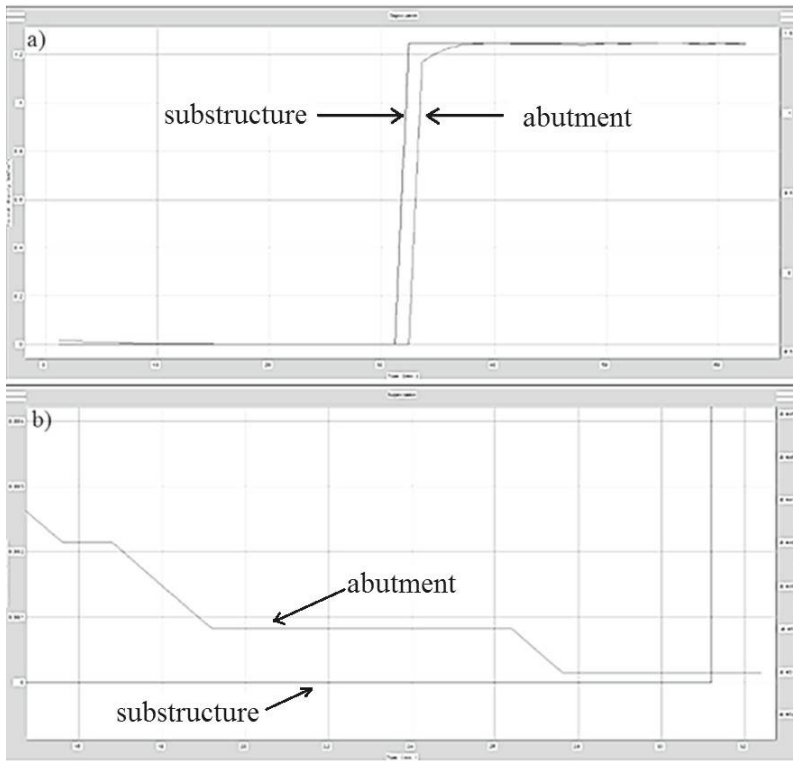
**Fig. 10.** Graphs of changes of the potential and current density in time (a) curves of polarization; (b) the point of intersection of the curves

cathode was set at 1:1. As a result of measurements recorded were the graphs (Fig. 10a) of changes course of the current density and potential in time for the abutment and substructure. On this basis, the values  $i = 0.13 \mu\text{A}/\text{cm}^2$  oraz  $E = -450 \text{ mV}$  at the curves intersection has been established (Fig. 10b).

Evaluation of resistance to galvanic corrosion for the substructure-abutment system showed that despite the conditions conducive to the formation of a galvanic cell, the examined elements exhibit invulnerability to this type of corrosion. This is due to the low current density value. The environment of tissues and body fluids in the course of inflammation, however, changes its characteristics and becomes more aggressive (higher temperature, lower pH). Corrosion changes on the surface of the substructure and the abutment observed through a stereoscopic microscope can therefore be the result of the implant stay just in the inflammatory environment. However, relevant experience has not been performed in conditions simulating the tissue reaction changed by inflammation, so it is impossible to formulate a clear opinion about the cause of corrosion changes referred to above.
