Lessons Learned from Analysis of Los Frailes Tailing Dam Failure

M. Shahriari^(III) and M.E. Aydin

Konya Necmettin Erbakan University, Konya, Turkey madi.shahriari@gmail.com

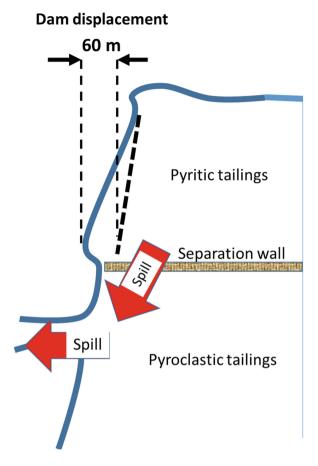
On April 25, 1998, the Los Frailes lead-zinc mine experienced a foundation failure due to sliding surfaces in the ground, leading to the dam breaking and releasing between 4 and 5 million cubic meters of mine tailings. The mine tailing, being acidic and containing several heavy metals, poured into the nearby river Rio Agrio. The river rose 3 m, flooding thousands of hectares of farmland. This has later been called the Doñana incident. Rio Agrio is a tributary to Rio Guadimar, which flows through Doñana National Park. The water eventually finds its way into the Mediterranean. It was therefore crucial to gather and handle the waste as soon as possible. However, the cleanup operation took a total of three years and had an estimated cost of €240 million [7].

The Los Frailes mine is owned by a Spanish subsidiary of the Swedish/Canadian company Boliden. Boliden has, though not presenting a report of their own, stated that the accident was caused by force majeure, and could therefore not be predicted and Boliden could not be blamed. However, this statement has been criticized. In fact, the problem with sliding surfaces in the ground was identified two years earlier [7] (See Fig. 2).

The bottom of the dam consisted of marl. The chemicals contained in the dam reacted with the calcium carbonate in the marl, causing it to decompose. Thus, the mechanical stability of the soil was deteriorating. Boliden had recently been applying for a licence for doubling the dam's capacity. Therefore, one can raise hypotheses that the dam was deliberately overloaded. Boliden has refused to pay any compensation for damages, still referring to the accident as a result of force majeure.

Fig. 2. Spill due to sliding surfaces in the ground

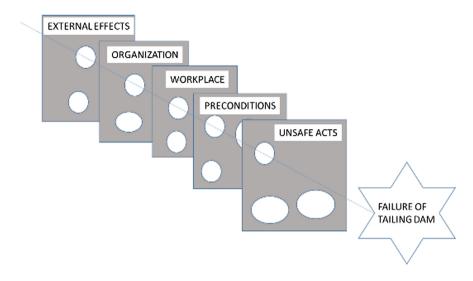
The failure of Los Frailes tailing dam has been analyzed using the Swiss cheese model (see Fig. 4). For the analysis of the case, 5 safety barriers were recognized as shown in Fig. 4.

Fig. 4. Safety barriers recognized in Los Frailes Tailing Dam

Category	Description				
External effects	 No serious enforcement/didn't follow the directives Poor control 				
Organization	 Poor design Improper site selection No care about the reports of two consultancy firms like Geocisa and Golder Associates AB, which found the weak points two years before the failure No coordination between two projects for building the tailings dam No safety culture Neglecting the regulations 				
Workplace	 No management change policy No monitoring and control: Lack of instruments for working correctly due to absence of working inclinometers Neglecting the regulations No risk assessment and emergency planning and responses Poor maintenance and no reporting system 				
Preconditions	 Type of material in the soil (marl) Dam built at the top of expansive clays Water presence where dry conditions were expected High pressure of water in the clayey foundation No communication Lack of knowledge Vibration due to the blasting at the nearby mine

Unsafe acts	 Overloading the dam Lack of foresight Late reaction after awaking of water presence where dry beaches should be expected and even where they found failure with electric cable due dam structure movement Problems of the deformations not accounted at all No care about not working instruments
