# Chapter 4

## IRT Versus Moisture: In Situ Tests in Indoor Environment

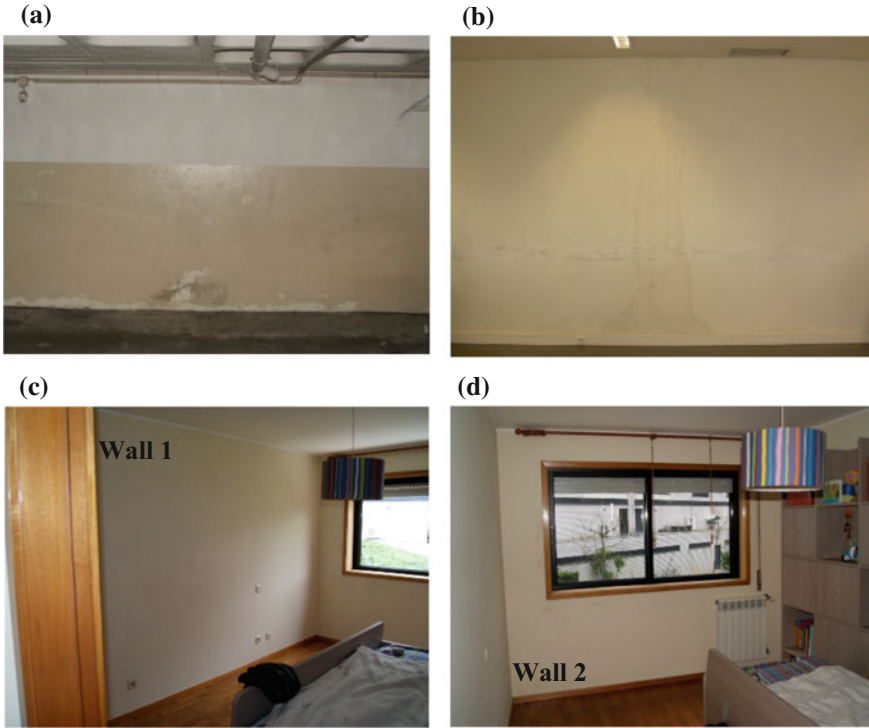
**Fig. 4.1** Elements under study: **a** exterior wall of a basement in a residential building; **b** wall 1 of a room in a residential building; **c** wall 2 of a room in a residential building; **d** wall of a classroom in University of Porto

The wall under study showed signs of degradation of the inner coating near the ground caused by rising damp (Fig. 4.1a). In the thermal image (Fig. 4.2a), a colder area near the ground, resulting from the evaporation of rising damp, is clearly displayed. The upper level of the colder area is above the visible degradation of the surface.

During the measurements, next to the corner and near the window, the coating of the two walls had visible signs of degradation caused by rainwater infiltration. The two walls were assessed individually (Fig. 4.1c, d). This infiltration had been detected before the test was performed and was not repaired by that time. Figure 4.5 shows the thermal images of the walls. The thermal images result from the assembly of individual images taken to restrict areas of each wall. Figure 4.6 shows the results obtained when using the moisture detector. Grey areas in Fig. 4.6a represent the position of the window and the radiator located in wall 1.

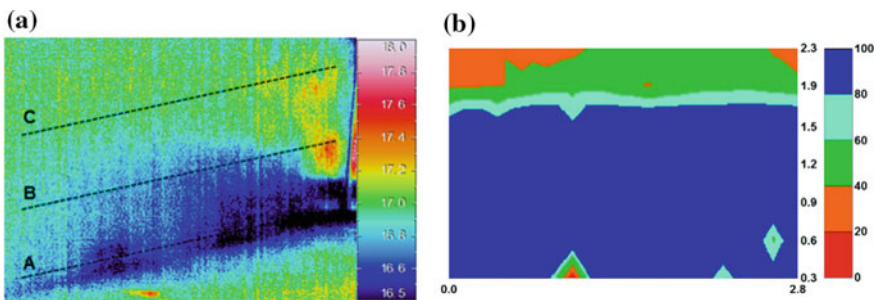
The results of the moisture detector (Fig. 4.2b) show that the moisture level in the wall was around 1.7 m from the ground, corresponding to a change in the superficial coating. The lower coating is less vapour permeable than the upper one, which can reduce superficial evaporation, increasing the amount of moisture in inner layers of the wall. When comparing the thermal image with the results of the moisture detector, they are not completely in accordance. One possible explanation may be related to the fact that IRT only detects surface evaporation, while the moisture detector assesses inner moisture.

**Fig. 4.2** Exterior wall of a basement in a residential building: **a** thermal image; **b** results of the moisture detector

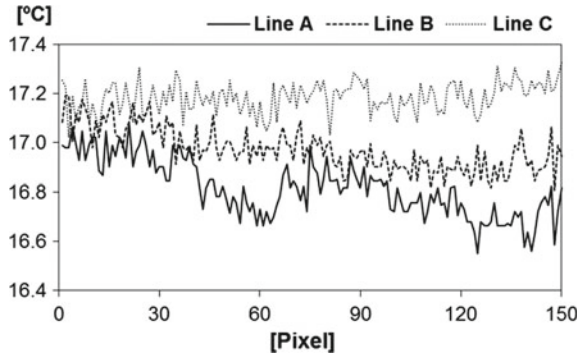
**Fig. 4.3** Temperature profiles of an exterior wall of a basement in a residential building at 0.2 m from the ground through (line A), at 0.7 m from the ground (line B) and at 1.2 m from the ground (line C)

C indicates that the wall, at this level, was drier, because no relevant variations of the values between pixel 0 and 150 can be observed. In lines A and B, temperatures near pixel 150 are lower than the ones around pixel 0, which indicates higher moisture problems near the corner.

Two critical zones can be pointed in line A, corresponding to the coating with greater degradation (between pixels 40 and 70 and between pixels 120 and 150, where temperatures are, on average, 16.8 and 16.7 °C, respectively). Due to the coating degradation, evaporation is more intense in these two zones and, thus, temperatures are lower.

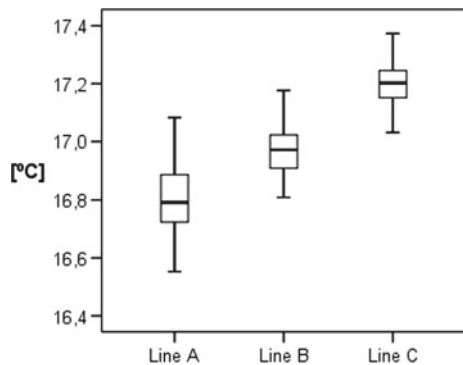
The box plot representation of the temperature profiles at different levels (Fig. 4.4) points to higher variability of the values at line A and lower at line C. This result is due to a more intense evaporation at the bottom, where the highest amount of water is available, and also to the degradation of some areas of the coating that enhances the phenomenon. Smaller fluctuations in temperature at the highest level indicate that the amount of water reaching it is lower and temperature variations due to evaporation are not so evident.

**Fig. 4.4** Box plot representation of the temperature profiles of an exterior wall of a basement in a residential building at 0.2 m from the ground through (line A), at 0.7 m from the ground (line B) and at 1.2 m from the ground (line C)

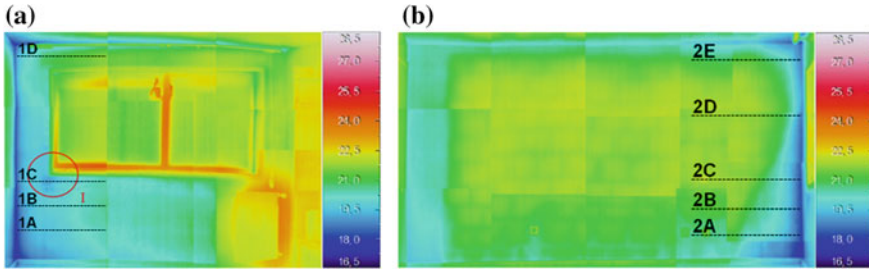
The thermal image of wall 1 displays lower surface temperatures around the left corner, under the window and at the top (Fig. 4.5a). The results of the moisture detector (Fig. 4.6a) showed that the wall is dry at the top, which indicates that the lower temperatures (dark blue) found in the thermal image correspond to a thermal bridge due to a beam. Although lower values have been measured with the moisture detector on the left vertical corner of the wall, at the thermal image, the lowest temperatures on this area (dark blue) are also related to a thermal bridge (structural column) and not only due to moisture. These considerations are supported by the information given by the structural plans of the building.

Fig. 4.5 Thermal images of the walls in a room: a wall 1; b wall 2

However, the surface temperature corresponding to the light blue colour results from the existence of moisture coming from outside. This conclusion was supported by the results of the moisture detector and by the existence of a damaged zone marked as I in Fig. 4.5a. Also, the visual inspection carried out on the exterior side of the wall revealed the existence of a crack. It must be stated that only the marked area is damaged in the inside. However, it is possible to assume that a larger area is affected by moisture, although not visually detected, taking into account the thermal image and the results of the moisture detector.

Figure 4.5b shows the thermal image of wall 2. Lower temperatures occur near the corners and at the top of the wall. The structural plans of the buildings indicate the presence of a beam and columns in those areas, which points to the existence of thermal bridges. However, there are clear differences between the colder areas on the left and right corners, indicating the presence of moisture in the right. The results of the moisture detector (Fig. 4.6b) support this conclusion, as the moister area is located near the right corner. Also, the existence of a crack on the exterior side of the wall in this area, as previously referred, strengthens this conclusion.

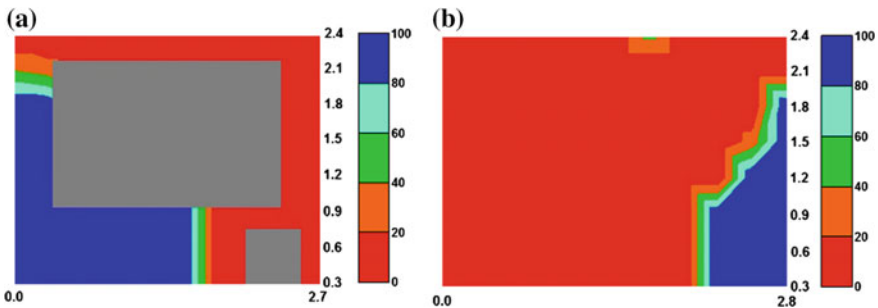
Fig. 4.6 Results of the moisture detector of the walls in a room: a wall 1; b wall 2

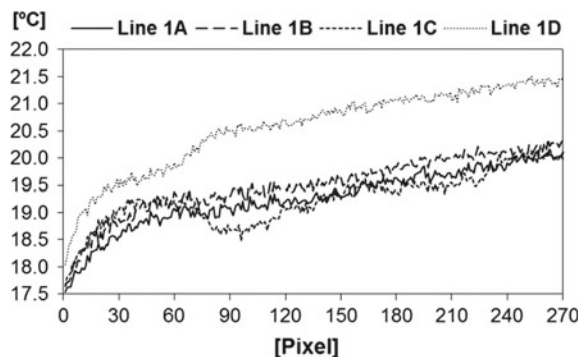
Temperatures on lines 1A and 1B are very similar, although in line 1A the values are always lower. That may be related to the existence of a thermal bridge due to a beam. Although line 1C also presents temperatures similar to the ones of lines 1A and 1B, there are some critical areas between pixels 80 and 120 (point I in Fig. 4.5a) and between pixels 170 and 230, which are related to infiltrations of rainwater, as supported by the results of the moisture detector. Temperatures on line 1D are always higher as no moisture was detected at this level (Fig. 4.6a).

**Fig. 4.7** Temperature profiles of wall 1 at 0.3 m from the ground through (line 1A), at 0.6 m from the ground (line 1B), at 0.9 m from the ground (line 1C) and at 2.4 m from the ground (line 1D)

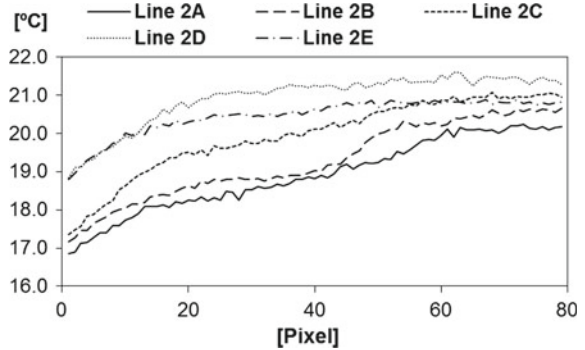
The temperature profiles of wall 2 (Fig. 4.8) show that at all levels there is an increase of surface temperature between pixels 0 and 10 related to a thermal bridge due to the existence of a column. However, at the lowest levels (lines 2A, 2B and

**Fig. 4.8** Temperature profiles of wall 2 at 0.3 m from the ground through (line 2A), at 0.6 m from the ground (line 2B), at 0.9 m from the ground (line 2C), at 1.8 m from the ground (line 2D) and at 2.4 m from the ground (line 2E)

2C), the superficial temperatures are lower, which indicates the existence of moisture that drops the values as a result of evaporation at the surface. Also, it is possible to detect that the moist area is larger at the bottom of the wall (line 2A) and decreases when the level is higher. In fact, the effect of moisture is noted until around pixel 60 at line 2A, around pixel 45 at line 2B and around pixel 20 at line 2C. Temperatures at lines 2D and 2E are very similar until around pixel 15, diverging from that point. The values are lower at line 2E due to the presence of a beam that decreases surface temperatures (thermal bridge).

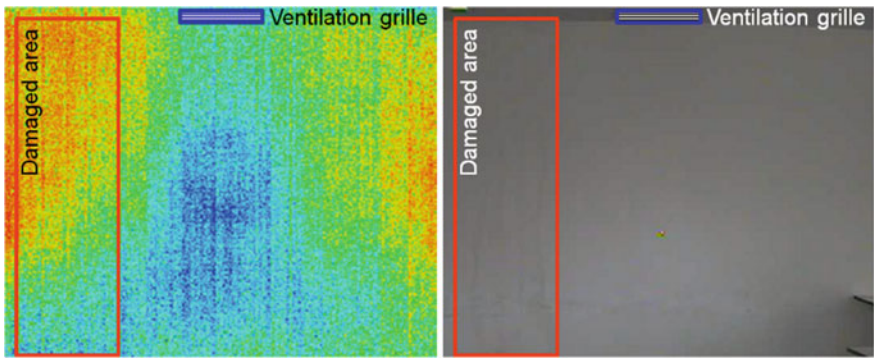
**Fig. 4.9** Visible and thermal image of the wall under study in the classroom

By the time the measurements were carried out, the coating of the wall was damaged due to an infiltration of rainwater through the roof. This problem had already been detected and repaired two months before the test was performed. Figure 4.9 shows, respectively, the visible and the thermal image, and Fig. 4.10 shows the results of the moisture detector.

If not analysed carefully, the thermal image could lead to a misinterpretation of the results. In fact, the colder area (dark blue in Fig. 4.9) is not located where the coating is damaged but aligned with the ventilation grille located in the ceiling. The results of the moisture detector confirmed that there is no moisture in the wall, what was expected as the problem had already been repaired.

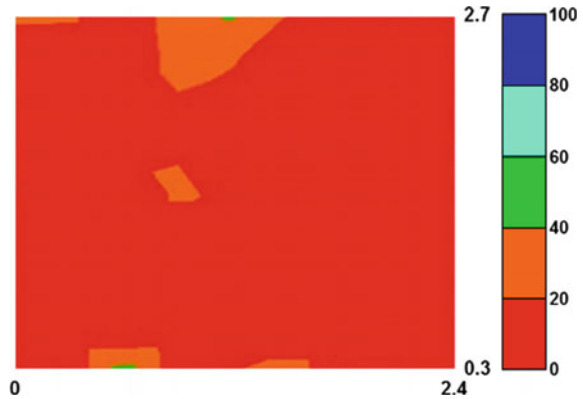
**Fig. 4.10** Moisture detector results of the wall in the classroom
