Chapter 5

IRT Versus Drying: In Situ Tests in Outdoor Environment

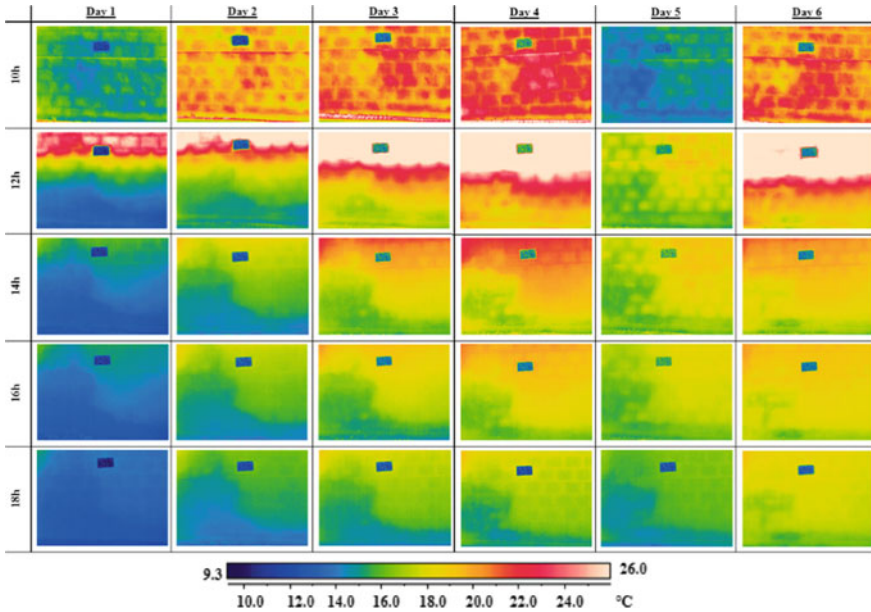
Fig. 5.3 Thermal images—wall 1

The thermal images taken in wall 1 are shown in Fig. 5.3. The thermal images show that temperatures vary with the hour of the day. They also show that in the first day, the superficial temperatures on the wall were lower than the ones obtained at the end of the test campaign.

Temperatures were higher at 10:00 and at 12:00 because there was direct solar radiation on the wall. During these periods is difficult trying to assess moisture because the effect of sun as a heat source enhances other phenomena rather than moisture, as detachments and materials with different thermal properties (Freitas

et al. 2014). Considering the thermal images taken in the afternoon, the temperature values were always lower at 18.00, what was expected as air temperatures are also lower (Table 5.1).

Over the six days of measurements and considering only the thermal images taken at 16:00 and 18.00, there is a clear increase of the surface temperature and a decrease of the area with the lowest temperatures. Although the air temperature generally increased over time, it is possible to say that the wall was drying out because, for similar air temperatures, the temperature values on the wall increased. Taken as an example days 2 and 6 at 18:00, the temperature of the air was 17.1 and 14.1 °C, respectively, and temperatures on the wall were higher in day 6. Darker colours on the thermal images on day 5 are related to the cloudy day that decreased the air temperature and, consequently, the surface temperature.

Based on the previous considerations, it is possible to point that the moist area was mainly located on the left side and at the bottom of the thermal image. Over time, it tended to decrease, and at the end of the measurement period, it was located mostly near the ground.

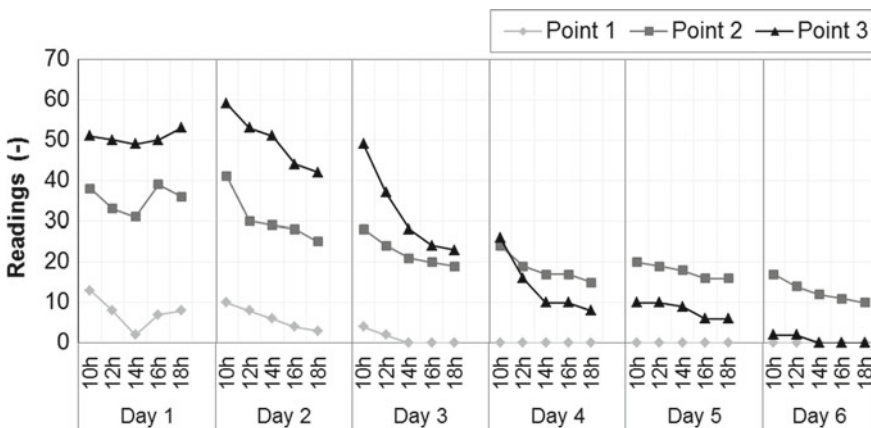
Fig. 5.4 Results of the moisture detector—wall 1

The results of the moisture detector (Fig. 5.4) support the findings of IRT. On the three points that were assessed, generally, moisture decreased not only over the day but also over the period of measurements. During day 1, there was an increase of moisture at the end of the day that may be related to the runoff of accumulated water on the wall surface. The increase of moisture at the beginning of each day, when compared with last reading of the previous day, was probably due to higher relative humidity of the air during the night that increased moisture at the surface.

Figure 5.4 also shows that point 1, at the highest level, dried out faster than the other two, and at day 6, the readings of the moisture detector were around zero. This may indicate that this part of the wall was less affected by rainwater. The decrease of moisture on point 3, at the lowest level, was sharper than on point 2, located at an

intermediate position. That can be explained because in the surroundings of point 2 there was a joint in the rendering, where accumulated water may have restricted the drying process.

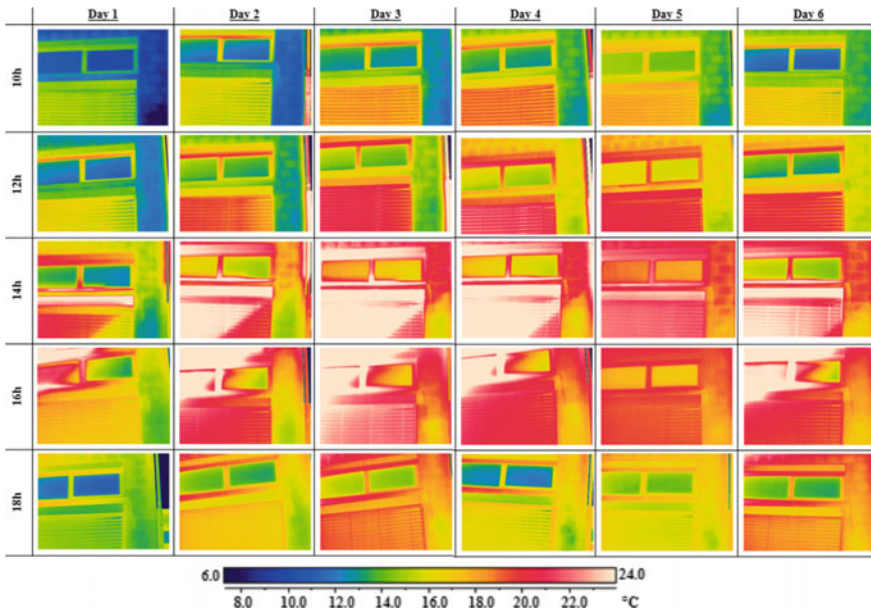
Fig. 5.5 Thermal images—wall 2

The thermal images taken in wall 2 are shown in Fig. 5.5. The temperatures were higher during the afternoon because there was direct solar radiation on the wall. Shadows are clearly detected in the thermal images and may mask the effect of moisture at 14:00 and 16:00. However, some findings can be enhanced in the remaining results.

As in wall 1, also in this wall the increase of temperature on the right side is clear. There was an increase of the values not only over the day but also over the period of measurements. It is, however, difficult to detach the effect of air temperature, which increased the superficial temperature of the wall, from the increase of surface temperature due to the drop of moisture at the surface. However, when considering days with similar weather conditions, it is possible to notice that at the end of the measurement period the values were higher than at the beginning, pointing to less intense evaporation and, consequently, to a dryer surface.

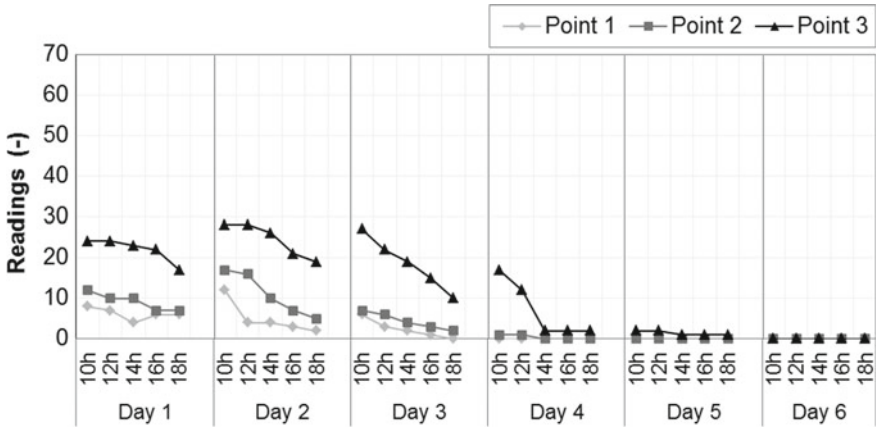
Fig. 5.6 Results of the moisture detector—wall 2

The results of the moisture detector (Fig. 5.6) were in line with the ones of the thermal images, because moisture decreased over time at all levels. At the end of the

fourth day, the readings were very similar and around zero, indicating that the wall has dried out. Similar results on the three points were somehow expected since they were very close to each other.

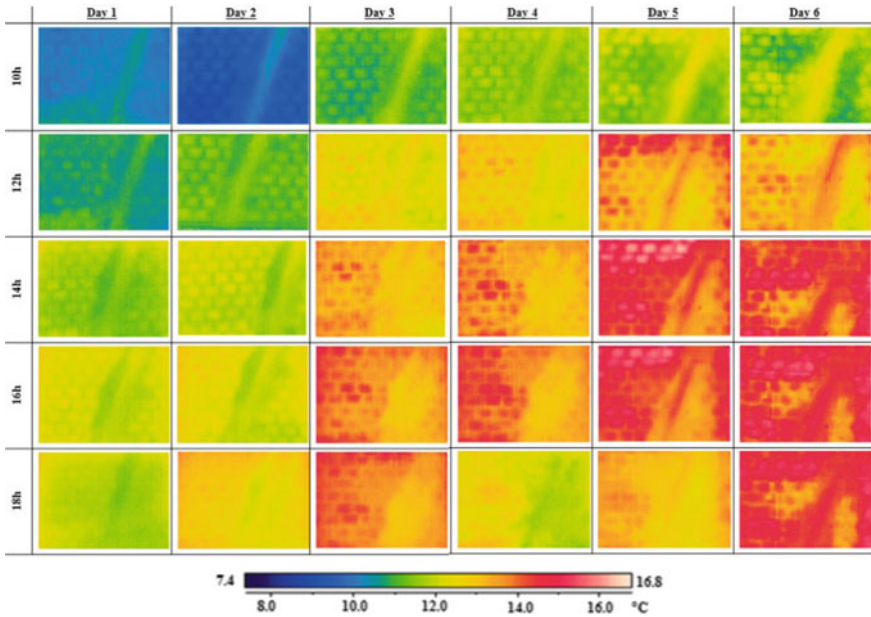
Fig. 5.7 Thermal images—wall 3

The thermal images taken in wall 3 are shown in Fig. 5.7. Temperatures on this wall were lower than in the previous ones because there was no direct solar radiation. Although the effect of the sun was less relevant, these images are not completely conclusive regarding the drying process, mainly due to the thermal patterns resulting from dirt at the surface, different thermal conductivity of the inner layers and/or influence of the surrounding environment, which are problems also verified by Rumbayan and Washer (2014).

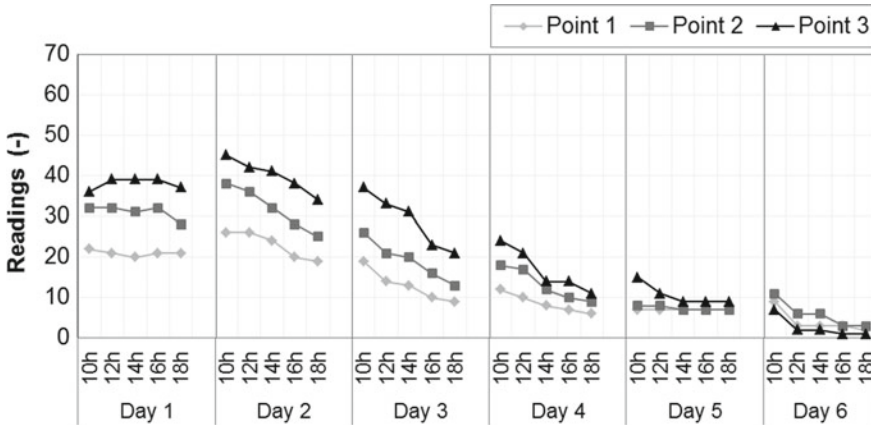
Fig. 5.8 Results of the moisture detector—wall 3

Although the results of IRT are not totally clear, the moisture content indicates that the wall dried out over time as at the end of day 6 the readings at all levels were around zero (Fig. 5.8).

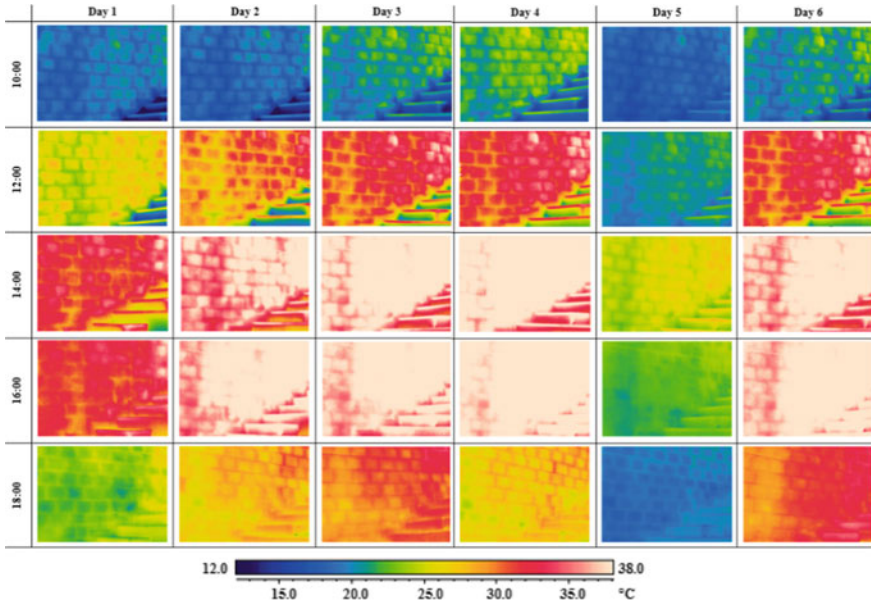
Fig. 5.9 Thermal images—wall 4

As in wall 3, also in this case (Fig. 5.9) the results revealed that tackling the drying process in the outdoor exclusively through qualitative IRT is not straightforward, although a tendency for higher surface temperatures throughout the analysis can be identified. Yet, the air temperature was also increasing, which highlights the

difficulty of isolating the effect of evaporative cooling. In addition, the influence of solar radiation in the thermal images is difficult to assess.

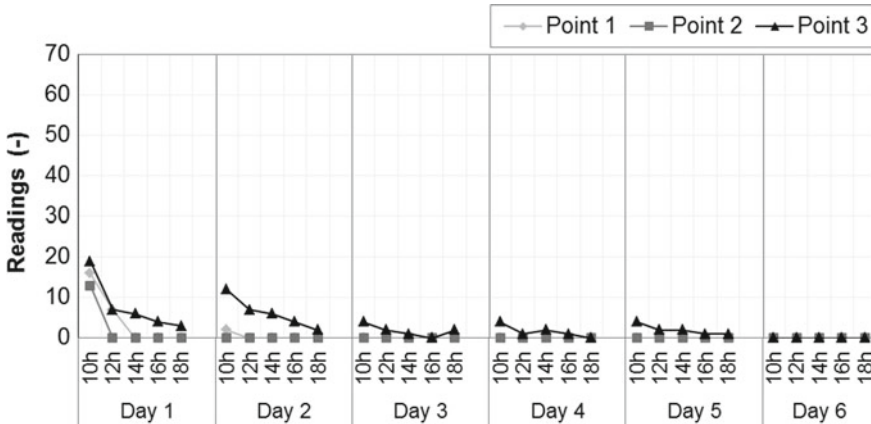
Fig. 5.10 Results of the moisture detector—wall 4

Figure 5.10 shows the results obtained with the moisture detector. From day 2, readings on point 1 and point 2 had null values, which mean that the wall was superficially dry. As expected, point 3 had higher moisture content as it was near the ground, where a larger amount of water was accumulated. However, at the end of day 6, it was also completely dry.

On the other hand, as expected, measurements on the wall 4, the only one facing south, presented lower values of moisture content because there was higher amount of incident solar radiation.
