# Historic Renders and Their Weathering at the Temple Wat Mahathat, UNESCO World Heritage Site of Ayutthaya, Thailand

H. Siedel, E. Wendler and B. Ullrich

**Abstract** Investigations of renders on buildings of the temple Wat Mahathat in Ayutthaya showed that two different types of mortars have been applied. The original mortars from the period before 1767 are lime mortars, whereas hydraulic mortars were obviously used for restoration and stabilisation of the ruins in the 20th century. The use of organic additives like starch from boiled rice for historic mortar production is suspected, but could not be proved by analytical means. The analysis of probable additives is made more difficult due to microbiological activity in tropical climate which might have led to enzymatical decomposition of the primary organic compounds. The porosity and the hardness of renders, analysed in situ by easily applicable, non- or less-destructive investigations like Karsten tube measurements and drilling resistance, reflect a wide range of different weathering states. Therefore, appropriate restoration measures must be planned in detail for every part of the buildings; an overall treatment with water r

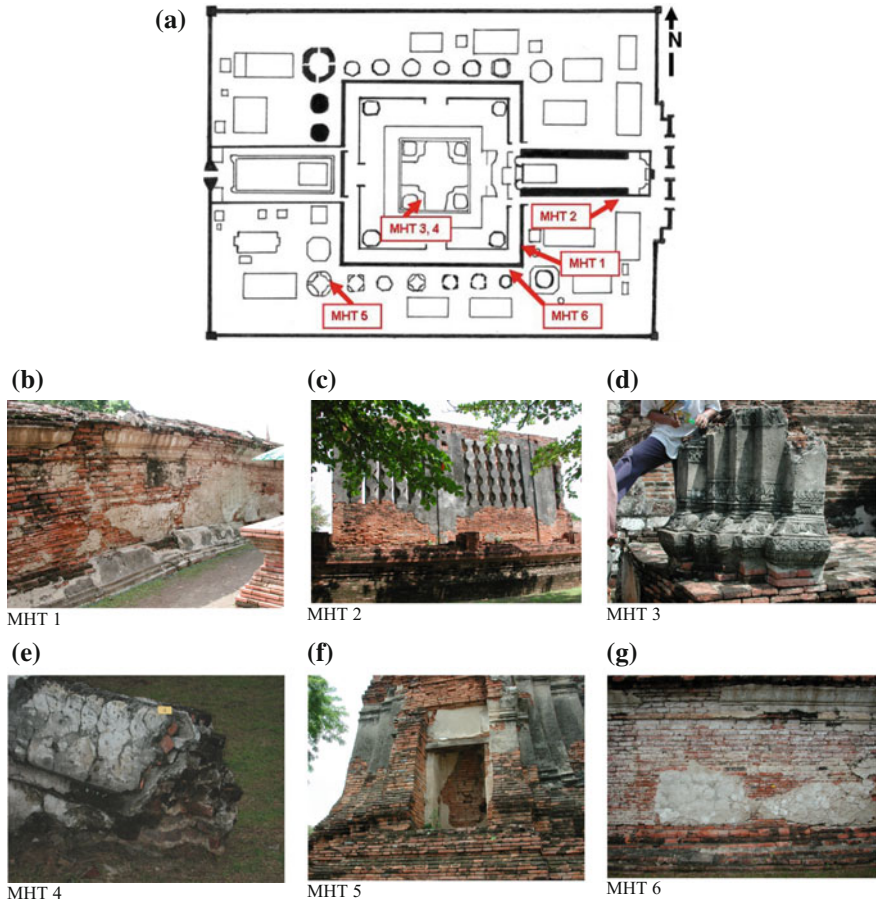
**Fig. 1** a–g: Sketch map of Wat Mahathat (a) and documentation of places (b–g) where material samples were taken and in situ measurements were carried out (cf. Table 1)

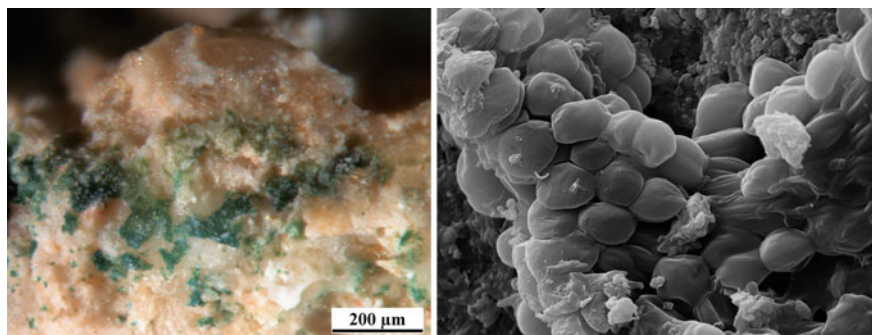
Some mortars (MHT 1/S3, MHT 2/S6, MHT 3/S7, MHT 4/S8) show a remarkable exothermic reaction in the DTA, connected with weight loss in the TG in the temperature range between 200 and 400 °C (Table 2). This might be due to the ignition of organic matter at these temperatures. The respective mortars show blackened surfaces (MHT 2/S6, MHT 3/S7 and MHT 4/S8) or green staining underneath the surface (MHT 1/S3, Fig. 4) due to microbiological activity.

**Fig. 4** Organic matter in the surface zone of mortar MHT 1/S3 in higher magnitude under the optical microscope (left) and SEM (right; right figure margin = 20  $\mu\text{m}$ ). EDS analyses of the structures in the SEM micrograph showed very high carbon contents

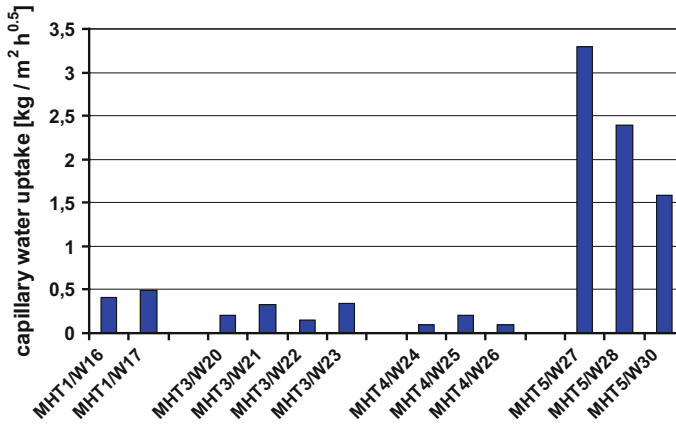
Dense mortars showing low capillary water uptake can be found in visibly intact areas with smooth, “polished” surfaces (on the enclosure wall, MHT 1 and 6, and on the fragment from the central prang, MHT 4, see Fig. 6). These renders normally consist of two layers: as confirmed by DR measurements, the polished surface is

**Fig. 6** Capillary water uptake ( $w$  values) calculated from Karsten tube measurements. The values displayed for area MHT 1 are also representative for area MHT 6

very hard due to sinter formation, while the interface between the two layers shows a low strength (insufficient contact), and in many cases, the outermost layer is already missing. In these cases, a hardened zone can also be found on top of these secondary surfaces, due to further transport of dissolved electrolytes (lime, silica) and deposition in the surface structure. Generally, the contact between the render and the brick underneath is rather poor in many cases.

Mortars with rough but stable surface and black staining may show a high capillary water uptake (MHT 2). Water absorption coefficients ( $w$ -values) for area MHT 2 could not be calculated due to irregular behaviour of the water uptake (influenced by water transport along cracks or parallel to surface), therefore results for this area are not displayed in Fig. 6. On the other hand, similar surfaces may have reduced capillarity (MHT 3), possibly due to “sealing” of the pores with organic matter.

All in all, the measured capillary water uptake scatters between 0.1 and 3.5 kg/m<sup>2</sup> h<sup>0.5</sup> (Fig. 6). The highest values were measured at a very soft render on the smaller prang (MHT 5), which is a poor hydraulic mortar with high portion of aggregates in a sheltered position inside a niche. In many cases, the results obtained from Karsten tube measurements suggest different pathways of water transport besides regular capillary water uptake, i.e. transport along cracks or parallel to the surface.

appropriate restoration measures for certain parts of the buildings should be made step-by-step on the basis of easy, non- or less-destructive measurements (Karsten tube, DR). An overall hydrophobic treatment of the entire surface of buildings cannot be recommended because of the very different capillary suction of the material surfaces and due to the risk of moisture infiltration through cracks which would even lead to severe damage.

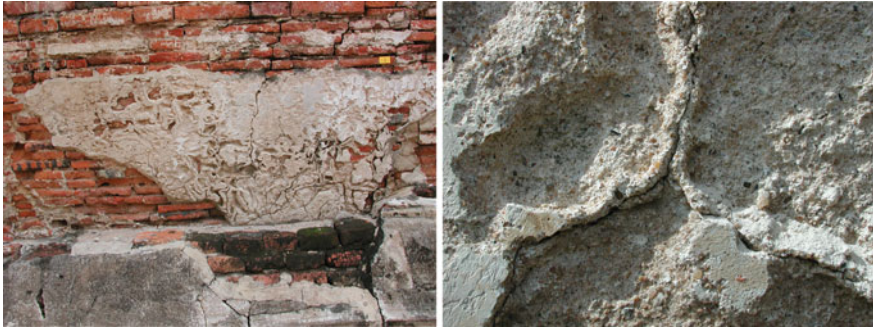
Bizarre weathering structures frequently occur on the walls of the inner enclosure (MHT 1 and 6, Fig. 7). Similar patterns are also known from other places and are

**Fig. 7** Alveolar weathering of renders on the enclosure wall (MHT 1, left, and detail from MHT 6, right). As can be seen on the right, the ridges are often preserved along cracks

often explained as a result of the formation of Liesegang patterns during the carbonation process (Rodriguez-Navarro et al. 2002) and subsequent differential erosion (Delgado Rodrigues 2016; Rodriguez-Navarro 2012; Dotter 2010). On the other hand, they are similar to those called “alveolar weathering” or “honeycomb weathering” on natural stones (e.g. Siedel 2010) with small “walls” or ridges that in parts still represent the original surface, surrounding deep, back-weathered “holes” between them. Although salts are often a driving force in the formation of alveolar structures in natural stone, no efflorescence or other activity of soluble salts could be detected in case of the renders in Ayutthaya. Most of the ridges are flanking a system of connected cracks in the mortar surface which might have already developed during shrinking of the thick render layers at an early stage of setting. Ridges along a directly connected network of shrinkage cracks in renders were also observed by Delgado Rodrigues (2016), who interpreted these structures as the result of higher weathering resistance of the respective areas due to intensified carbonation, facilitated by better access of  $\text{CO}_2$  from air. However, the typical concentric, ring-shaped wall structures within the “cells” surrounded by the above mentioned ridges with cracks are lacking in Wat Mahatat. These patterns, called “flos tectorii” in Italian literature, might be assigned to differential erosion of “Liesegang rings” with higher or lower concentrated carbonated binder (Delgado Rodrigues 2016). In contrast, in the renders described here irregular shaped “isles” and “holes” within the cells marked by the surrounding system of cracks can be found. Measurements of DR topography of a weathered render surface show hardened surfaces on the ridges (and on the smooth surface of the visibly intact outer render layer), whereas the surfaces at the bottom of the adjoining holes are softer (Fig. 8a). Microscopic investigations on a thin section of a ridge structure displayed thin layers of silica coating the surfaces along the crack between the two flanks of the ridge (Fig. 8b). This indicates an intensified capillary transport of dissolved matter ( $\text{Ca}(\text{OH})_2$ /lime, soluble silica) from the mortar to the evaporation zones along the cracks (arrows in Fig. 8a) and also on even surfaces in the neighbouring areas. As shown by Karsten tube measurements (cf. Fig. 6), the latter

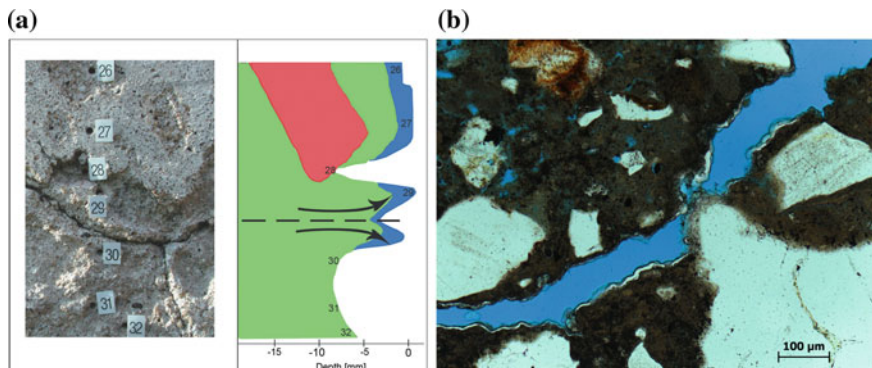
**Fig. 8** **a** Drilling resistance measurements no. 26 to 32 along the surface topography of a render structure. Blue: very hard material on the surface of the outermost render layer (26, 27) as well as on the flanks of the cracks (29). Red: very soft zone between the two render layers = zone of detachment. Green: normal strength of the inner render layer. Dashed line: crack. Arrows: transport of electrolytes ( $\text{Ca}^{2+}$ ,  $\text{OH}^-$  and mobile silica?) towards the surface zone, reinforcing the flanks by deposition of minerals. **b** Thin section across a ridge with two flanks and a crack in between at higher magnitude. The edges of the crack show a light, thin layer of silica (as chemically analysed by EDS in SEM) (Color figure online)

are dense, which is in good accordance with the higher DR measured near the surface. The intensive wetting of walls and ground during the rainy season in tropical climate provides enough water for intensive capillary transport of soluble components to the evaporation surfaces during the drying process in the dry season. Selective hardening of the border zones flanking the crack areas might thus lead to their better resistance against surface weathering. At the same time, the zones beneath the render surface next to the hardened zones along the cracks are depleted in binder, thus losing contact to the underlying material when stressed by hygrothermic changes. It seems worth to be mentioned that the areas showing these deterioration patterns are mainly situated near the bottom of the walls, where the moisture is continuously rising from the ground into the wall even in the dry season. The transport rate of dissolved matter through the render near the ground is higher compared to that on the upper parts of the wall. Observations and measurements at the walls of Wat Mahathat lead to the assumption, that the driving force for the formation of differential erosion in the renders in our case is capillary transport, migration and precipitation of dissolved  $\text{Ca}(\text{OH})_2$  or lime, respectively.

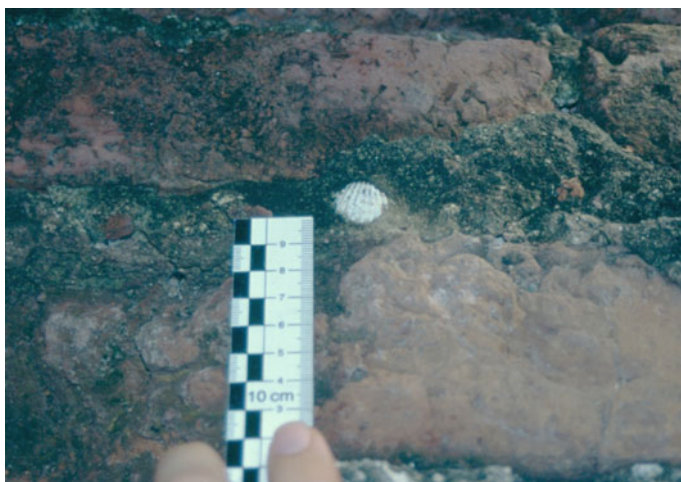
**Fig. 9** Shell in a joint mortar in area MHT 2
