# Some Examples of Incomplete Diagnostic Analyses of Industrial Machinery

Nicolò Bachschmid<sup>(✉)</sup>

**Abstract.** Diagnostic tasks on industrial machinery can sometimes be dealt basing only on previous experience with successful model based identification techniques. This may be required when necessary time and resources for complete diagnostic analysis are not available. Some examples of machines affected by malfunctions that have been more or less successfully analyzed, often without resorting to machine specific models, are presented. Journal ovalisation in a HP-IP steam turbine was identified in the first example, the vibration changes in a LP steam turbine could be attributed to coupling misalignment and to a loose last stage blade of the shaft in the second example. Rubs and thermal bow combined to axial shaft expansion restriction could explain the severe vibrational behavior of a steam turbine that prevented its operation in a third example. The abnormal noise of a vertical shaft generator of a hydroelectric power plant was attributed to a structural resonance excited by electromagnetic forces in a third example, where the diagnostic process was completed by validat

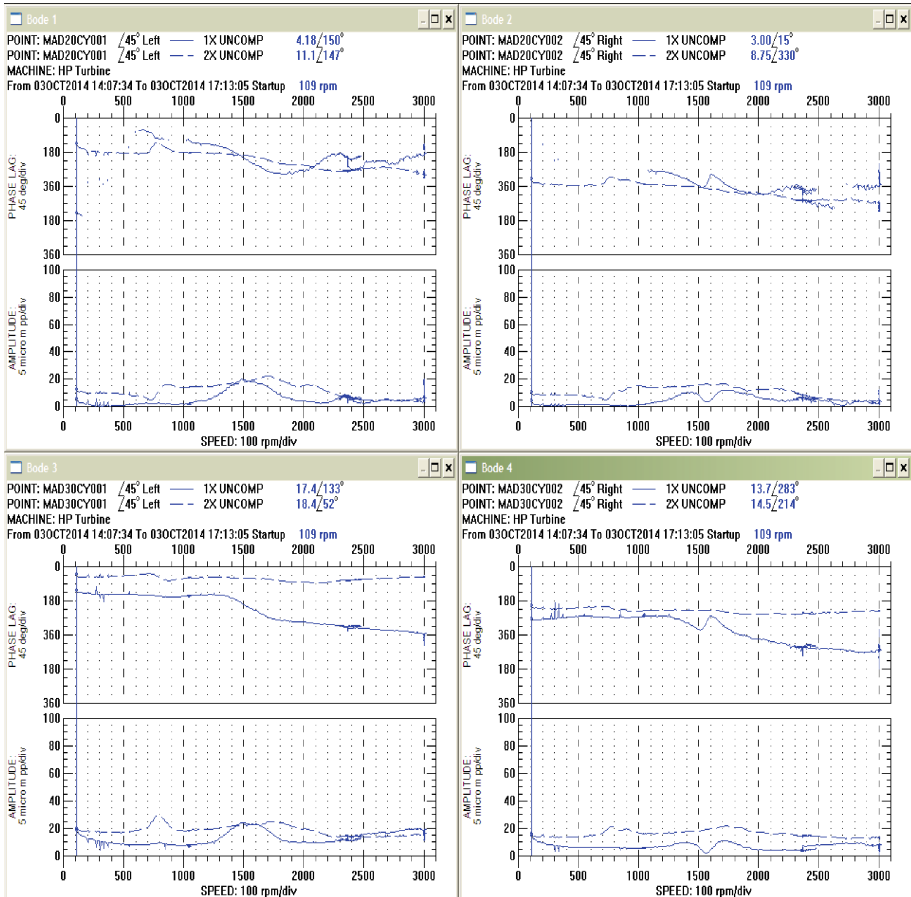
Fig. 1. 1X and 2X amplitudes and phases during a startup *after realignment* of HP-IP turbine

Impressive are the differences in the 1X behavior, the huge reduction of the vibration amplitudes, especially in the second bearing which, being close to the coupling flanges of the LP section of the machine, is mostly sensitive to the bearing/support alignment of the complete machine.

Interesting is the analysis of the 2X component which seems to be rather insensitive to alignment conditions, having similar trends before and after realignment. On the second bearing the 2X amplitude is something less than 20 μm in the all speed range except when crossing the secondary resonance at 750 rpm, half the critical speed, where some dynamic magnification is recognizable. The phase of this component is rather constant in the complete speed range.

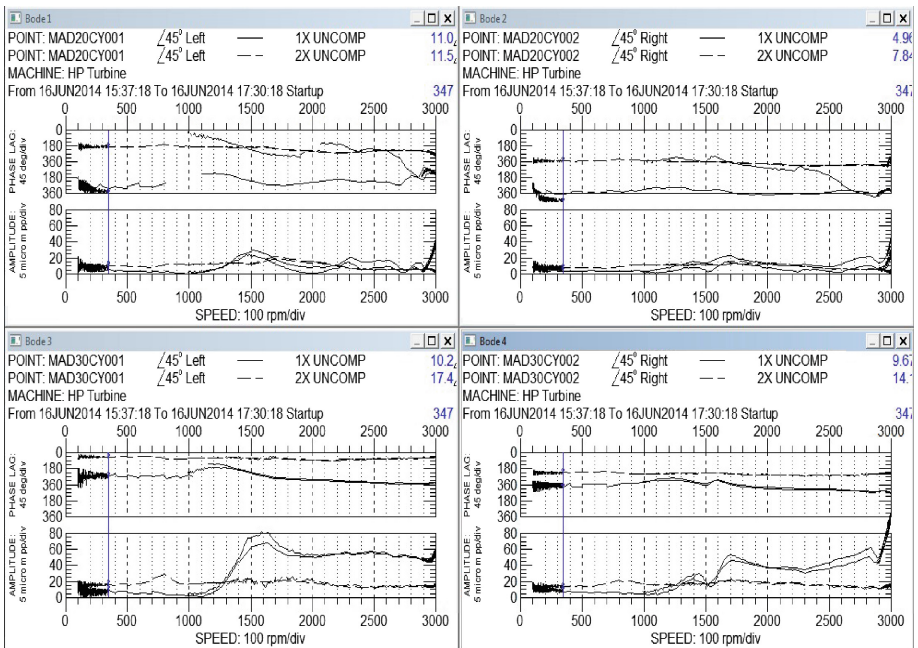
Figure 2 shows the same diagrams that were recorded during a startup before the maintenance stop. Small differences in behavior are obviously due to little different thermal conditions of the rotor during the startup transients.

Fig. 2. 1X and 2X amplitudes and phases during a startup before realignment of HP-IP turbine

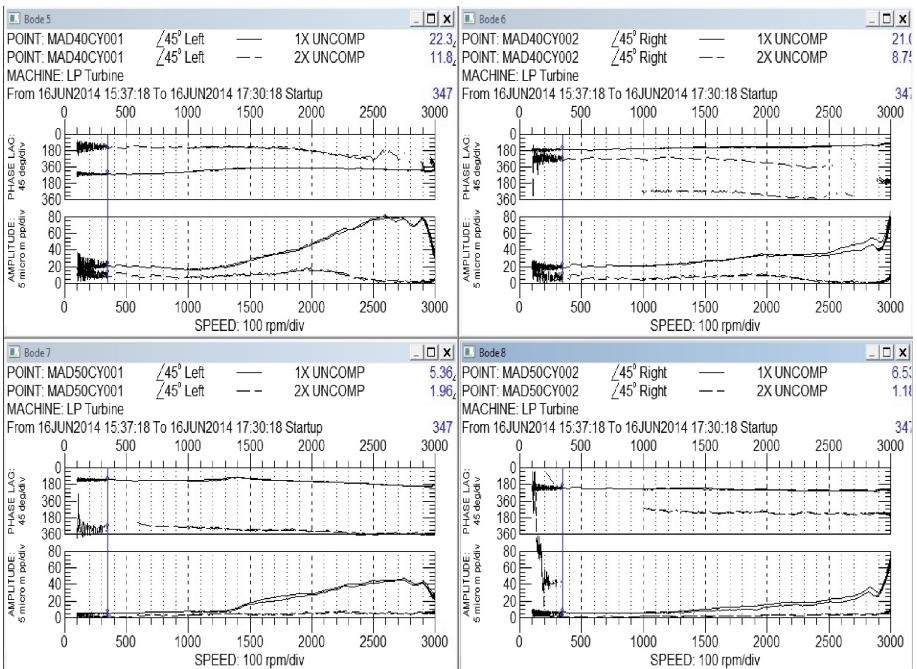
**Fig. 4.** 1X and 2X amplitudes and phases during a startup before realignment in LP turbine

Looking closely to the diagrams of the first bearing, it can be noted that at increasing rotational speed the 1X amplitudes increase up to the speed 2600 rpm, with no change in the phase, that indicates poor dynamic behavior with no evident critical

speed crossing. This trend is consistent with a misalignment, that can be conveniently modelled as an external rotating bending moment with constant amplitude [2]. This generates also the constant 1X amplitude of 20  $\mu\text{m}$  at very low speed. Above 2600 rpm the vibration amplitude increase is opposed by some dynamic effect which prevails in the last 100 rpm before reaching the rated speed of 3000 rpm. A similar effect but in opposite direction is recognizable on the second sensor of the first bearing. The other bearing shows the same behavior although with smaller amplitudes. This huge dynamic effect might be attributed to some unbalance which opposes its centrifugal force (proportional to the square of the rotational speed) to the misalignment effect in an effective way only in the higher speed range close to the rated speed of the machine. Also the HP-IP rotor bearing on the load side is involved in this strange behavior by means of the coupling.

During the standard inspection of the last stage blade row through a window in the casing, it was discovered with surprise that the closing blade of the last row had moved along its seat from its original position for roughly 30 mm in axial direction.

This displacement generates a change in the balance situation of the rotor which is equivalent to a rotating bending moment with amplitude proportional to the square of the speed. The bending moment at rated speed evaluated with these data resulted to be roughly  $10^5$  Nm, a value which is consistent with the generated vibrations.

The phase shift between the two bearings of the 1X component is close to  $180^\circ$  which supports the assumption of the huge local bending moment acting on the shaft.

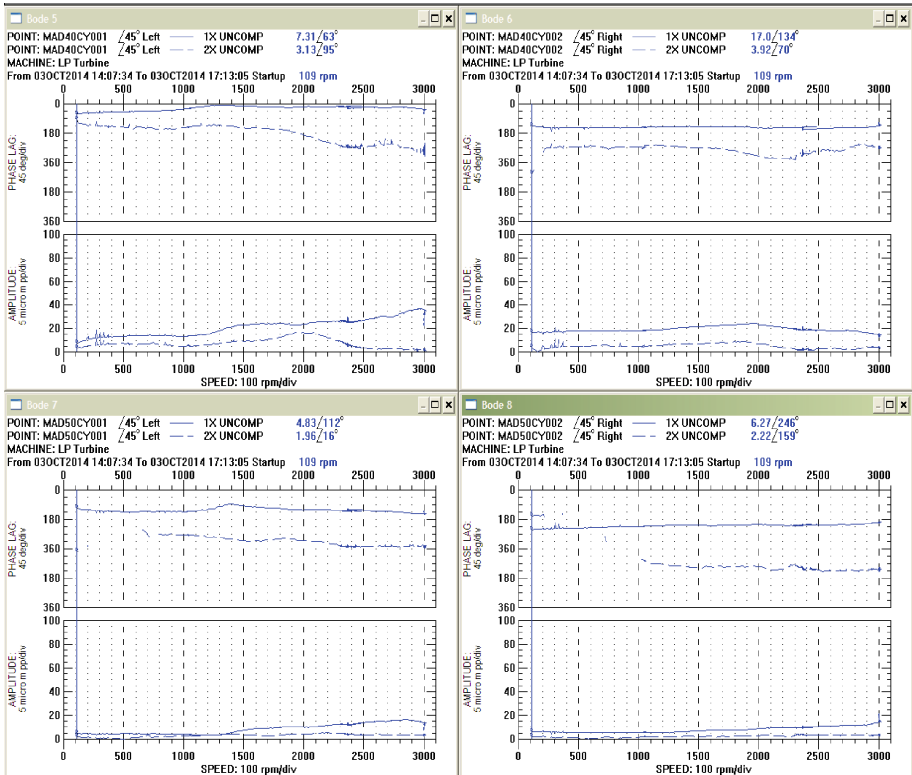
Fig. 5. 1X and 2X amplitudes and phases during a startup after realignment in LP turbine

Figure 5 shows the diagrams of the same bearings which were obtained during the startup after having aligned accurately the shafts and having fixed the blade in its proper position.

It can be seen that a huge reduction in vibration amplitude has been obtained by proper alignment and by fixing the blade in its original position.

The strange dynamic behavior at rotational speeds close to the rated speed disappeared completely. The reduction of the 1X component at low speed was rather small, which could indicate the presence of a small permanent bow or that the alignment could be still improved.

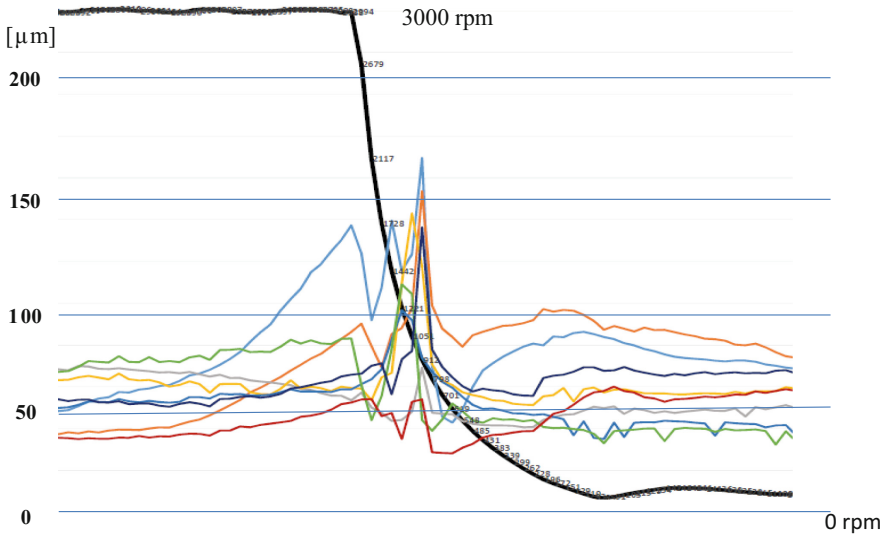
Figure 7 shows the time history of all vibrations of turbine and generator during this event. Vibration of free end of steam turbine starts to increase and reaches trip level after around 30 min. During the run down at critical speed still higher amplitudes are reached in almost all sensors and at low speed vibrations that are higher than at rated

**Fig. 7.** Vibration time histories (during 60 min) before and after trip: orange and blue curves are related to the free end turbine bearing, dark red and dark grey are related to the other turbine bearing, black line indicates the rotational speed.

speed are measured in all sensors of the turbine. The behavior during and after the run down is consistent with a thermal bow, which was confirmed by the plant management: before starting again the turbine, the rotor needed to be slowly rolled for 20 h, in order to reduce and equalize the thermal stresses. Regarding the cause of the thermal bow it can be assumed that it has been most likely generated by severe rubs in some sealing. The rising of amplitude in 30 min is consistent with that hypothesis, as can be deduced from analysis described in [4].

It was finally discovered that the axial elongation of the shaft due to heating, at the increasing of output power, had been restricted by error after the overhaul. This caused the bending and rubbing of the shaft. After having removed the axial restriction the machine could be operated smoothly at full power.

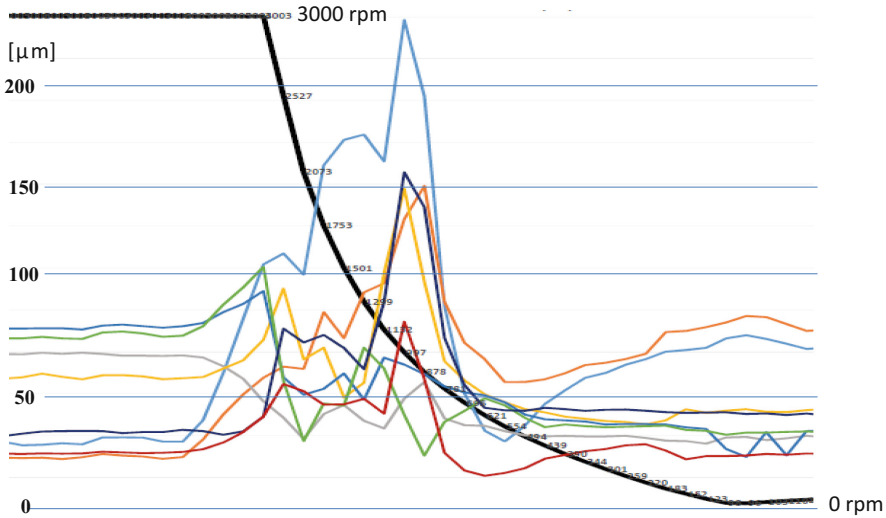
At the following startup (2 days later) the behavior was similar but with a much sharper increase of vibrations (trip level was reached in 5 min), higher vibration amplitudes (with a peak at 240  $\mu\text{m}$ ) in passing the critical speed and higher residual vibrations at low speed, as shown in Fig. 8.

What has changed in the machine? Was it a much more severe rub, that generated a much greater bow? Or was there an additional cause that changed the vibrational behavior so much? Difficult to decide, since additional information like Bode diagrams with amplitude and phase of 1X and 2X components or journal orbits in the bearings were not available. The only available additional data were some spectra at rated speed, which showed the presence also of a consistent 2X component that could have been generated by a crack in the rotor.

**Fig. 8.** Vibration time histories (during 42 min) before and after trip: orange and blue curves are related to the free end turbine bearing, dark red and dark grey are related to the other turbine bearing, black line indicates the rotational speed.

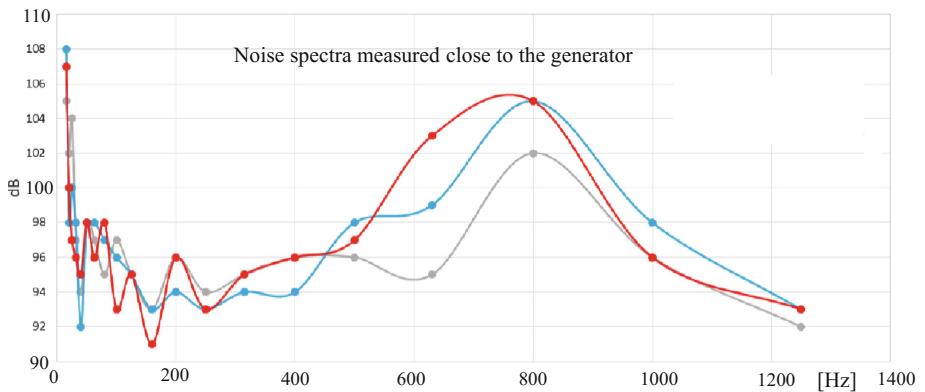
Figure 10 shows the noise measurement results, at rated speed in 3 different operating conditions: without excitation, with excitation and no output power, with excitation and a power output of 31 MW.

At the frequency of 800 Hz the noise reaches 105 dB when the machine is excited, both with and without load, and something less, 102 dB, when the machine is without excitation. The reason why, even without excitation, the measured noise was so high could not be clarified. At the frequency of 700 Hz direct noise measurements were not taken; but we have measurements at 650 Hz, which show that the differences among the 3 different conditions are higher: the maximum is reached by the condition of load.

**Fig. 10.** Frequency analysis of noise in 3 different conditions: grey without excitation, blue with excitation but no load, red with excitation and 31 MW load.

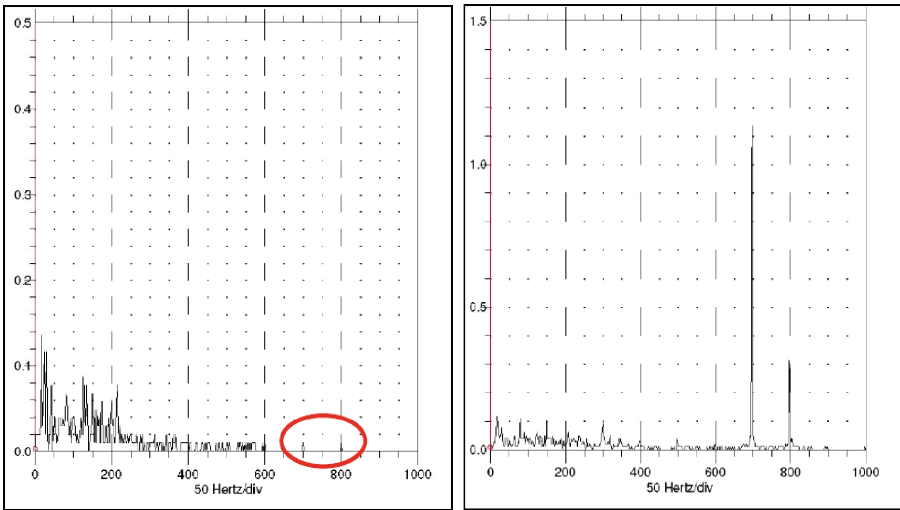
Very interesting are the vibration measurements on the casing of the generator shown in Fig. 11 in case of no excitation (left) and with excitation (right). Due to the excitation the vibration velocity at 700 Hz jumps from 0.01 mm/s to 1.2 mm/s and at 800 Hz from a similar value to 0.6 mm/s.

**Fig. 11.** Vibration spectra of generator casing: left without excitation, right with excitation

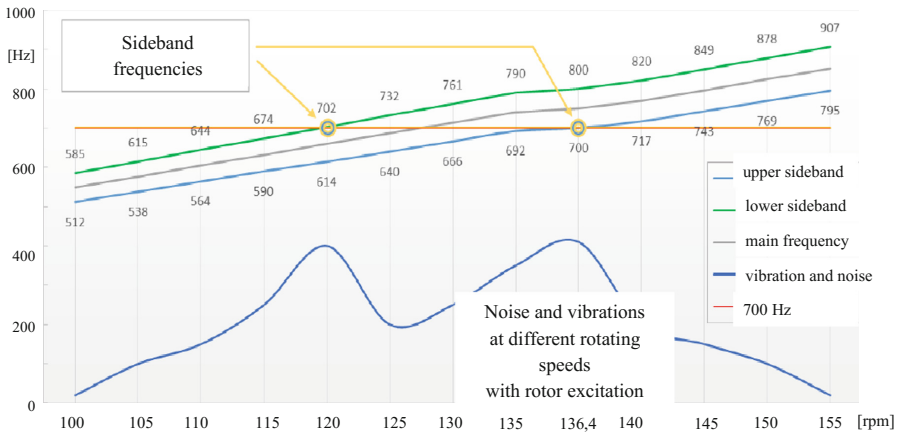
Fig. 12. Noise and vibrations at changing rotational speeds, with external rotor excitation.

The stator resonance could be proved experimentally by changing the rotational speed whilst the rotor coil current was fed by means of an external current generator. This resonance was not excited in the original design of the machine that had 360 slots instead of 330 slots. This generated a shift of around 10% in the exciting frequencies.

Figure 12 shows the results of noise measurements at different rotational speeds. Two peaks are obtained at the rotational speeds of 120 rpm and of 136.4 rpm, the last one is the rated operating speed of the generator. Maximum noise (and vibrations) are obtained when one or the other of the above exciting frequencies was equal to 700 Hz: this suggests that at that frequency a resonant condition is likely to occur.

At the rotational speed of 120 rpm we have again a resonance at 704 Hz similar to that one at the rated speed of the machine.

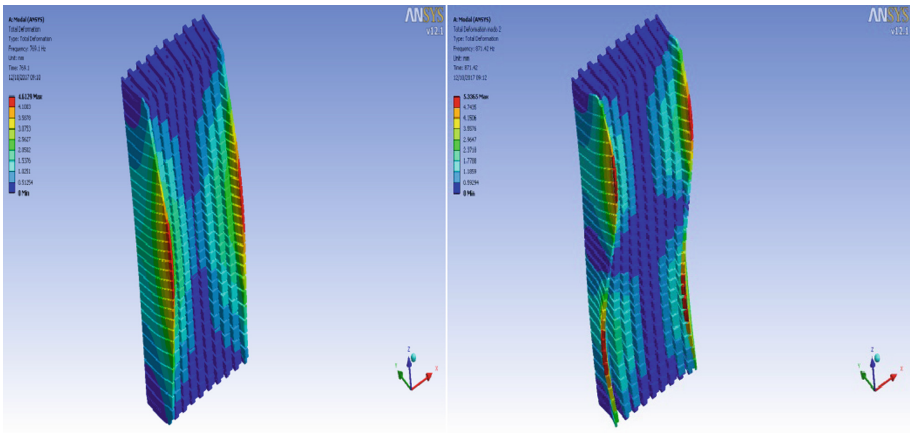
Fig. 13. Vibration modes of one sector of the stator pack: left at 769 Hz right at 871 Hz

Figure 13 shows two mode shapes respectively at 769 Hz and 871 Hz which at least demonstrate that the structure with more realistic boundary conditions could vibrate with similar shapes at a lower frequency, such as the measured frequency of 700 Hz.

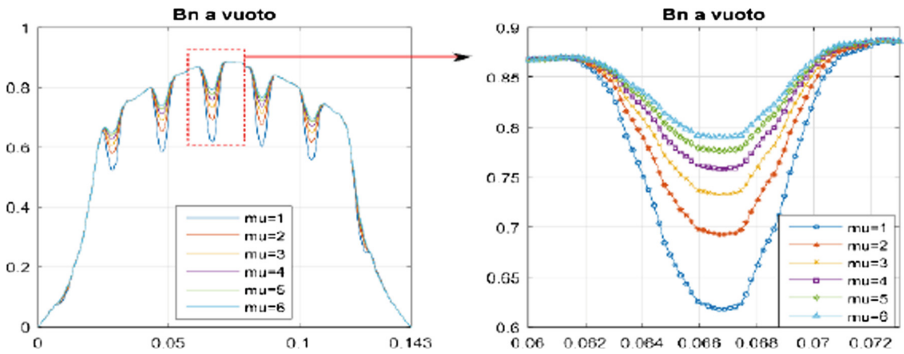
**Fig. 14.** Magnetic flux versus angular displacement, for different values of slot wedge magnetic permeability  $\mu$ . Left 1/44 of rotation, right enlargement over one slot.

Figure 14 shows the magnetic flux amplitude as function of the angular position in case of no load, for different values of magnetic permeability. Strong reduction flux amplitude can be obtained with a permeability 6 times higher than its value in air. This corresponds to a still higher reduction of the force acting on the stator, but in case of full load of the generator this reduction tends to vanish due to the interaction with the stator electromagnetic field.

Since the amplitude of the magnetic force periodical irregularity depends on the magnetic permeability of the wedges in the stator slots, it was proposed to change its material in order to increase its permeability for reducing the irregularity and the strength of excitation. The possibility of changing the frequency of excitation or the natural frequency of the stator pack was discarded, due to obvious reasons.
