Building Techniques and Structural Damage of Historical Constructions Detected Through the Point Cloud Survey

Keywords: Laser scanning technique · Point cloud · Building techniques
Deformed configuration · Historical constructions · Santa Fosca church

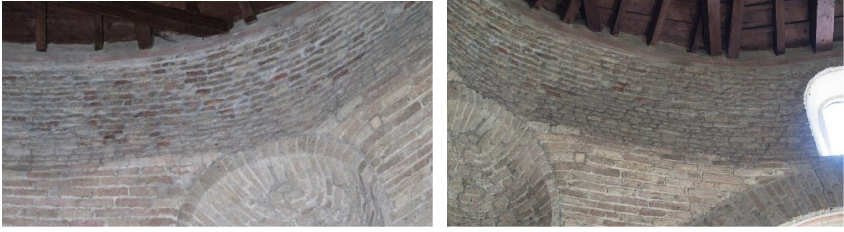
Fig. 2. Detail of the drum masonry pattern

Unfortunately, due to the presence of re-pointed mortar all over the inside masonry walls, and, in particular, on the drum, it is not possible to understand the stratigraphic sequence of this element. In any case, a clear difference can be observed between the masonry pattern of the drum and those belonging to the underneath arches and pendentives: at a first glance, focusing only on the visual inspection, it can be stated that the drum and the couples of niches do not belong to the same construction phase.

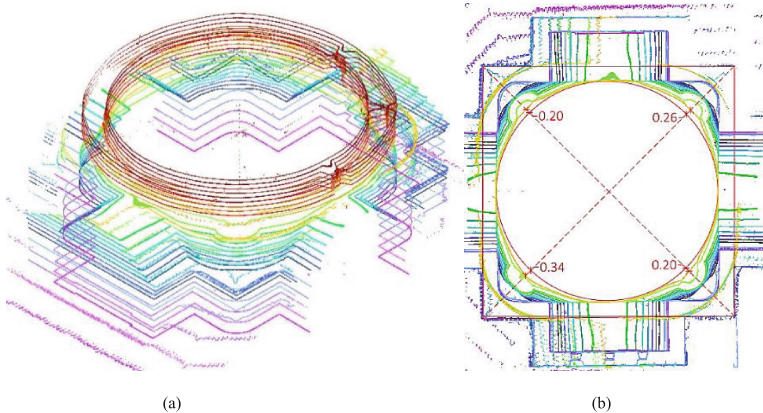
Fig. 3. Horizontal slices of the upper part of Santa Fosca church: (a) assonometric view; (b) plan view

As it can be seen in Fig. 3(b), the drum shows a vertical development in the proximity of the middle sides of the square, where the horizontal slices from its bottom to its top always match. This overlapping does not occur above the couples of niches,

By analysing the drum more in depth, it is also possible to observe that its geometry is mined by some structural problems that involve the whole building: Fig. 3 shows an out-of-plumb of about 34 cm near the South-West side. This anomaly is emphasised in Fig. 6 where the vertical profiles of the four corners are compared. The South-West corner (the green profile) is in a rearward position with respect to the others: its out-of-plumb measures around 10 cm at a height of about 3,5 m from the ground level.

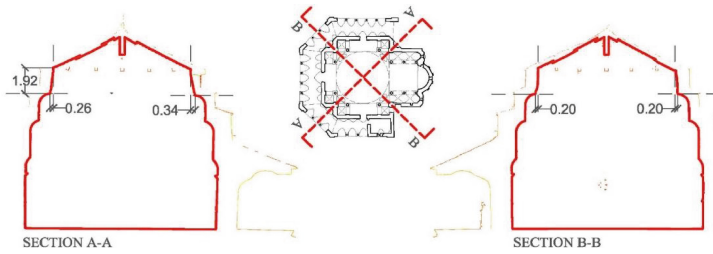
through which the transition from the octagon to the circle is not completely achieved: the circle at the top of the drum is finally obtained through the drum itself that shows a slant development next to the diagonal direction. Hence, as shown in Fig. 4, in order to reach the perfect circle, the drum fills the gap of about 20 cm and even more, by corbelling courses for about 1,9 m.

Fig. 4. Juxtaposition of the slices taken in the middle of the aisles

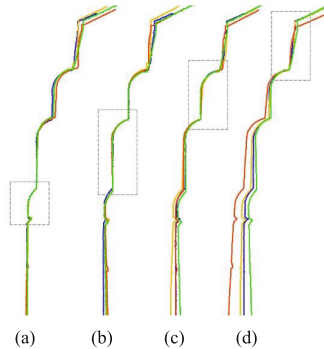
The drum irregularity is emphasised by juxtaposing the vertical profiles of the four main corners of the building. In fact, while the profiles corresponding to the pilaster strips, the pendentives and the couples of niches are similar to each other, the development of the drum results particularly lopsided (see Fig. 5).

Fig. 5. Different criteria to overlap of the corner slice profiles: overlapping of pendentives (a), lower niches (b), upper niches (c), drum (d). The only constructive element showing an irregular development is the drum.

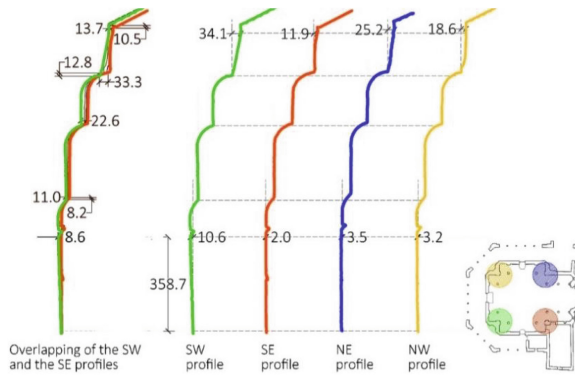
Fig. 6. Comparison among the profiles obtained from the diagonal sections

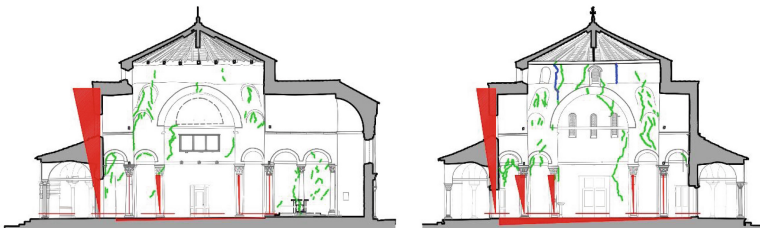
This significant out-of-plumb is coherent with the inside relevant cracking analyzed in [17]. In particular (see Fig. 7), the Northern elevation shows the highest out-of-plumb in the Western direction, while the Western elevation shows that the out-of-plumbs of the Southern wall and of the columns are coherent with the vertical cracks present on the upper part.

Fig. 7. Superposition of the crack pattern and the deformations detected through the point cloud survey: Northern (on the left) and Western (on the right) internal elevations

The crack pattern, together with the analysis of the deformed situation, suggests that the South-West corner is subject to a differential ground settlement. This assumption is further sustained by looking at the crack on the ground floor, dividing the South-West corner from the rest of the church and consistent with the displacements of the ground floor observed on the Western and Southern sides. Unfortunately, up to now it has not been possible to know the details about Santa Fosca foundation system, since only punctual excavations were made in the past.
