An Extensive Survey of the Historic Center of Cusco for Its Seismic Vulnerability Assessment

Abstract. This paper presents the main important typological data collected during an extensive survey carried out on the buildings of the historic center of Cusco, Peru. These data will represent the basis for a future analysis devoted to large scale seismic vulnerability assessment, to develop, in a structured and efficient manner, policies and measures for the seismic risk mitigation. Starting from the collection of available data and from the historical analysis of the urban development of the center, also accounting for earthquakes of the past, the most representative architectural typologies are identified. Moreover, statistical analyses are carried out, in order to detect the most recurrent structural details. On these bases, the main potential fragilities are identified, giving a preliminary idea of the structural behavior of the considered buildings under seismic forces.

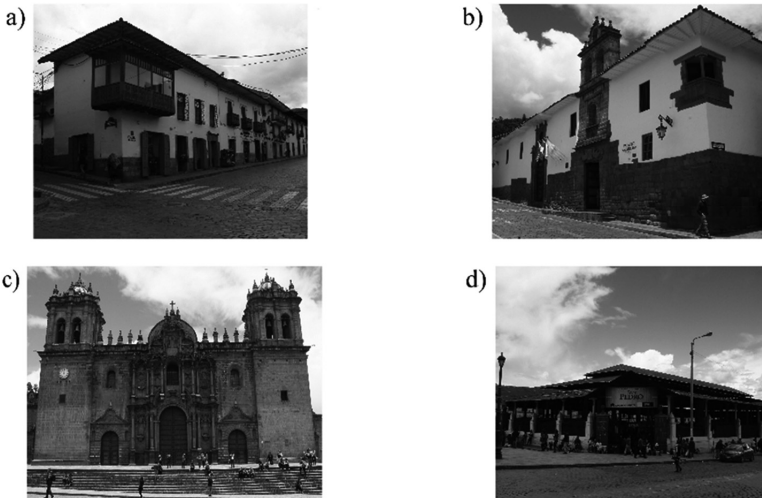
Fig. 1. Building Typology: (a) “Simple” – (b) “Important” (Nazarena Palace) – (c) “Monumental” (Cusco Cathedral) – (d) “Special” (San Pedro Market)

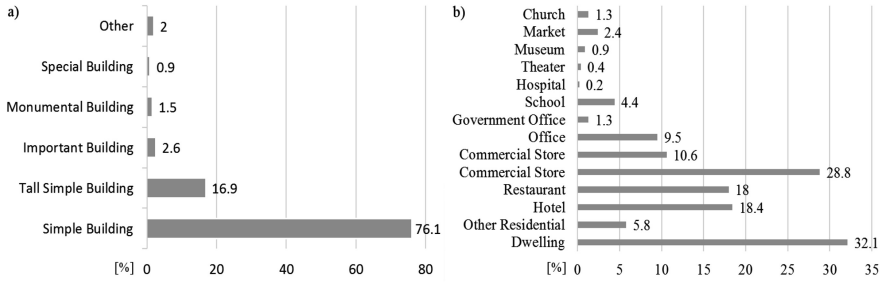
As can be seen from Fig. 2(a), the “Simple Building” typology is the most widespread. Considering an average inter-storey height equal to 3 [m], it can be deduced that the average height of the two-storey buildings, which represent the 74.6 [%] of the total surveyed, is 6 [m].

Most of the surveyed buildings presents a mixed use destination, commercial/services on the first floor and residential/hotel on the upper floors. Figure 2 (b) shows the results in terms of the intended use.

Fig. 2. (a) Buildings typology – (b) Use Destination
