Numerical Analysis of Settlement-Induced Damage to a Masonry Church Nave Wall

Abstract. Differential soil settlements can induce structural damage to heritage buildings, causing not only economic but also cultural value losses. In 1963, the Saint Jacob's church in Leuven was permanently closed to the public because of severe settlement-induced damage caused by insufficient bearing capacity of the foundation. Currently, the church is stabilized using a temporary shoring system. This work aims at implementing a practical modelling approach to predict damage on church nave walls subjected to differential settlements. For that purpose, a finite element model of the Saint Jacob's church nave was generated and validated through on-site monitoring data including levelling, damage survey and laser scanning. The model takes into account the non-linear behavior of the masonry by means of continuum smeared cracking. The paper introduces two approaches to model the settlement on the structure. One of them consists in the direct application of vertical displacements underneath the structure according to the deformation profile measured on-site. In the second approach, interfaces with different

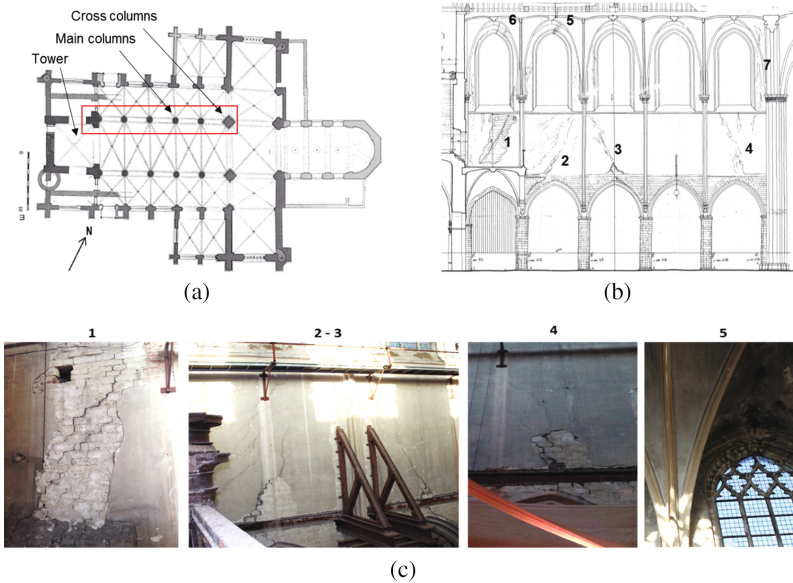
Fig. 2. Analyzed nave wall, plan view (a), crack pattern (b) and photographic survey (c). The numbering of the cracks on the crack pattern (b) corresponds to the pictures presented in (c)

The main structural problems of Saint Jacob’s church originated from a lack of load-bearing capacity of the foundation, which is built on compressible sandy clay soil. Investigations in pits, dug underneath different columns, allowed to identify the foundation system, which is composed of enlarged masonry pillars made of regular blocks of natural stone and lime mortar joints. The depth of the foundation pillars under the current floor level is about 2.9 and 3.7 m for the main and cross columns, respectively. In addition, decayed wooden elements were found underneath the pillars, placed 1.6 m below the water table. After a rigorous assessment, Schueremans et al. [1] concluded that the foundation system did not fulfill the required load-bearing capacity causing severe differential settlements. This system was not originally designed for the self-weight increase of the church over time. In addition, these settlements intensified as a consequence of the decayed wooden elements underneath the foundation pillars, which might have caused the pillars to be punched into the subsoil.

The wall that is analyzed in this paper is the severely cracked northern wall of the main nave (Fig. 2a). The damage pattern is shown in Fig. 2b, c. This crack pattern is mainly caused by the settlement of the nave columns. The vertical displacements of the cross columns as well as the tower are significantly smaller than those of the columns in the nave. As a result, diagonal cracking appears in the masonry wall above the arcade similarly to shear cracking in a simply supported beam, with supports on the cross columns and tower.

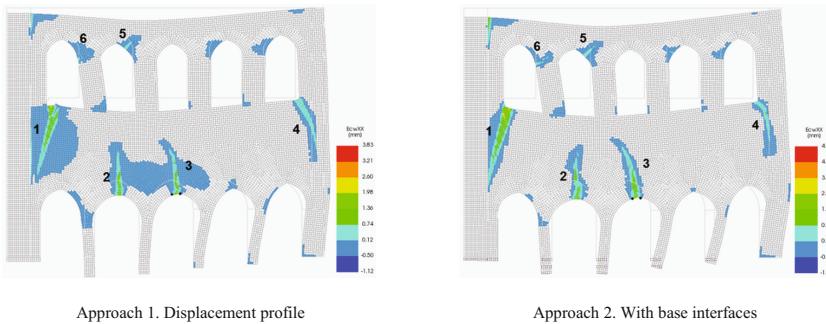
Figure 4 shows the results of the models in terms of the crack pattern at the final step of the numerical analysis. Both approaches match well throughout the entire analysis, suggesting the ability of both to accurately simulate settlement-induced cracking. They both captured the main cracks observed in the damage survey (cracks 1 to 5 in Fig. 2). However, the location of some of them is slightly shifted, for instance cracks 1 and 4 appear from the external corner of the windows rather than from the internal corner as shown in the damage survey.

Fig. 4. Final deformed mesh and crack pattern indicating crack width

Approach 1 shows a lower maximum vertical displacement at the top of the wall than approach 2, with values of 3.9 mm and 5.8 mm respectively. This occurs because in approach 2, the loading (self-weight and extra load) acts uniformly on the entire structure, in contrast to approach 1 in which the applied vertical displacement is localized only at the base. This phenomenon might cause local stress concentrations and additional minor cracks when using approach 1.

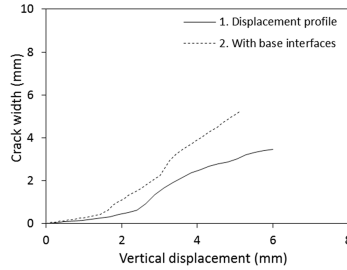
Figure 5 shows the width of crack 3, located on top of the middle arch, in terms of the maximum vertical displacement at the base of the second column, which presents the highest displacement. This crack width was calculated as the horizontal separation of the nodes indicated with black dots in Fig. 4. Even though approach 2 considers a very low normal stiffness at the base of the second column, the vertical displacement did not reach 6.0 mm but only 5.1 mm. The model still exhibits a larger crack width, up to 4.9 mm. Approach 1 induces a maximum crack width of 3.4 mm. Although the crack patterns present very good agreement with the on-site crack survey, the actual crack widths could not be validated as no crack width measurements were done and the initial deformations in 1994 (reference levelling measurement) are unknown.

Fig. 5. Width of crack 3 as a function of maximum vertical displacement at the column base

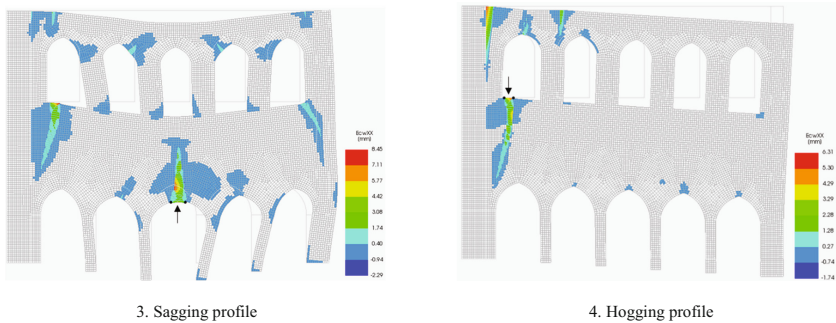
Figure 6 shows the deformed mesh and crack pattern for the sagging and hogging profiles when reaching the maximum applied vertical displacement of 6.0 mm. The sagging settlement profile causes the middle arch to open with a large crack in the middle top (4.1 mm wide) as a result. The hogging profile induces cracks on the left part of the nave wall, next to the stiffer masonry wall. It seems that the crack pattern acts as a hinge, where the right part rotates clockwise around the crack tip. The crack width obtained with this profile type is lower (the indicated crack is 2.3 mm wide).

Fig. 6. Deformed mesh and crack pattern indicating crack width for sagging and hogging

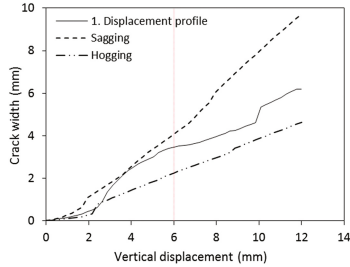
Figure 7 shows the width evolution of the marked cracks as a function of the maximum vertical displacement at the base for both profile types. It also shows the width of crack 3 obtained with the measured settlement profile (1. Displacement profile). Extra analysis steps were performed to proportionally apply the double settlement profiles at the base up to a maximum settlement of 12 mm. The most critical situation occurred with the sagging profile in which the crack width went up to 9.7 mm. In the hogging profile, the crack width reached 4.6 mm. The crack width for the measured profile remained in between throughout the analysis.

Fig. 7. Crack width as a function of the maximum vertical displacement at the base
