# Evaluation of Factors Influencing Slope Instability: Case Study of the R523 Road Between Thathe Vondo and Khalvha Area in South Africa

F. Sengani and T. Zvarivadza

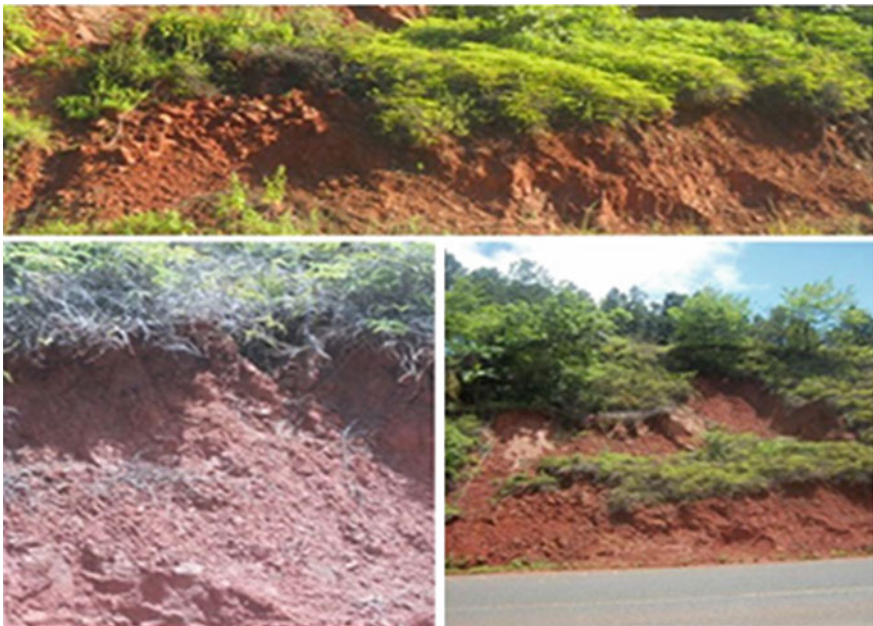
During field observation, the evidence of a previous slope failure was noticed (see Fig. 1) in the study area where slope failures are not active. There were also mitigation measures implemented after slope failure occurred. In this case, the gabion wall to prevent future slope instability was built. The gabion wall was noted to be effective where two-tiered steps were employed. It was found to be ineffective where less than two-tiered walls were employed. The ineffectiveness of the gabion was noted by through a slope failure that had been reactivated. As a result, the failure of the gabion was noted to have led to the road interruption due to soil slides which blocked the road.

**Fig. 1** Slope failure at R523 road

Based on the observation, in most of the areas where slope failure was more pronounced, several cracks were noted and a number of short streams were also noted. It was believed that the slope failure in the study areas was highly influenced by the presence of a large quantity of water flowing around the areas. It was also observed that most of the slope failure took place during the rainy season.
