INVESTIGATION ON THE NANJING GYPSUM MINE FLOODING

Guangya Wang

ACEI, Department of Geoscience, Nanjing University

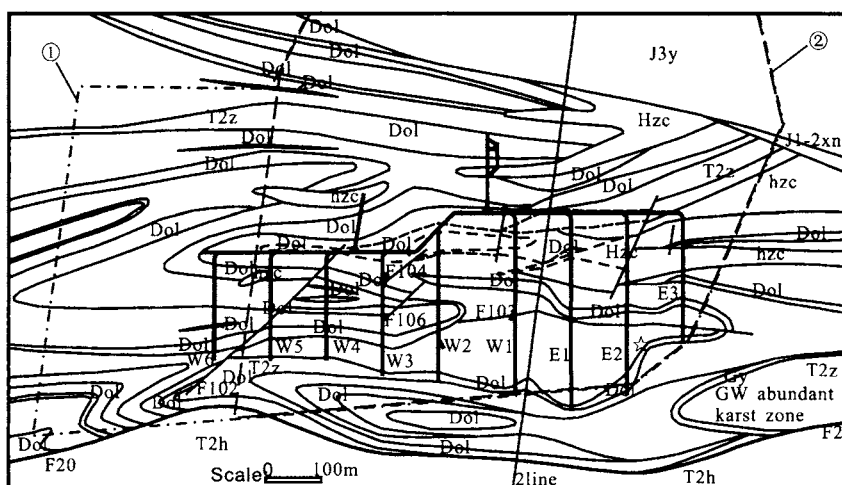
Figure 3. Horizontal section map of -344m deep in NGM area

There are some faults in the mine area. The strikes of the majority of the faults are either parallel or perpendicular to the axis of the syncline. The perpendicular faults located in the Jurassic basin are small with little influence to the orebody. But the parallel faults in the Zhouchong Group basin are large, deep and concealed, such as F16, F18 and F20 in Figure 3 and Figure 4. Table 2 is the characteristics of F16, F18 and F20.

The likelihood that F20 in the southern part of the mine might be connected with the water-bearing karst zones in the crown stratum was considered in the 1st phase design of NGM, so a 200m wide strip along the full length of the fault, 1300m, was designed as the safety pillar reserve (Zhu, 1994). But the mining room was just 100m away from the fault when the flooding was triggered. At the early stage of the inflow prior to the catastrophic flooding, the broken zone of F16 was activated due to mining disturbance and the seepage pressure was estimated as 400 kPa, the flooding disaster in NGM might have been avoided if the mining operation had been immediately stopped and measures had been taken to reinforce the roof and walls and to seal the seepage by underground grouting and construction of bulkheads. However, in the reality, the single measure of grouting had failed to stop the seepage, furthermore it might have adversely enlarged the hydraulic channels to the karst water bodies and worsened the flooding disaster, consequently the large mine was ruined at a moment.
