Relationship Between Geological Structure and Landslides Triggered by the 2007 Mid-Niigata Offshore Earthquake

Tamotsu Nozaki and Baator Has

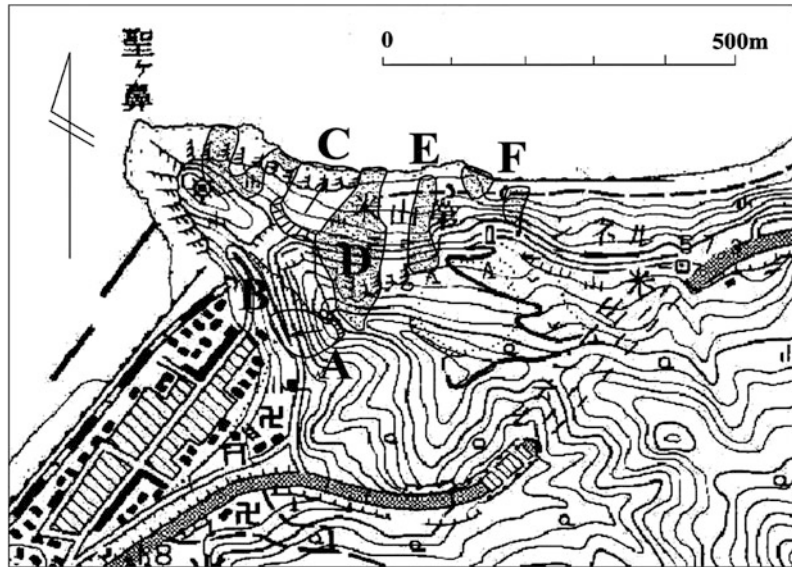
Fig. 14.2 Distribution of landslide units triggered by the earthquake

Fig. 14.2). These landslides blocked a local road at two places, and accidentally a car passing along was trapped between them (see Photo. 14.1), fortunately the driver and his car were safe. Geology of the study area is composed of sedimentary rocks simply dipping to the sea. An open anticline gently plunges to north, and the study area is just located on and around its axis. Due to the topography 'cuesta', both of translational and rotational slides occurred on the cataclinal and orthoclinal slope, respectively. It had been thought that mechanism of those landslides was not so complicated because of the simple homoclinal structure. During the excavation for the counter measure of those landslides, however, a vertical fault, which looked like a tectonic one, with some others including bedding faults were found behind the new slides. In this paper, we described the hazard of landslides, and discussed the mechanism of the new and old rockslides with the issue of non-tectonic geological structure.

Two units of the landslide A and B rotationally moved without clear boundary between them on the western side of the cape, where is rather steep orthoclinal slope. On the other hand, four units of landslides C, D, E, F and small others occurred on northern side, where is gentle and typical cataclinal slope (see Figs. 14.2, 14.3).

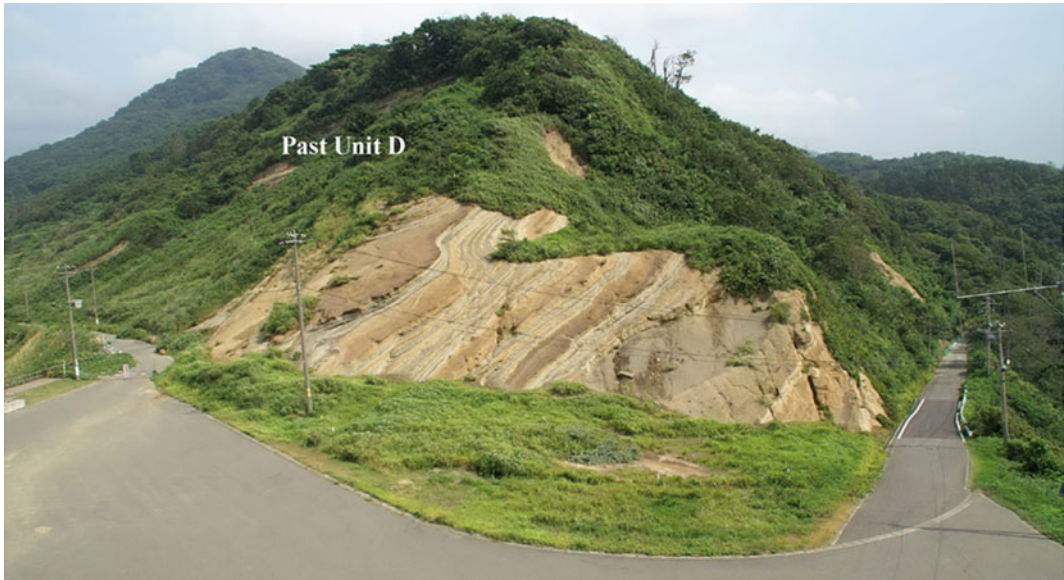
Photo. 14.1 View of the study area before the earthquake (Photograph taken on Aug. 10, 2005 by Atsuo Ueki, Kashiwazaki city education center)

scarp of Unit D was controlled by them. The almost entire slope including Unit C, D, E and F were located in a bigger old landslide area, and it is reasonably inferred that translational slides had been repeated on this slope in the past. In comparison between Photos 14.2, 14.1, we found that extents of Unit D and past Unit D were almost same. Therefore, it is inferred that Unit D must have occurred on the same slope of the past slide extending a little to the head area, and only 2–3 m thick veneer of alternating beds on the upper slope slid down to the beach as a new rockslide including a little old debris, because the volume of the debris was less than 10,000 m³.

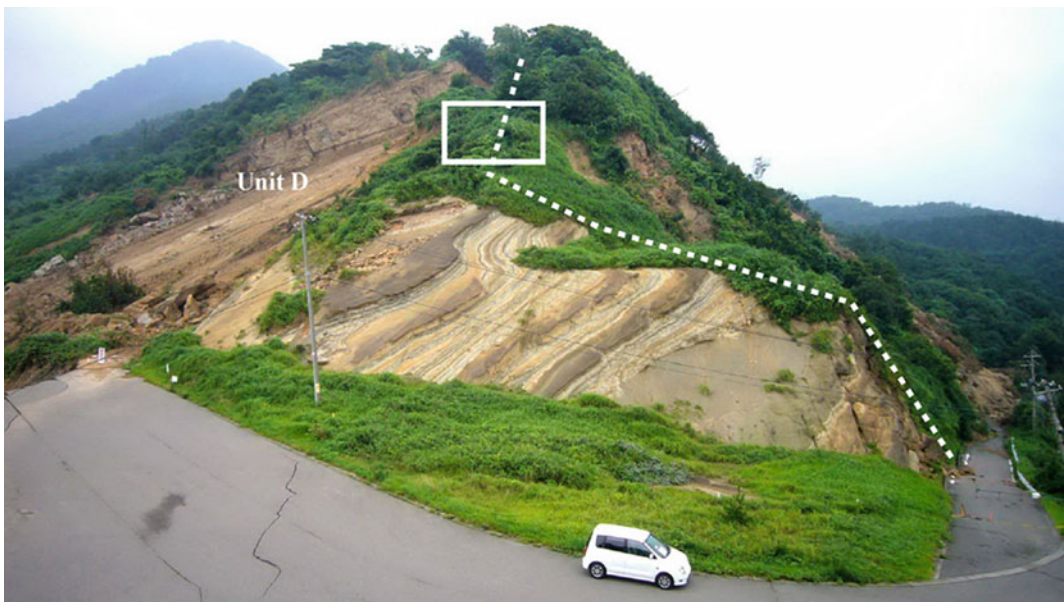
Photo. 14.2 View of the study area after the earthquake (Photograph taken on Aug. 4, 2007. Dotted line is trace of the fault observed at the *box*, location of Photo 14.3)

A fault tilted with high angle toward SW direction appeared during excavation work for one of the countermeasures at the northern part of the ridge between Unit A and B (see Photo 14.3). Although its precise direction of the separation and the throw was not known, it was evidently a normal dip separation fault. The right side of the fault in the photo was hanging wall; both sides of the wall looked intact. Incidentally, the upper central bushy part in Photo 14.2 was the cut slope in Photo 14.3. On its

extension line on the outcrop in the foreground of Photo 14.2, however, no such a fault was seen. It means that the fault did not extend there. Figure 14.6 shows the sketch of the outcrop observed from west (right hand side), where was right-end portion of this outcrop (see Fig. 14.3). Although this part was loosened a little, and some tiny failures and/or peeling off occurred in places by the tremor, some high-angle faults were observed as shown in Fig. 14.6. We had thought at first, therefore, this outcrop had been a part of the intact rock before the earthquake. However, it was clarified that only a central part of the rock was intact and surrounded by the displaced masses after our detail observation.

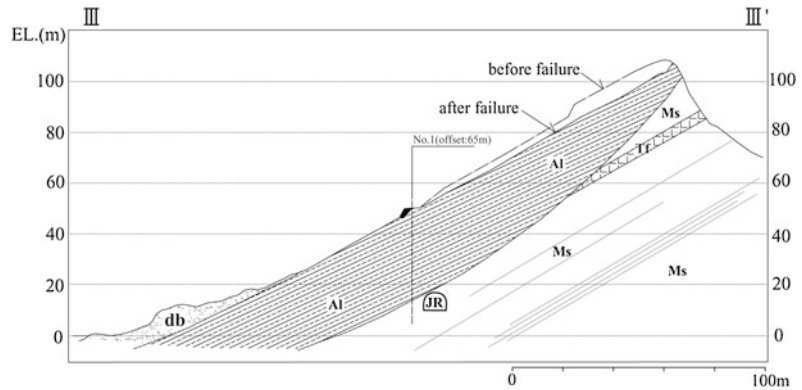
Fig. 14.4 Longitudinal section of Unit D

The most hazardous unit D, which pre-existed before the earthquake, extended mainly to the upper slope, and only thin strata must have been ripped off on the central to lower part of the unit (see Fig. 14.4), because a part of the road, which

had run across the central part of the unit, remained intact. The maximum width is about 100 m, the length is about 200 m, the head was a little more than 100 m above sea level, and the volume accumulated at the foot of the slope was evidently less than 10,000 m³. The upper end of the sliding surface reached beyond the ridge along a bedding-plane, hence no head-scarp remained. On the eastern side of the slide, however, “detached scarp” rose sheer more than 10 m, and the sequence of alternating beds of sandstone and siltstone was well-observed there. On the western side of the slide, 5–8 m high side-scarp was created, and a part of it toppled as rock-panels separated by high-angle joints trending NW. Almost entire sliding mass reached to the beach, and the sliding surface was widely exposed.

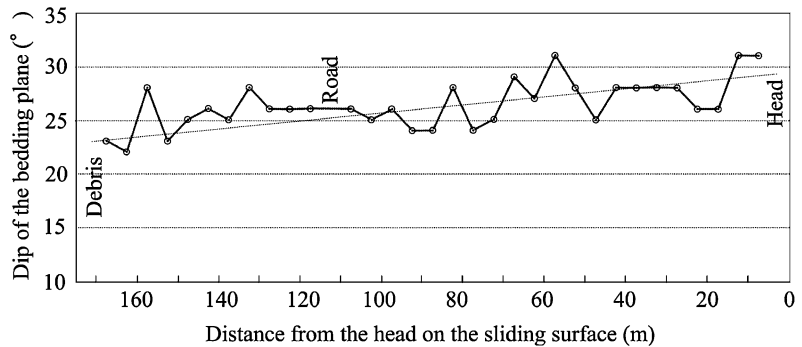
Fig. 14.5 Changing dip of strata along longitudinal section of Unit D

Figure 14.5 shows the changing dip of strata at intervals of every 5 m along the center line of Unit D. The attitude of the bedding plane was approximately EW25–30°N, and it became gentler little by little descending from the head to the

foot of the slide with undulation. As a result, the configuration of the sliding surface drew a very gentle arc as a whole due to this changing dip and the micro steps.

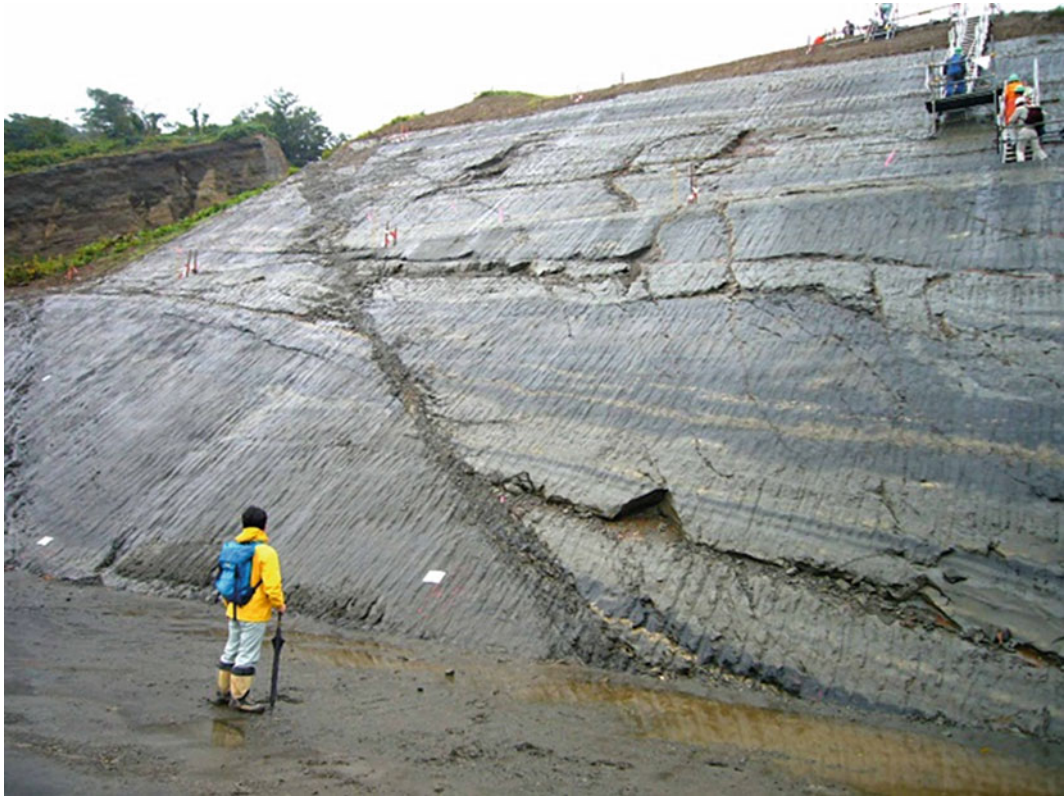
Photo. 14.3 Fault appeared on the cut-slope

It was not discernible during excavation whether the fault shown in Photo 14.3 was tectonic or non-tectonic, because both walls of the fault looked utterly intact. Beautiful alternating beds had widely cropped out around its northern extension line, and sliding surface and/or bedding plane had been widely bared stripping off the mass of Unit D on its southern extension line: no evidence of fault was there on both sides. It is impossible that tectonic fault dies out in such a short distance. On the other hand, throw of the normal fault found behind the head scarp of Unit A was about 10 m tilting with high angle toward west, and it became abruptly gentle and made an arc at the intersection with the bedding-plane-slip fault. In addition, the strata of hanging wall were apparently disintegrated or crushed at random in places, and thick crush zones along bedding-plane-slips were observed (see Fig. 14.8). Therefore, it was clear that this fault was a part of old sliding surface. Although its extension to north was not traceable because of covering of debris or soil, it must be the identical one described above. It reasonably

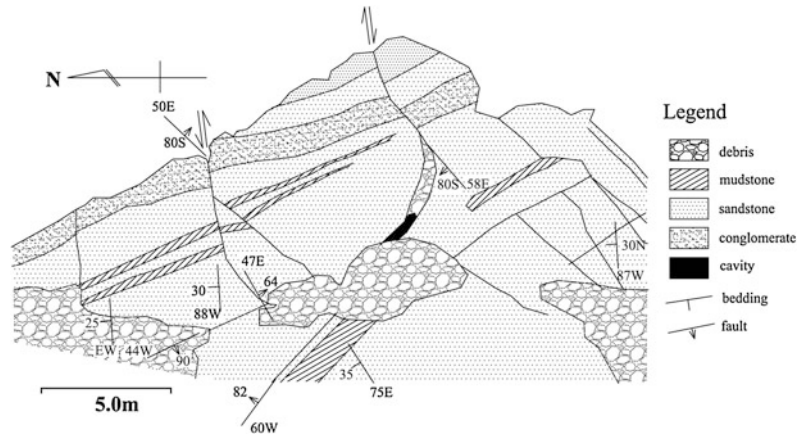
Fig. 14.6 Sketch of outcrop located on the western side slope

extends turning to west toward the natural outcrop shown in Fig. 14.6. It means that the whole structure was non-tectonic created by the old gravitational movement except for some bedding-slip faults.

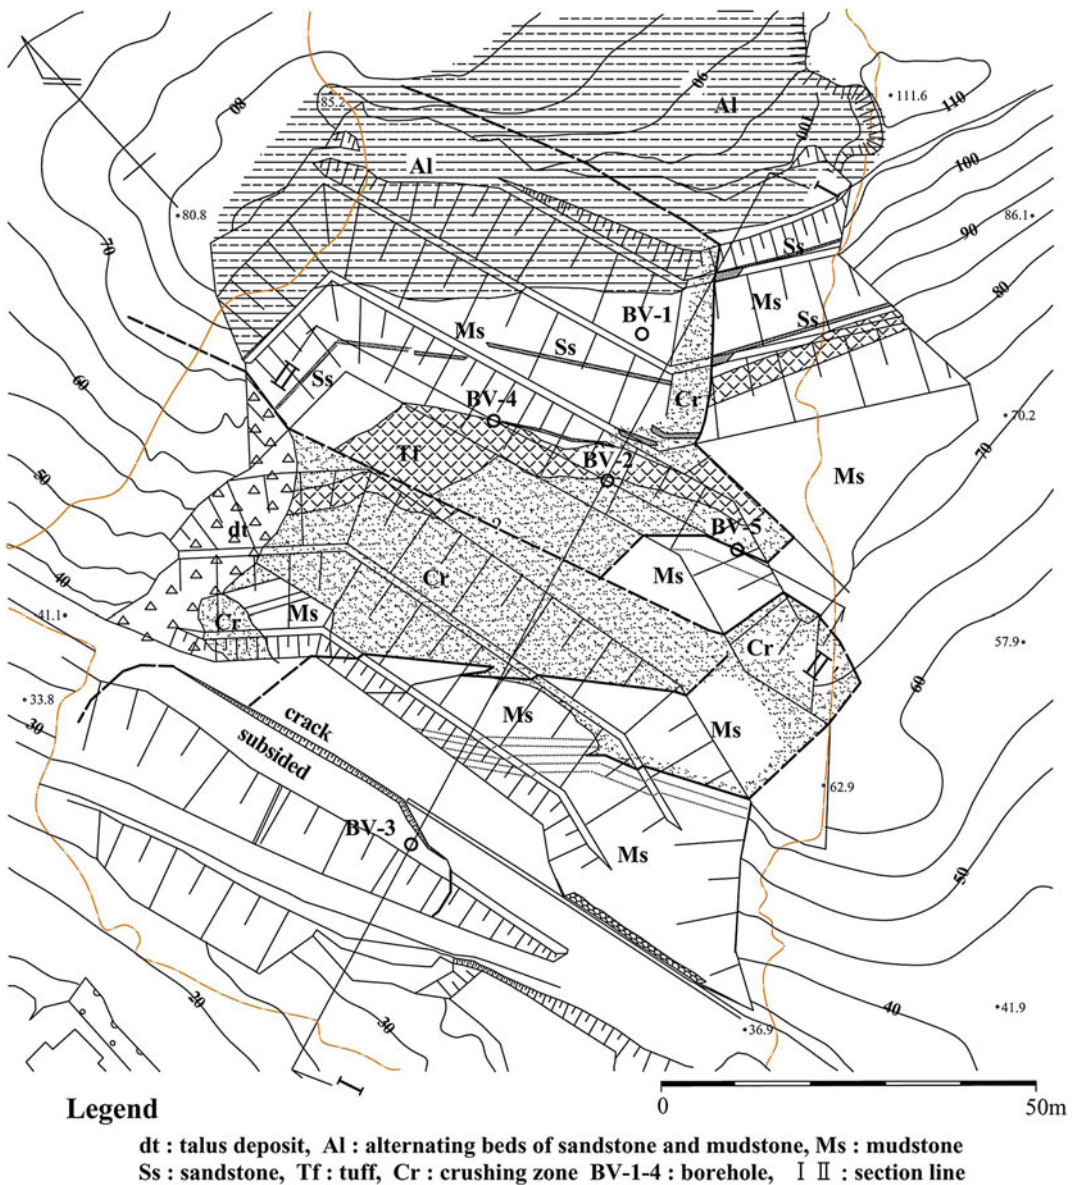
Fig. 14.7 Sketch map of cut-slope during excavation work of Unit A

Figure 14.7 is the sketch map of the cut-slope observed during the excavation work of the unstable debris, which was made for the stabilization of Unit A. Unfortunately, this sketch had not been schemed before the work, some parts of this map, therefore, were analyzed from the photos taken during the cut-work. We observed, however, all the cores drilled just after the earthquake at this site, and draw this map and geological sections (Fig. 14.8) with reference to those data. Although landslide debris moved by the earthquake had been completely excavated, a high angle fault dipping to west appeared at the head of the cut slope, and thick crush zones along bedding-planes and/or bedding-plane-slip faults also appeared at the middle and lower part of the slope, hence the original scheme had to be changed (Niigata Branch of the JLS 2008). As a

result, the excavated volume reached to $70,000 \text{ m}^3$, much larger than the original plan of $20,000 \text{ m}^3$.

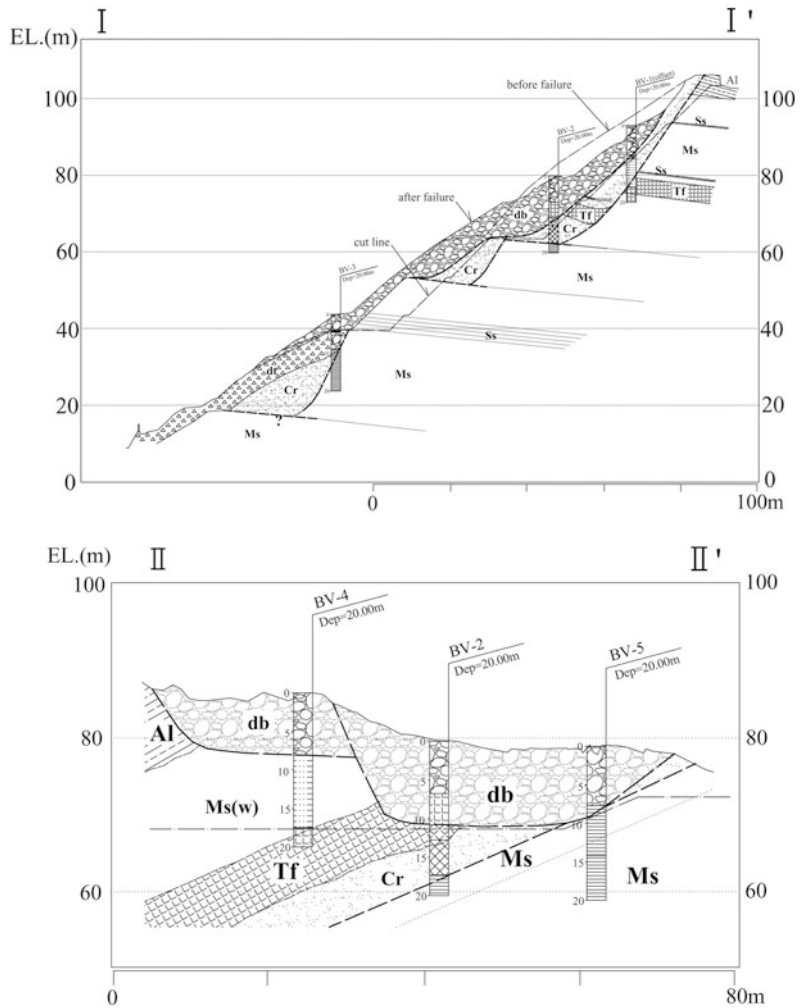
Fig. 14.8 Geological sections of Unit A

Although the head area of Unit A started to move west, that displacement was deflected from west to north at the lower part. This

movement is well-explained with the structure above-mentioned, that is, the head area displaced creating the head scarp along the non-tectonic fault or vertical joints, then the sliding mass was deflected along pre-existed bedding-plane-slip associated with crush zone at the lower slope. Mechanism of Unit B is unknown the detail, because the visible displacement was
