Chapter 9

The Severe Reactor Accidents of Three Mile Island, Chernobyl, and Fukushima

Abstract Three major severe accidents with core meltdown/core disruption occurred at Three Mile Island (USA) in 1979, Chernobyl (Ukraine) in 1986 and Fukushima (Japan) in 2011.

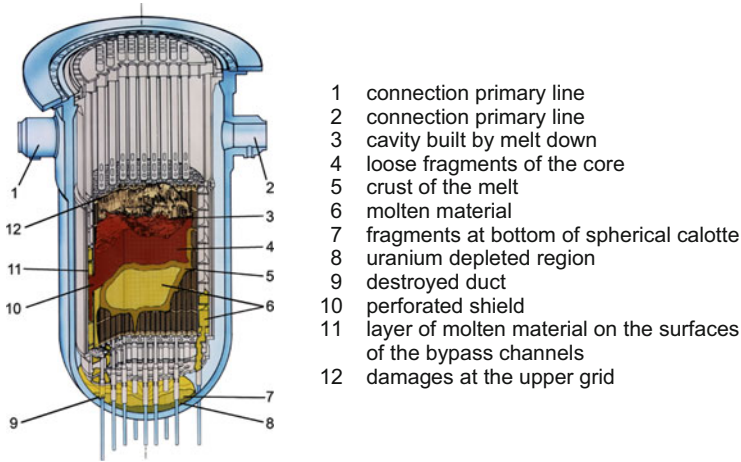
Analysis of the accident (Fig. 9.2) indicated that roughly one third of the zircaloy fuel rods had reacted with steam and produced hydrogen. When the water of the emergency cooling feed systems contacted the hot fuel rods, this resulted in fragmentation of the zircaloy fuel rod claddings and the UO₂ pellets. The silver-indium-cadmium control rods had molten almost completely. Nearly the entire

Fig. 9.2 Molten reactor core of the Three Mile Island accident [1, 2]

fission gas plena of the fuel rods had been destroyed, and gaseous fission products had been released. Parts of the reactor core had molten through at the edge of the grid plate and collected at the bottom of the reactor pressure vessel. However, the hemispherical bottom of the pressure vessel did not melt through.

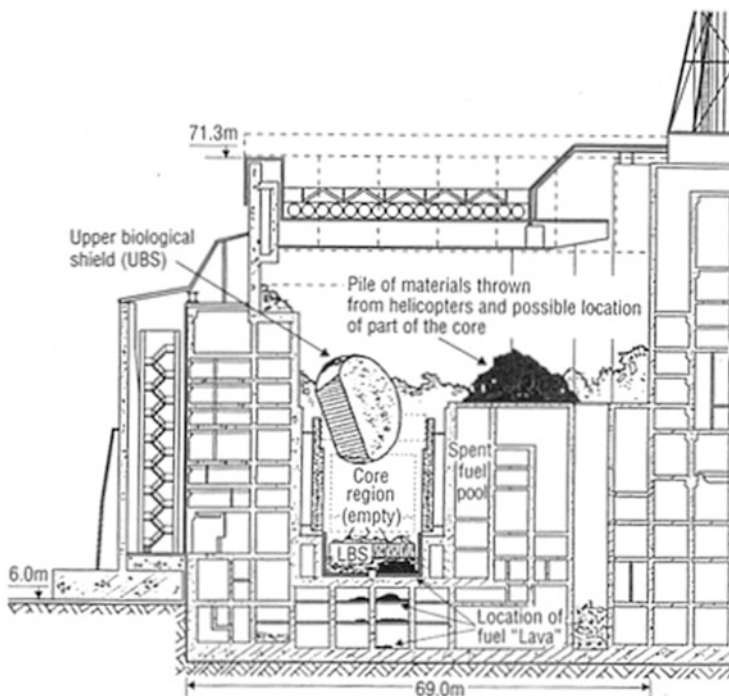
At this point in time the emergency shut down (SCRAM) bottom was pressed manually. All control rods started immediately to be fully inserted. The control rods moved with a speed of 0.4 m/s into the 7 m high core. The control rods contained a graphite section in their bottom parts followed by absorber sections with boron carbide. During insertion into the upper core neutron-absorbing water was displaced by non-neutron absorbing graphite. This led to an additional increase of the effective neutron multiplication factor k_{eff} . A steep power increase occurred causing the core to overheat. The fuel rods ruptured under the pressure of overheated fuel and fission product gases. The finely dispersed fuel abruptly mixed with the cooling water causing of steam explosion (Sect. 10.2.1). According to theoretical analysis the reactor power jumped to about 30,000 MW(th), ten times the normal operational output. The last reading on the control panel showed 33,000 MW(th). The steam generated caused the destruction of the steam boiler and of core structures and lifted the 2,000 tons top shield together with the refueling machine upwards. Fuel elements and red glowing (not burning) graphite parts were ejected from the core. The reactor building was heavily damaged [8]. A second explosion occurred some seconds later terminating the nuclear reaction and destroying the reactor core and building structures even more, dispersing damaged fuel elements and red glowing graphite parts. There are hypotheses that this second explosion was a second steam explosion or a hydrogen explosion (hydrogen generated from a chemical reaction between the zirconium fuel rod cladding [8]). As bitumen had been used for the construction of the reactor building floor and the turbine hall ejected material ignited fires. The remains of the overheated reactor core were now open to the atmosphere. The fission product gases as well as fission product aerosols and fuel aerosols released were driven by the heat release to an altitude of roughly 2,000 m, in some cases even 10,000 m. Strong winds at these altitude distributed the aerosols over the Ukraine, Belarus, western parts of Russia and Europe. The damaged RBMK1000 (unit 4 of the Chernobyl reactor plant) is shown by Fig. 9.4.

Fig. 9.4 The destroyed Chernobyl reactor after the accident [8]

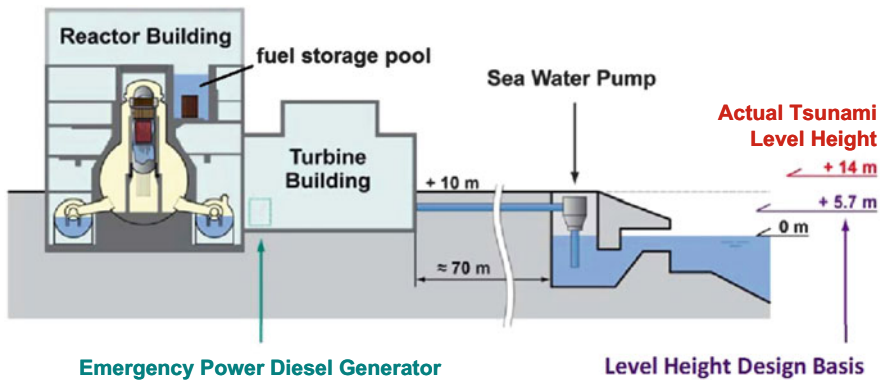
Roughly 1 h later, a tsunami wave hit the coast, flooding the Fukushima nuclear power plant up to a water level of 14 m. The earthquake was number four on the list of the severest earthquakes so far registered worldwide; its intensity had not been foreseen by Japanese seismologists when the reactor was designed [15]. Tsunami waves of much greater heights (up to 38 m) had impacted the Japanese coast in the past in the course of earthquakes of lower intensity (Richter scale) (Table 7.14, Sect. 7.4). However, the Fukushima-Daiichi nuclear power plant had been designed only against tsunami waves up to 5.7 m high (Fig. 9.8) [12].

Fig. 9.8 Fukushima-Daiichi reactor plant with countermeasures installed against tsunami waves [12, 13]

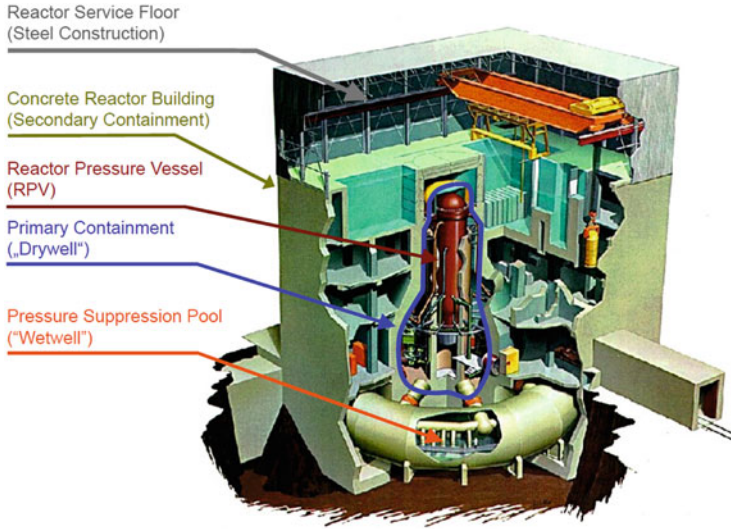
The seismic waves hitting the Fukushima-Daiichi nuclear power plant from the epicenter caused a horizontal acceleration of 507 cm/s^2 of the most highly loaded reactor of the three units (unit 1). This plant had been designed to 449 cm/s^2 . Nevertheless, the BWR was duly shut down. The reactor cooling system and the reactor core were not damaged. In units 2 and 3, horizontal acceleration had not exceeded the design basis levels (Fig. 9.9) [12, 13, 16, 18].

Fig. 9.9 Schematic design of the General Electric BWR-3 boiling water reactor of Fukushima-Daiichi [12, 13]

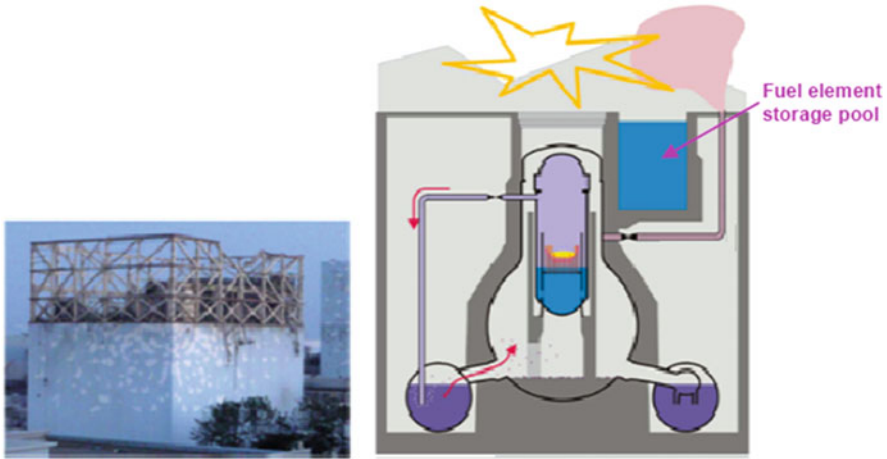
Cs-134, Cs-137, Sr-90 etc. were released into the pressure vessel and into the primary containment. The water in the primary containment with pressure suppression chamber heated up and its design pressure was soon exceeded (Fig. 9.9). Leakage paths within the primary containment vessel led to hydrogen release into the upper part of the reactor building (Fig. 9.10). About 1 day after the earthquake and the impact of the tsunami wave on unit 1 a hydrogen detonation occurred in the upper part of the reactor building. It destroyed the upper structures of the reactor building. Four technicians were injured [20, 21].

Fig. 9.10 Hydrogen explosions within the reactor auxiliary systems building destroyed the upper steel structure and the roof [12, 13]
