Concise History of Liberty Bridge in Budapest

Keywords: History of Liberty Bridge, Erection methods, Damages of bridges, Refurbishment of bridges.

Abstracts: The “Fővám tér” (1896), “Ferenc József” (1896-1946), “Szabadság” Liberty Bridge (1946-) was completed in 1896. The bridge was demolished by explosion during the Second World War (1944). On the site of the bridge a temporary bridge was used for a while and in 1946 the bridge was reconstructed. In 1979-80 the deck of the bridge has been replaced. The reconstruction of the main structure was started in 1985, which has been finished successfully in 1986 after several unexpected events. In 1998 some changes has been applied to the deck again, which was followed by a full reconstruction in 2009. Since that time the bridges being an ornament and jewel of Budapest, but also it is a symbol of the Hungarian Capital development to a metropolis.

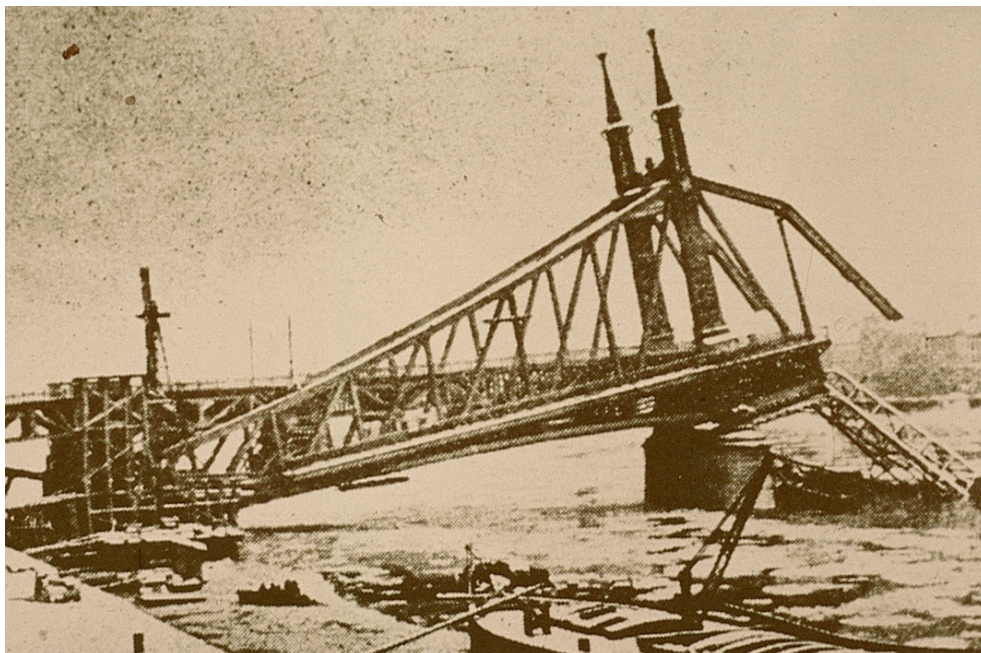
The simple supported mid-span and the cantilevers were **blown up in January 1945**. During the construction of a provisory bridge the Buda side span fell down, as the ballast weights at the side support were not removed. (Fig. 5)

Figure 5: Blown up the Bridge

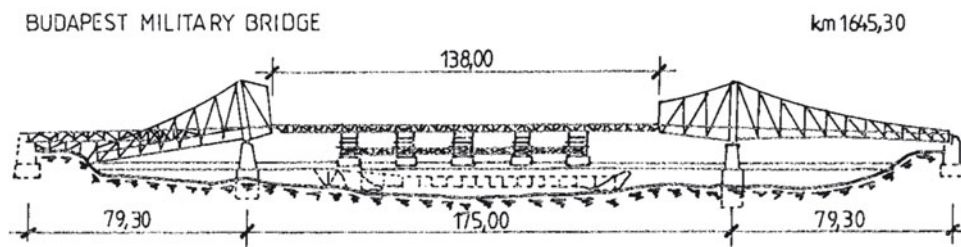
A **provisory bridge** was built in the mid-span on five barges and on the wrecks of the Buda span from March 15, 1945, but it was drifted by an ice-flow in January 10, 1946 (Fig. 6).
Fig. 6 Provisory bridge in January 1946

Figure 6: Provisory bridge in January 1946

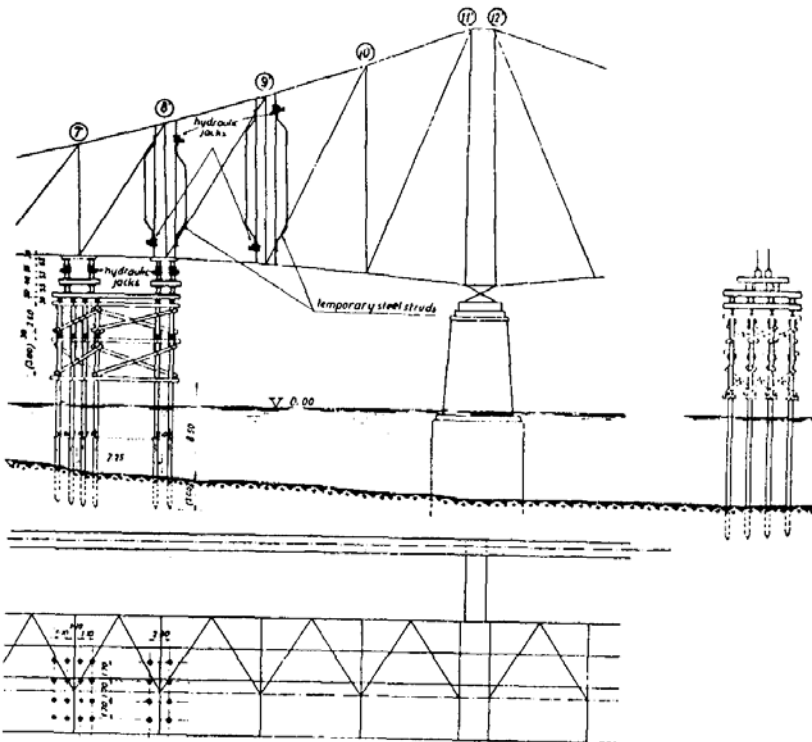
Figure 9: The stage for lifting

Buckling of the two struts the stresses in the chords computed by Hook's formula exceeded the ultimate tensile strength of 3600 dN/cm^2 of the steel material. Actual stresses, however, exceeded but slightly the yield point, because straining compensated and leveled the increase of the stresses. However, luckily the bridge did not collapse owing to the fact that the stiffness against bending was much greater in the chords than in the lattice work. In this way similarly to a continuous girder the chords transmitted the load over the damaged vertical columns to the other undamaged parts of the bridge. At the final reconstruction of the bridge it was impossible to insert columns which were shorter by 11.2 cm and 6.7 cm respectively because large bending stresses could have remained in the lattice work that in case of live load the structure would have failed due to these excessive stresses. The chords which were bent had to be move apart first. This could be done in two ways:

The stage needed for lifting was built on 24 wooden piles driven in the river bed at the joints of the main girder marked 7 and 8. (Fig. 9) Beside each buckled strut two temporary steel columns were placed for pressing the chords asunder. On one end of these temporary columns hydraulic jacks were inserted.

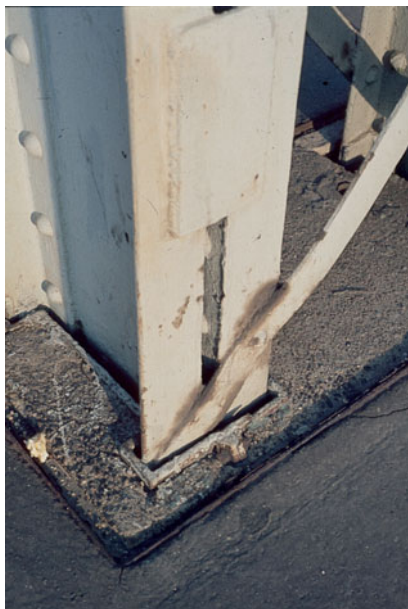
The next step of rehabilitation became necessary in 1985, when the replacement of the side walks and the repair of main elements were performed. [Iványi, M. 1998] There were some corrosion of different parts of the bridge.(Fig. 11).

Figure 11: Original states of the pavements

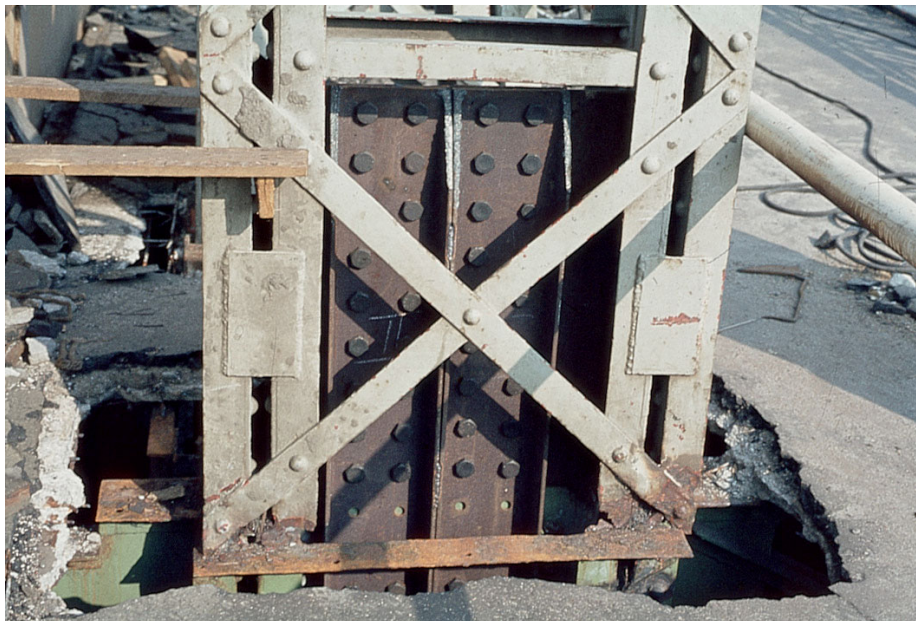
During this process, because of very heavy corrosion damages of some members of the main girder, a local collapse developed in a column of the main truss. After it the corroded parts of the main trusses were strengthened. (Fig. 12)

Figure 12: Temporary strengthening of the collapsed member

Vertical and diagonal members of the main trusses are led through the slab of the side walks, practically without any gap, which is the “result” of a previous repair. Dust and salted sand, were thrown in winter time, caused very heavy corrosion. Cross section reduction of the diagonals was around 10%, while that of verticals exceeded 40% in some cases.

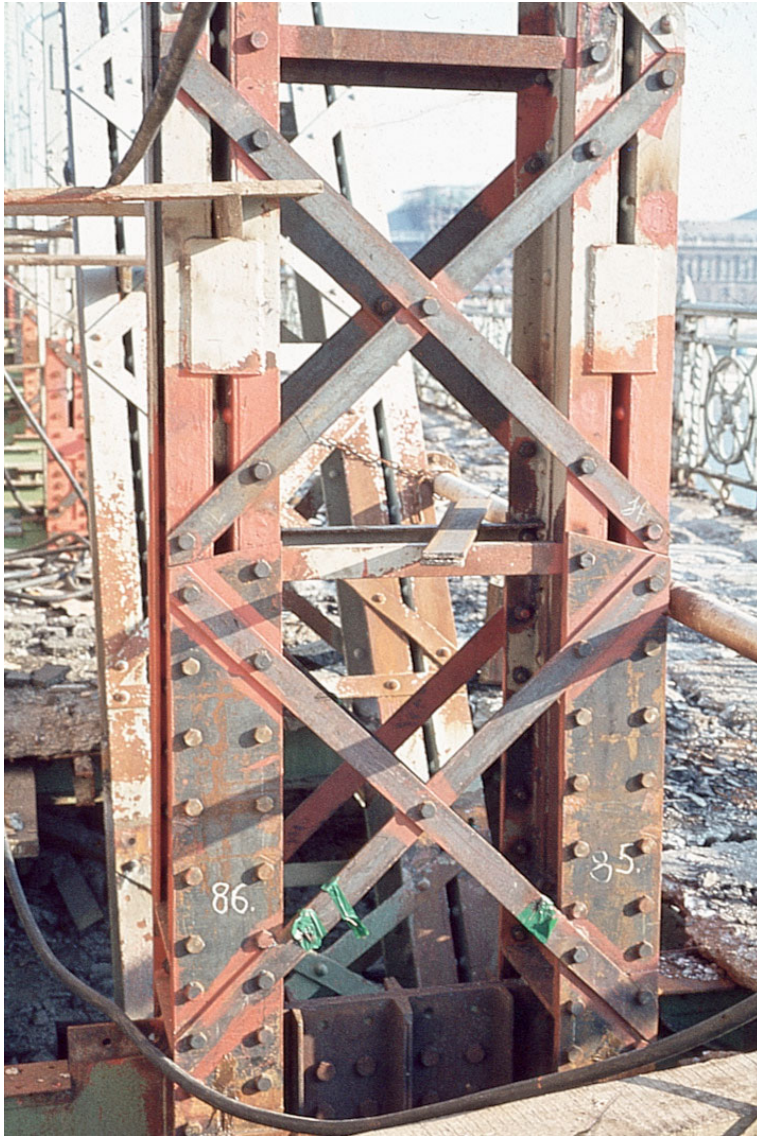
Figure 13: Reconstructed of the member

During the rehabilitation process, the one of the mostly damaged columns in its complete cross section broke and moved 15 mm downward and 35 mm sideways. The traffic was closed immediately; provisional fixing elements were built in by HSFG bolts. (Fig. 13)

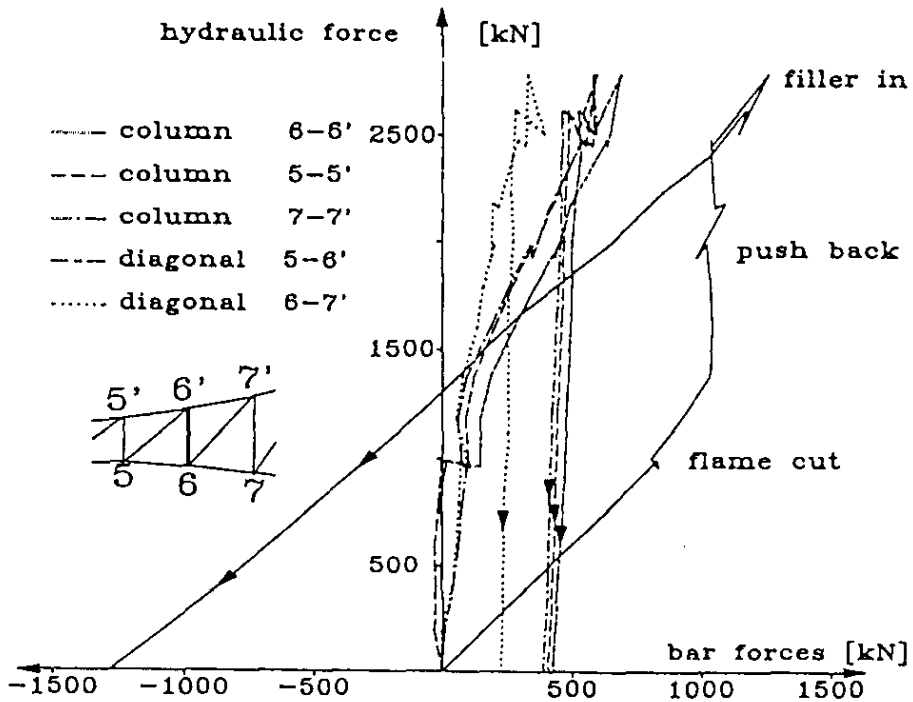
The reconstruction (1985-1986) started with the determination of the remaining force in the damaged member. Applying the trepanation method, strain gages were bonded to the elements of the column. Drilling pairs of hole near the ends of strain gages, the remaining stresses could be measured and the total force was calculated. The active force in the column was found as 871 kN instead of 1930 kN, calculated from the dead loads.

Figure 14: Bar forces vs. hydraulic lifting force during the repair process

The renovation of the broken bar was carried out in the following steps (Fig. 14).

(a) At 20 kN hoisting force the provisional fixing elements were removed.

(b) The force was slowly increased until the compression force in the broken bar decreased to zero. This in fact happened at 1000 kN, because the raising force was partially taken by the neighboring parts. At this point, the column was fully flame cut at the plane of the damage. No significant effect of the cutting process was observed at any of the measuring points.

(c) The force was increased further, up to 2000 kN. Here, the horizontally shifted bar end of the upper part was forced back to its proper place by two 50 kN jacks.

(d) Increasing the force up to 2500 kN, the position of the broken bar ends were temporarily fixed. The damaged sections were removed and the two opposite butt ends were cut plane.

At a force of 2800 kN, the gap between the butt ends opened wide enough for a prefabricated element of 200 mm height to be put into it. Now decreasing the hoisting force back to 2500 kN, four new cover plates were welded to the flanges, then connected by precision bolts to ‘the angles.’ The bar ends were also welded to the fitted in order to ensure the continuity of material and a more favorable transmission of force.

(e) The repair was finished by unloading the hydraulic system, i.e., by transmitting the force from the trimming structure to the repaired column. While unloading, the transfer of the load to bar No. 6-6’ was found to be linear. The reduction of the lifting force from 2610 kN to zero resulted in a measured compression force of 2548 kN in the upper part of the bar, and, in 2816 kN, in the lower.
