# Three Decades after Chernobyl: Technical or Human Causes?

Nikolaus Muellner<sup>1</sup>

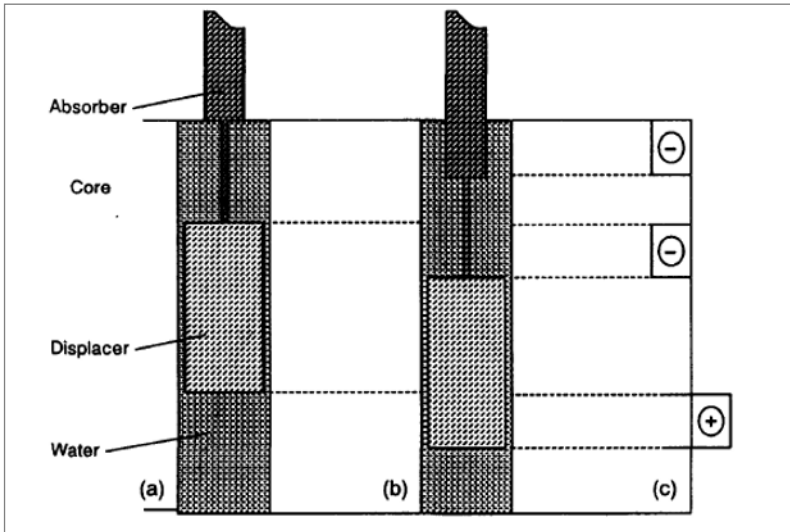
According to Shteynberg (1991), as well as by Abagyan et al. (1991), the design of the control rods triggered the accident. The RBMK reactor core is large compared to other cores, therefore a large number of control rods are necessary to ensure an even power distribution. The so called “operational reactivity margin” (ORM) is a very important operational parameter for RBMK reactors which played a key role in the accident. Roughly speaking it specifies for the RBMK reactor how many control rods are fully extracted at a certain point in time. More precisely, the ORM reports the “equivalent” withdrawn control rods, which means that two control rods withdrawn to 50% count as one. Furthermore not all control rods are equally effective, and furthermore effectiveness of a rod is not equal over the whole size. The algorithm for calculating the ORM takes those effects into account. According to the operating instructions, there is a minimum value for the ORM value, which must not be exceeded. There must always be 26–30 equivalent control rods withdrawn. The main engineer may permit operation also down to an ORM value of 15 equivalent control rods. Operation below this value is not permitted.

But the ORM value has a critical influence on the safe shutdown of the reactor. Due to the design of the control rods, the efficiency of the reactor SCRAM (the emergency shutdown) system was linked to the ORM value. When the reactor emergency shutdown was triggered at an ORM value of 30 and more, negative reactivity could very quickly be introduced to reduce the power; at an ORM value of 15 it took six seconds to introduce the relatively small value of 1\$ of negative reactivity; and at an ORM value of 7 the introduced reactivity was positive over 8 seconds (which means the reactor power increases further for eight seconds when the operator hits the emergency shutdown button). Only after that the power would decrease (Shteynberg 1991). The design of the control rod is the reason for this effect: to ensure better performance during normal operation when the control rods are fully withdrawn, displacement bodies made of graphite were fitted with telescope rods at the lower end of the control rods. This means that during normal operation the middle of the core region (approximately 7m) was filled with a graphite displacer of 5m (see Figure 5). Above and below the displacer in the reactor core was a 1 m water column. When a fully withdrawn control rod was inserted, the graphite displacer had to pass through 1m of water in the lower core region. However at this position the water acts as a neutron absorber, the graphite body acts as a moderator, which means that positive reactivity is introduced into the lower region of the reactor (power is increased). In the upper part of the reactor core, negative reactivity is inserted because the absorber material is introduced into the core (see Figure 5). If the rods are already one meter inserted, the graphite displacer will be at the bottom of the core, and no positive reactivity will be introduced. This is the reason why a minimum ORM value is enhancing safety – it means, that a certain number of rods are already inserted into the core.

**Fig. 5** Design of the control rods of the reactor protection system (Abagyan et al. 1991) (a) rod completely withdrawn with graphite displacer (b) situation while inserting the rod introducing positive reactivity over several seconds in the lower part of the core.
