## Chapter 17

# Learning on the Safety Issues of Reconstructed Houses from the 2004 Great Indian Ocean Earthquake and Tsunami in Aceh, Indonesia

Kenji Okazaki, Krishna S. Pribadi, and Dyah Kusumastuti

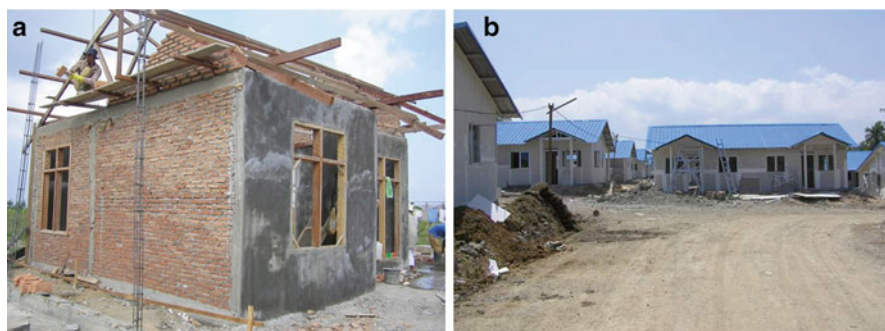
**Fig. 17.1** (a) Type 36 houses under construction by BRR. (b) Houses with imported materials

The design of structures for housing and schools generally follow typical design structures. Most school buildings surveyed showed that one- or two-story buildings were commonly used for school buildings, and the two-story buildings were often engineered buildings while most of the one-story buildings were categorized as non-engineered buildings. The houses were mostly what is called type 36 houses, meaning total floor area is 36 m<sup>2</sup>, most of them can be categorized as non-engineered, one story buildings. Type 36 houses were endorsed by the government as replacement houses for the victims. Most buildings were made of burnt brick walls with reinforced concrete columns and beams. Roofs were constructed with wood trusses and galvanized iron sheets or roof tiles. Because these materials are commonly used for buildings in Indonesia, these buildings conformed with the local culture. Figure 17.1a shows a typical example of this type constructed by BRR. However, some projects used imported materials and technology, which resulted in questionable maintenance and sustainability (Fig. 17.1b).

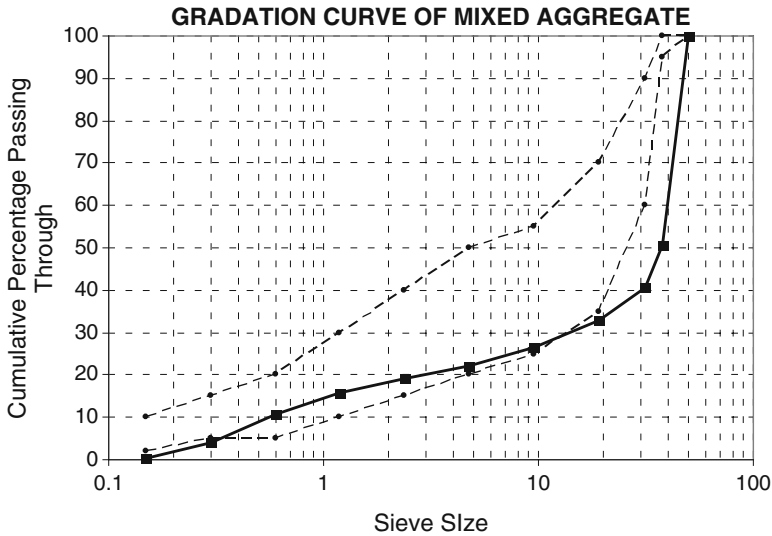
**Fig. 17.3** Gradation curve of mixed aggregate of three samples (The two *dashed lines* show the range of ASTM C33-90)

The concrete mixture was a serious problem for reconstruction of houses. The materials used for the mixture were adequate in most cases. However, almost no projects used the proper composition for the concrete mixture (volume ratio of 1 cement: 2 sand: 3 gravel). The most common mixture is cement and sand-gravel (sand with some gravel) with composition of 1 bag of cement for 3 carts of sand-gravel (about 1:5.25 in volume ratio). No sieving process was done to comply with the standard material gradation used for concrete mixture and no effort was made to avoid large aggregates getting into the mixture, which lead to a mixture having a very poor gradation with a high percentage of coarse aggregates. The laboratory tests conducted clearly illustrated this fact, as seen in Fig. 17.3.

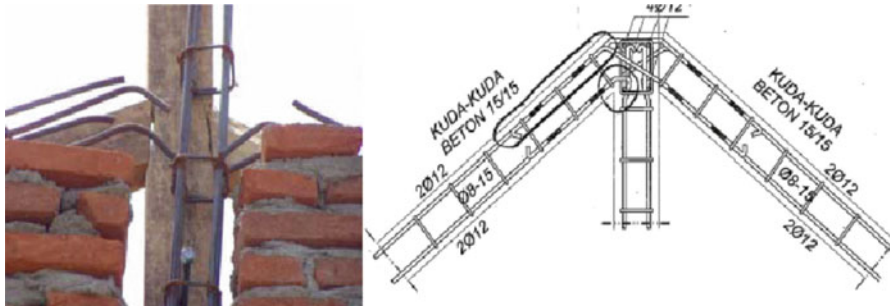
emphasized by the large number of columns and the substantial dimension of structural elements. It should be noted that there was another big problem of the quality of construction. The field observations found that not a few of the materials used were different from the specifications and requirements of the drawings.

**Fig. 17.4** Construction does not follow the drawing

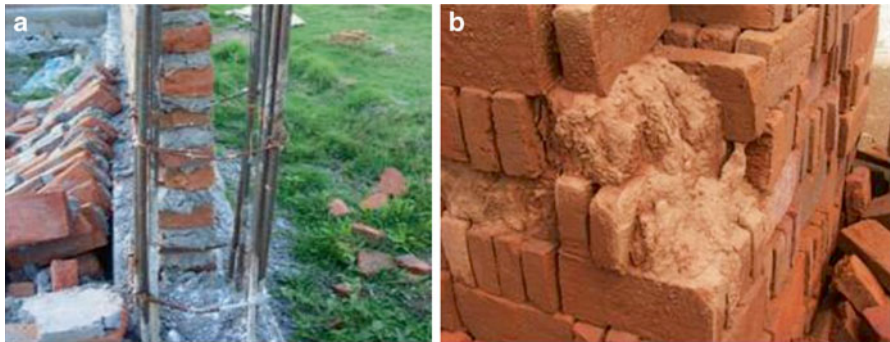
**Fig. 17.5** (a) Wide spaced hoops. (b) Melting bricks

longitudinal plain rebars and diameter 4 mm for hoops. The Indonesian seismic code (Badan Standardisasi Nasional 2004a) specifies the following minimum diameters for materials to be used in earthquake resistant buildings: 12 mm deformed bars for column longitudinal reinforcements, 10 mm deformed bars for beam longitudinal reinforcements, and 8 mm plain bars for hoops. Most of the reinforcements found in the field survey violated the building codes (Badan Standardisasi Nasional 2004b). Even worse, detailing of reinforcement such as bending work did not satisfy seismic demands for safety. Figure 17.4 shows the contrast between the drawing (the intended design) and the actual situation, a difference that was quite common in the area. The spacing of the hoops also posed a problem, with spaces averaging 200–250 mm, in contrast to the code’s requirement of minimum spacing of 150 mm or less (see Fig. 17.5a). The quality of bricks used in the area was very low. The lowest class of bricks in the Indonesian code is Class III, which requires strength of minimum 25 kg/cm<sup>2</sup>. Most bricks fell below the minimum strength and even “melt” when soaked with water (Fig. 17.5b).

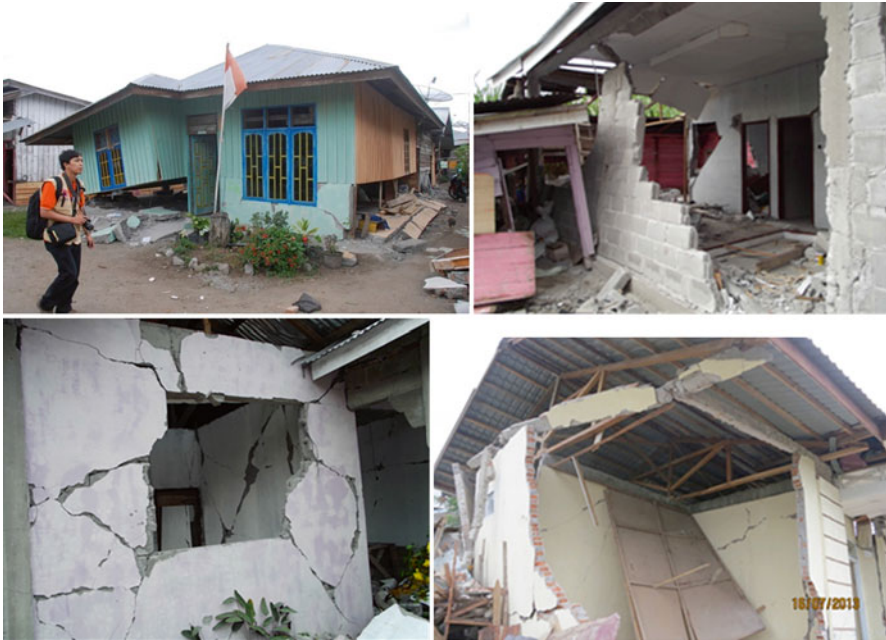
**Fig. 17.8** Typical damaged houses (mixed masonry and timber house, cement brick material, diagonal cracks, collapse of adjoining walls)

Damages in mixed brick-timber structure mostly are due to the absence of good foundation supporting the lower part masonry wall as well as the failure of the lower part masonry wall. The damages of unconfined masonry are particularly due to out of plane loading to the masonry walls although damages to walls due to in-plane loading were observed in many cases, with typical diagonal cracking of the walls. Damages in confined masonry are due to the failure of the concrete frames, mainly in the column and beam joints due to the bad connection of the main reinforcement bars as well as shear failure of the column due to lack of stirrups. The failure of the gable walls due to the out of plane loading are often observed in many unconfined and confined structures, due to inadequate framing (Fig. 17.8). Damages in in-filled

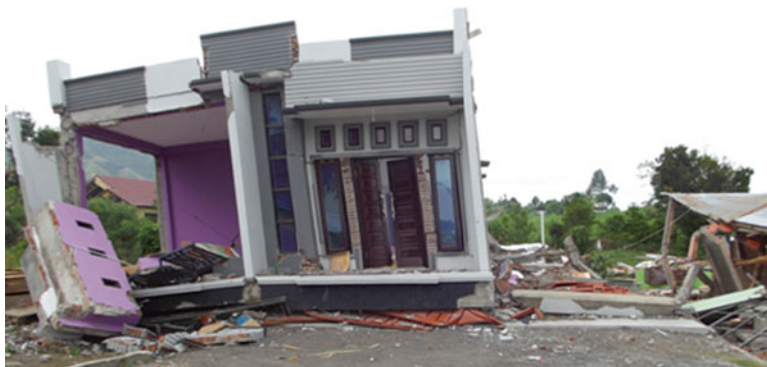
**Fig. 17.9** Soft story failure of two storied house

RC buildings (mostly two stories) are due to the failure of the RC frames, as well as the weakness of the lower story (soft story effect), where the weak first story absorbs most of the lateral forces transferred by the more rigid upper story (Fig. 17.9).

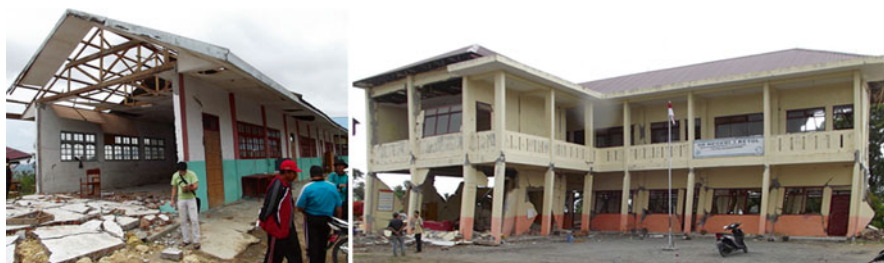
**Fig. 17.10** Damaged school buildings

Damages due to short column effect are also observed in many buildings. Some building failures due to ground failure (landslide) are particularly observed in the first earthquake site, as the site is particularly hilly and many houses were built on steep slope. Typical school building damages are also observed (Fig. 17.10).
