# Chapter 12

## Some Socio-Economically Significant Landslides in Uttarakhand Himalaya: Events, Consequences and Lessons Learnt

Surya Parkash

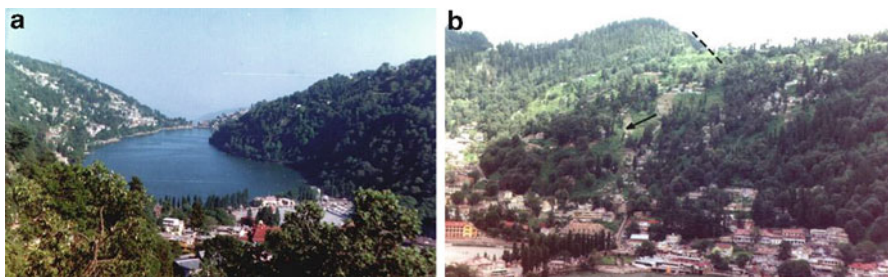
On Saturday 18 September 1880, a landslide took place at the north end of the town (Fig. 12.2a, b), following heavy rainfall for 3–4 days and an earth tremor, burying 151 people. A large number of buildings were swept away in a matter of a few minutes and the landslide debris covered the slopes as well as filled a part of the lake. In fact, the flat area at the toe of the slope represents the filled up portion of the lake. Two days preceding the slip there was heavy rain, 20–25 in. fell during the 40 h ending on Saturday morning, and the downpour still lasted and continued for

The presence of a longitudinal fissure, at the top of the Sher-Ka-Danda ridge, running almost over the full length of this ridge is considered to be a tensional opening due to the slow gliding of the entire slope along deep seated cleavage planes or shear zones dipping towards the lake. The presence of highly puckered fissile and weathered slate, in the slope areas, indicates gradual movement of the slope towards the lake. The debris covered areas and the slope steeper than  $30^\circ$  commonly show the presence of tilted trees. The exploratory studies carried out near the base of the slope reveal the presence of thick fluvio-glacial upper material, lake sediments and landslide debris. It also shows that there is no toe support of bedrock even at a depth of more than 60 m for this slope,

**Fig. 12.2** (a) A view Nainital Lake with toe slopes at Sher-ka-Danda hill. (b) A view of Sher-ka-Danda hillslopes

hours after the slip. To prevent further disasters, storm water drains were constructed and building bye-laws were made stricter.

Later during 1980s when a ropeway was constructed at this location, slope stability has been improved by adding to the shearing resistance of the rock mass at the incipient plane of sliding. This can be accomplished either by (a) grouting the rock mass chiefly to improve the overall shear strength or (b) providing rock bolts/anchors chiefly to add to the effective normal pressure on the potential plane of sliding. Grouting is expected to improve both  $c'$  (effective cohesion) and  $\phi'$  (effective angle of internal friction) values but inhibit natural drainage. Rock anchoring is expected to improve effective normal stress values particularly in the zone of sliding.

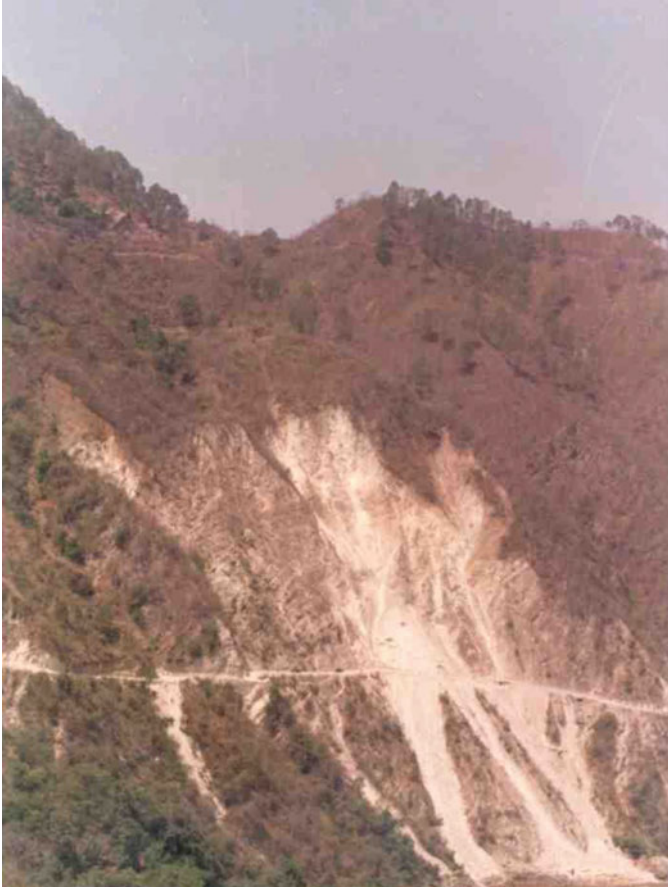
The Kaliasaur Landslide (Fig. 12.3) is the chronic, complex, most persistent and regularly occurring landslide. It disrupts the entire life-line on the most important national highway leading to Badrinath and Kedarnath. It was reported first time in 1920, then in 1952, 1963, 1964, 1965 and a major landslide in 1969, 1970, 1971, 1972, 1985, 1987, 2011, and recently in 2013 after Uttarakhand flashfloods.

The landslide on the 19 September 1969 had blocked nearly three-fourths of the river, about 100 m below the road level. A 300 m stretch of the road was dislocated both vertically and laterally by about 2.5–3.0 m, and damage to the road structure was indeed severe. The slide was reported to have remained active for 4 days at a stretch. During 1970, 1971 and 1972, moderate to heavy landslide activity was witnessed. In the process, the communication system was disrupted, and each time there was a new formation a width for road had to be cut. During September 1984, following heavy rainfall, the landslide became violent and damaged the road

**Fig. 12.3** A panoramic view of Kaliasaur Landslide

The remedial measures included grading of the slope, uphill of the road, sealing of tension cracks and fissures on the slope surface, timber piling to stitch the colluvium on the slope, construction of an anchored drum diaphragm retaining wall along the road to support the slide mass overlooking the road. Construction of an anchored stone masonry wall towards the other side of the road to check the under cutting of the road due to palaeo-channels, vegetative turfing of the slope and construction of a toe wall in masonry at the junction of the slope down hill of the road and the river. This wall was designed to withstand the scour of the river.

Driving of timber piles made the loose and shallow granular slide prone carpet on the slope dense and provided the ‘stitching action’. Timber piles 10 cm<sup>2</sup> from Deodar, Sheesham and Eucalyptus wood were driven in lengths of 1.5 m each suitably spliced. For a multi-tier slide like the Kaliasaur, the vegetation by itself will not be meaningful unless used in conjunction with other remedial measures.

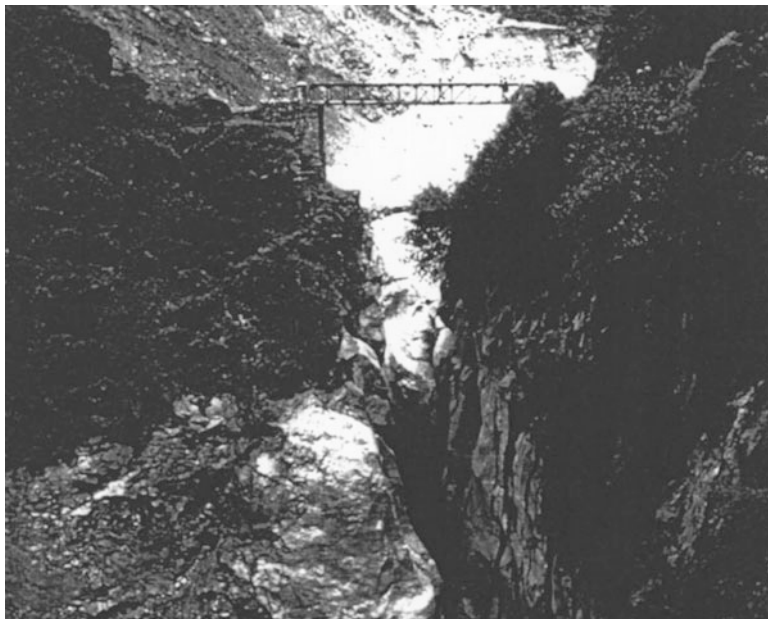
The cloudburst prompted river Patalganga to move a huge pile of debris discharged by river Patalganga drove river Alaknanda to its right bank, choking it badly. Soon Patalganga itself got blocked at its constriction. Thereafter, the water level began to rise rapidly. The shifting of Alaknanda to its right bank created a situation identical to the one usually found in the middle of a meander. A massive blockade also occurred on the Karamnasa nallah near Helang.

**Fig. 12.4** A rare catastrophic landsliding and flooding in Alaknanda river

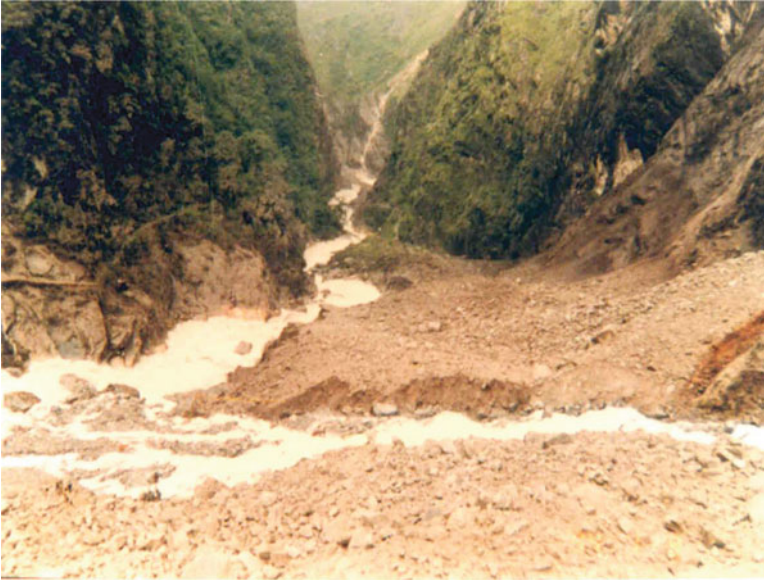
the head region of the parent rock, broke into a number of pieces, and hurtled down the slope (Fig. 12.5). The detached part of the rock mass generated a spectacular and huge rock avalanche, bright flashing light and sparks on the upper slopes, and a dust storm (Bhandari and Kishor 2000). The rock avalanche so generated eventually came to rest but not before killing 270 people including 60 pilgrims. The heaps of debris so created were about 15 m high, and these included rock fragments as big as 5 m. The estimated velocity of the avalanche in some of its reaches was 30 m/s. Before the disaster, the hit the slopes surrounding Malpa village, it looked green, virtually without any visible signs of instability.

**Fig. 12.5** Post-disaster view of Malpa Landslide site

This was the first time landslide occurrence in that area. The mountain slopes were generally high and steep and the rocks were of fractured nature. River Kali passes along this rock bed and that perhaps caused widening of the rock fissures. The river water thrust on the fractured rock and the drainage, and the excessive construction work together were the major contributing factors for the avalanche.

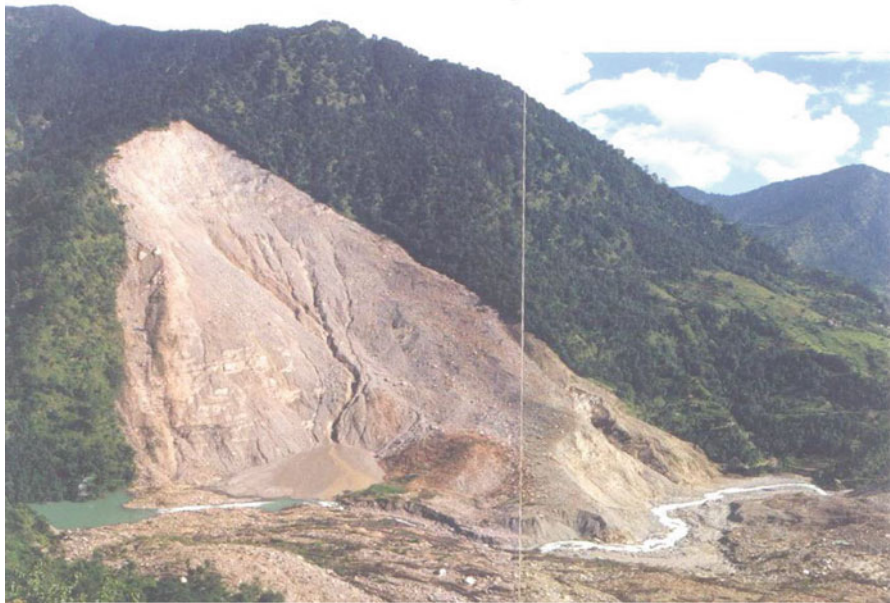
**Fig. 12.6** A panoramic view of Bhenti-Paundar Landslide

Gully erosion and toe cutting by the drainage is very much predominant in this area. Slopes from both the side of landslide zone washed out by the hydraulic action. By viewing the landslide scarp it could be assumed that this is the result of rotational and translational failure of slope. So, it is registered after calculation that the volume of debris at source is higher than the volume of debris deposited at fan. It is assumed that the rest of amount was swept away by the river or rain.

It is recommended that the valley side slopes should be planted with local varieties of stabilizing plant by the local community or by village panchayat.

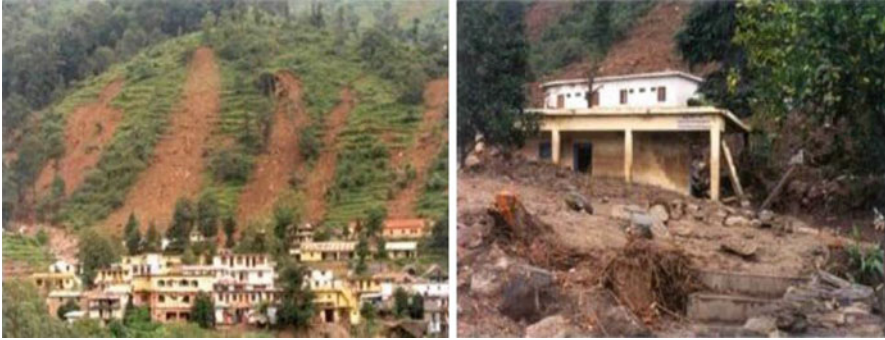
The landslide of 16 July, 2001 was also a deadly event along the Guptakashi-Kedarnath route, NH 109, District Rudraprayag. The two landslides, Phata and Byung (Fig. 12.7) were the two separate major events that occurred in the area,

**Fig. 12.7** Phata Byung Landslides on Guptkashi–Kedarnath road

So a combination of several factors like tectonically disturbed and fractured lithology of the MCT zone, seismic events, loose soil cover, solifluction lobes on steep slope and prominent seepage zone are responsible for this tragedy, but the action of water during the torrential rain appears to be the main triggering factor.

Many villages in this area like Dhani, Jamu, Semkurala and Talla Khumera may be washed away in the next rainfall. Hence people, livestock, etc. need to be shifted to safer places.

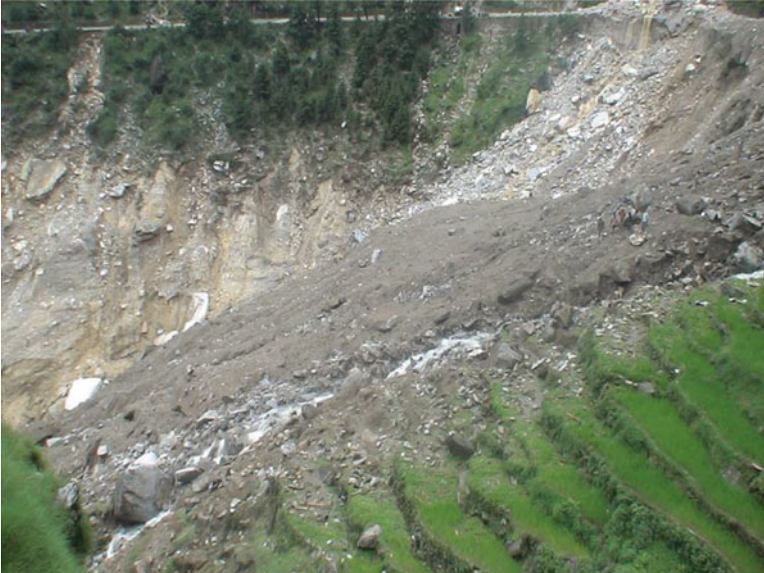
**Fig. 12.8** A partial view of La-Jhekla Landslide

The prime cause of the landslide was an unprecedented heavy rainfall. It seems that the slope before the slide must have been in a marginally stable condition due to erosion by the stream, weakening the weathered geological strata overlain by loose rock boulders. The other preparatory factors could be the neo-tectonic activities as the area is close to MCT.

- No-housing construction zone should be marked clearly.
- Jhekela and La villages are situated near Sukalya nala which caused lot of damage. During rainy season even dry Nala take threatening shape. The survived families should be rehabilitated to safe areas.

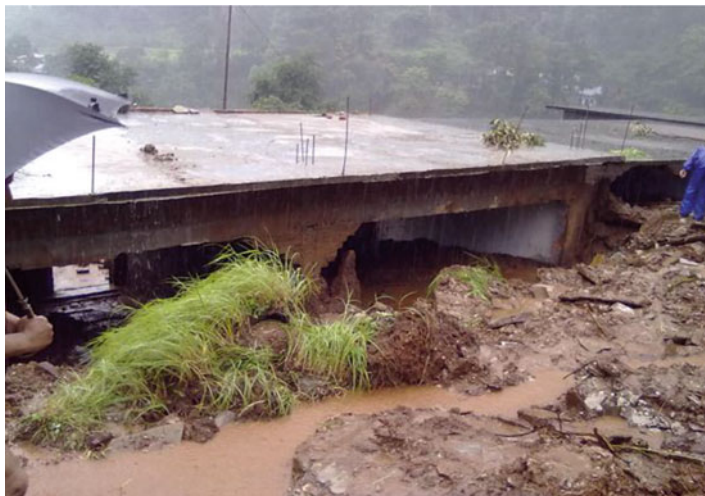
**Fig. 12.9** A view of Primary School hit by landslide where 18 children were buried alive
