Fukushima Nuclear Power Plant Accident and Thereafter

Tadashi Narabayashi

Keywords Fukushima Daiichi Nuclear Power Plant • Isolation condenser • Emergency core cooling system • Hydrogen explosion • New regulatory requirements • Defense in depth

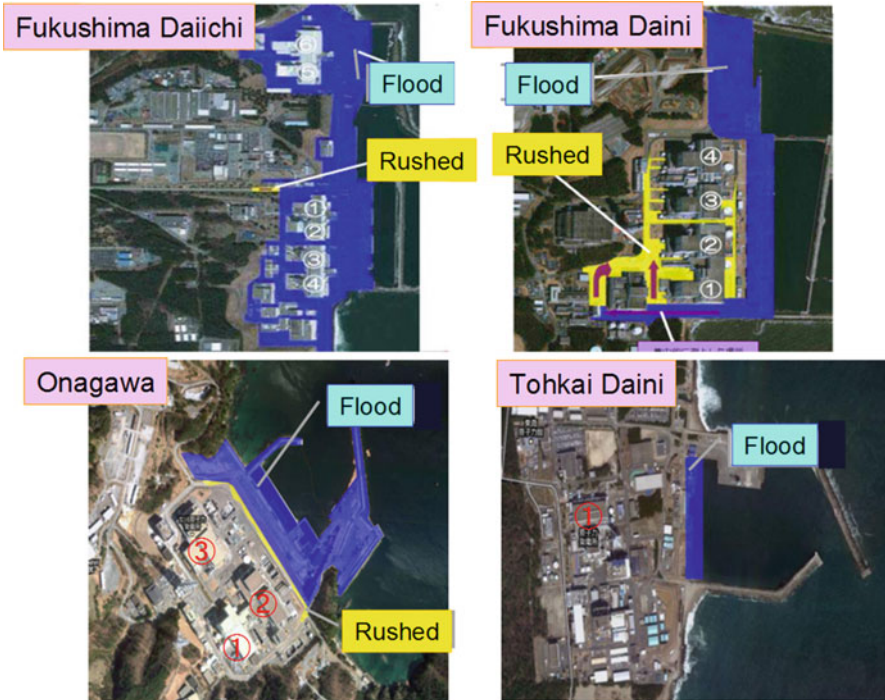
Figure 1 compares flooded areas at each NPP. Although other NPPs such as Fukushima Daini, Onagawa, and Tokai Daini were also struck by the tsunami, they all were able to safely terminate operation, until the cooldown condition. The Fukushima Daini NPP succeeded in safe shutdown, even though Unit 1 was affected by water flooding through hatches and an emergency diesel generator (EDG) air intake. AC power was restored by changing the power cable, and the seawater pump motors were replaced by bringing in new motors from the Toshiba Mie Works and Kashiwazaki-Kariwa NPP by helicopter. At the Fukushima Daiichi NPP, Unit 5 was brought under control by using EDG power from Unit 6 [3].

Fig. 1 Comparison of flooded areas at each NPP [3]

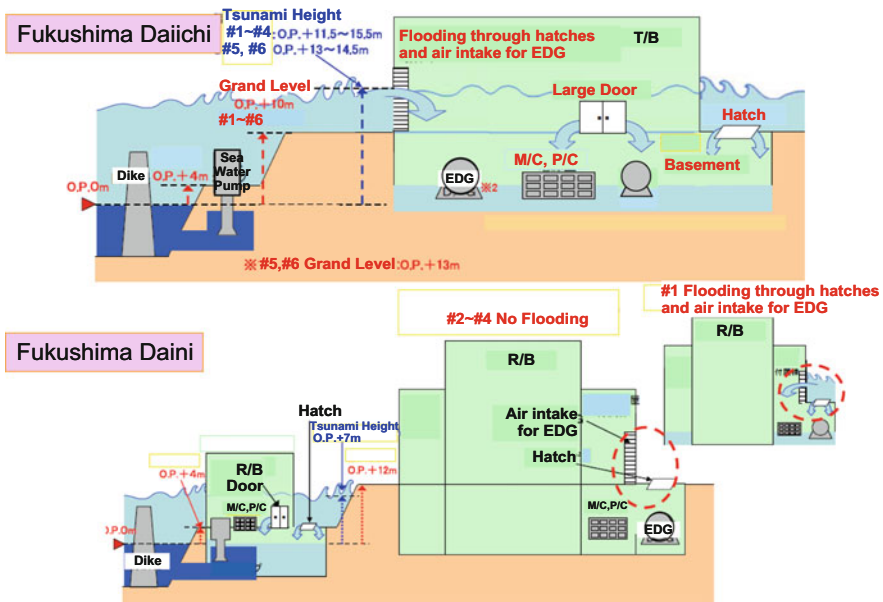
Figure 2 shows a comparison of the flood damage to EDGs. At Units 1 through 4, there was a complete loss of both AC power from the EDGs and DC power, and this was the main cause of the ensuing severe accidents [3] (Table 1).

Fig. 2 Comparison of flood damage to emergency diesel generators for Fukushima Daiichi and Daini NPPs [3]

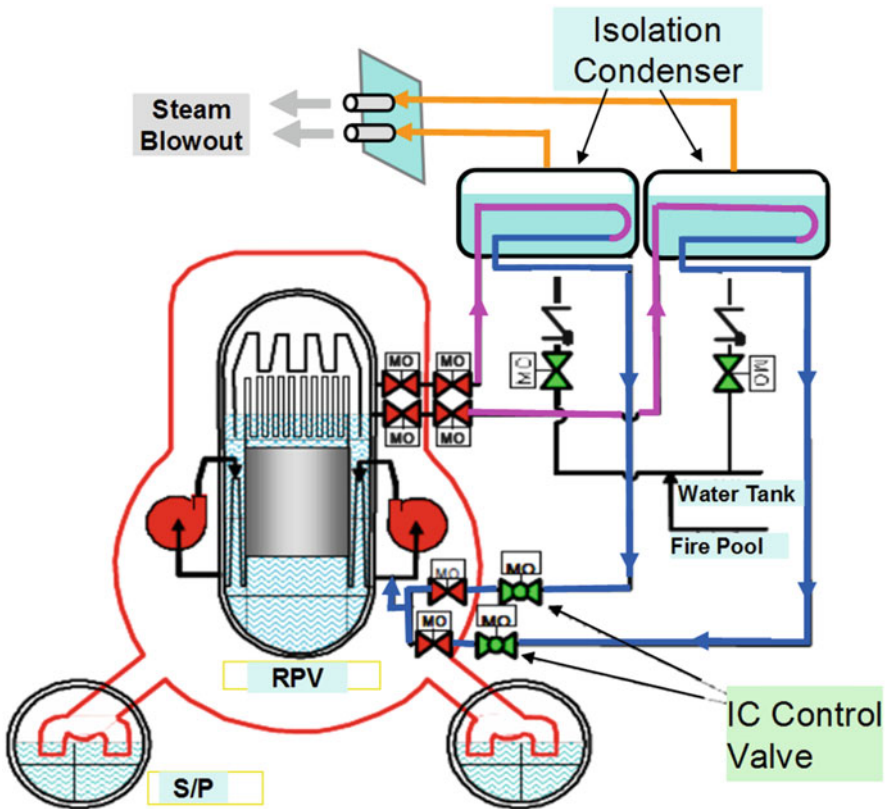
At Unit 1, DC battery power was lost in the main control room. This caused motor-operated (MO) isolation valves to undergo fail-close action, thereby cutting off the isolation condenser (IC), as shown in Fig. 3. This was a fail-dangerous system under such situation. If the IC had continued to operate, the situation would soon have been brought under control [1].

Fig. 3 Isolation condensers in Fukushima Daiichi Unit 1 [1]

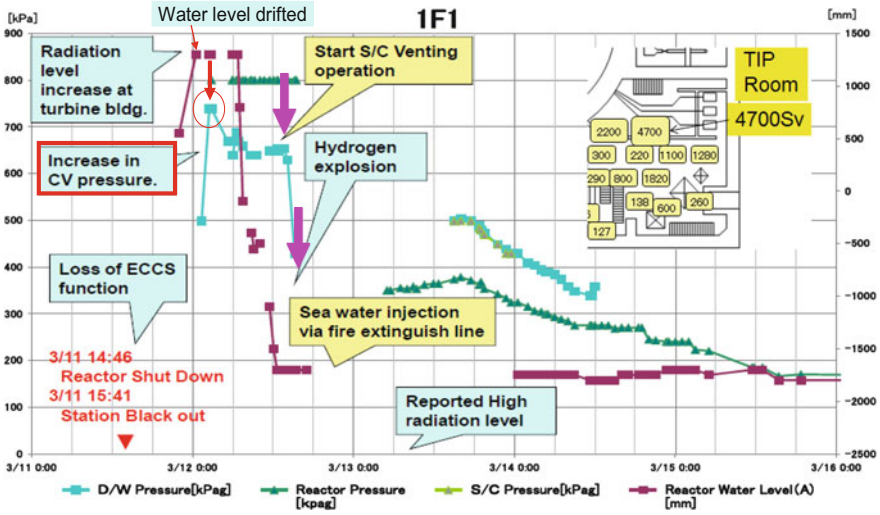
After the loss of both the emergency core cooling system and IC core cooling, primary containment vessel (PCV) pressure increased. Water level measurement drifted because of water evaporation in the reference leg (Fig. 4). Radiation level increased at a turbine building (T/B). There was a hydrogen explosion the after suppression chamber (S/C) wet venting.

Fig. 4 Measured pressure and water level in RPV and CV of Unit 1 [4, 7]

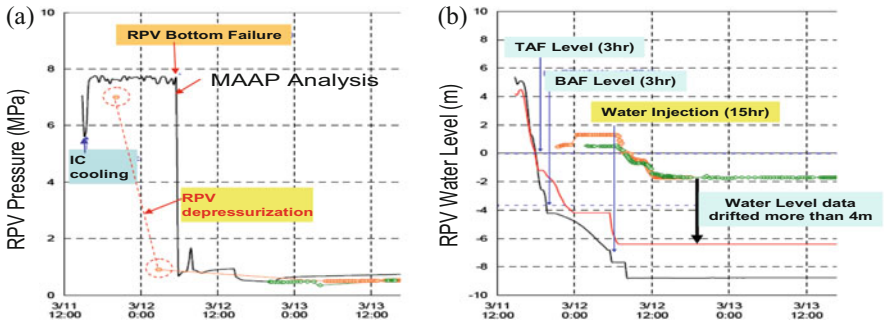
As shown in Fig. 5a, both Modular Accident Analysis Program (MAAP) code analysis results and actual data suggest that depressurization of the reactor pressure vessel (RPV) began before its bottom failed. This might have been caused by the melting of traversing in-core probe (TIP) tubes in the core. It was confirmed that the TIP room radiation level is very high even now. Figure 5b shows that the measured water level measurement drifted by more than 4 m owing to water loss in the reference leg. This is likely to have been caused by the high-temperature superheated core. Water should have been supplied to the water level reference leg through instrumentation piping.

Fig. 5 MAAP analysis results compared with actual plant data for Unit 1 [3]. (a) Pressure in RPV. (b) Water level in RPV

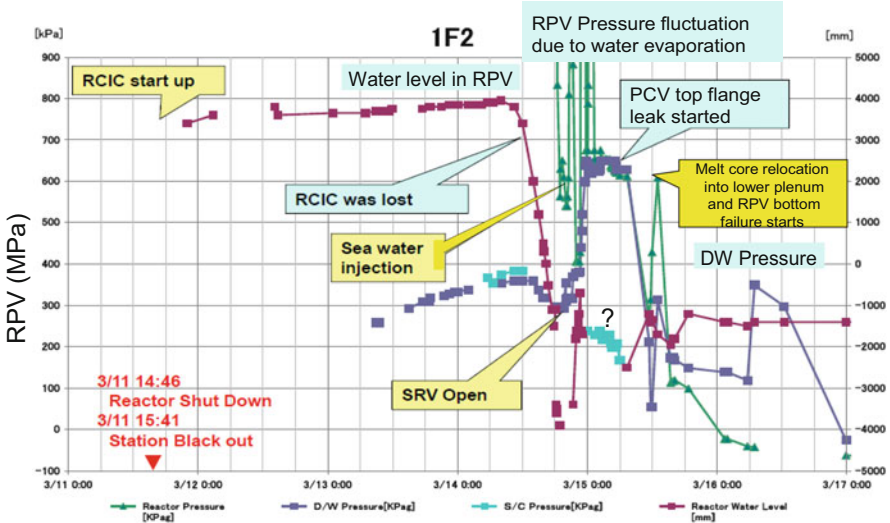
At Unit 2, reactor core isolation cooling (RCIC) continued to function for about 3 days. Figure 6 shows that soon after the loss of RCIC water injection, the water level in the RPV declined. The safety relief valve (SRV) was opened and seawater injection started. But, RPV pressure shows fluctuation due to water evaporation and metal-water reaction in core. Dry well (DW) pressure increased from 400 to 750 kPa (abs), and PCV top flange leak began through silicon rubber O-ring. It was an initiation of severe contamination around the NPS. In the afternoon on March 15, wind blew toward Iitate village. Melted core relocation into the lower plenum caused the RPV bottom CRD pipe failure and PCV pressure and radiation level increased (Fig. 7). The radiation level was measured by containment atmospheric monitoring system (CAMS) [15].

Fig. 6 Measured pressure and water level in RPV and PCV of Unit 2 [4]

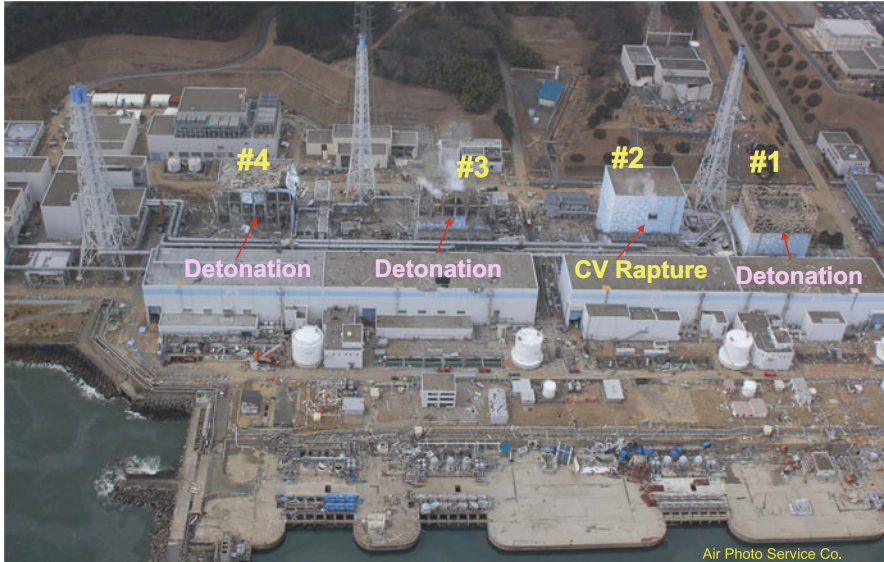
Figure 8 shows H₂ explosion in Unit Nos. 1, 3, and 4. Upon the occurrence of Unit 3's detonation, the blowout panel of Unit 2 was opened. Hydrogen in Unit 2 was released through the opened blowout panel and there was no explosion/detonation in that unit. The sound of an explosion was reported near the S/C of Unit 2. However, examination of the data showed that this was due to a hydrogen detonation in the reactor building (R/B) of Unit 4. Soon after this detonation, DW pressure in Unit 2 decreased (Fig. 6). Figure 9 shows trends in monitored radiation

Fig. 8 H₂ detonations occurred after vent operations (Units 1, 3, and 4) [11]

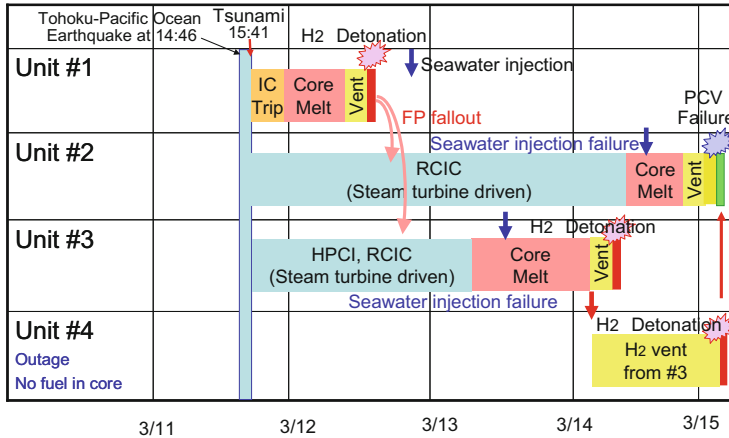
Fig. 10 Chain of major events at Units 1 through 4 causing severe accidents at Fukushima Daiichi NPS [11]

It appears that the explosion occurred after venting operations. The radiation level increased soon after the Unit 2 PCV rupture on March 15. A loss of core cooling occurred because of the IC trip in Unit 1, and the RCIC steam turbine also tripped owing to loss of battery power in Units 2 and 3. Suppression pool (S/P) temperature and pressure became so high that water injection actions for accident management took a long time. This was the reason for the chain of severe accidents in the four units of the Fukushima Daiichi NPS, as shown in Fig. 10 [11].

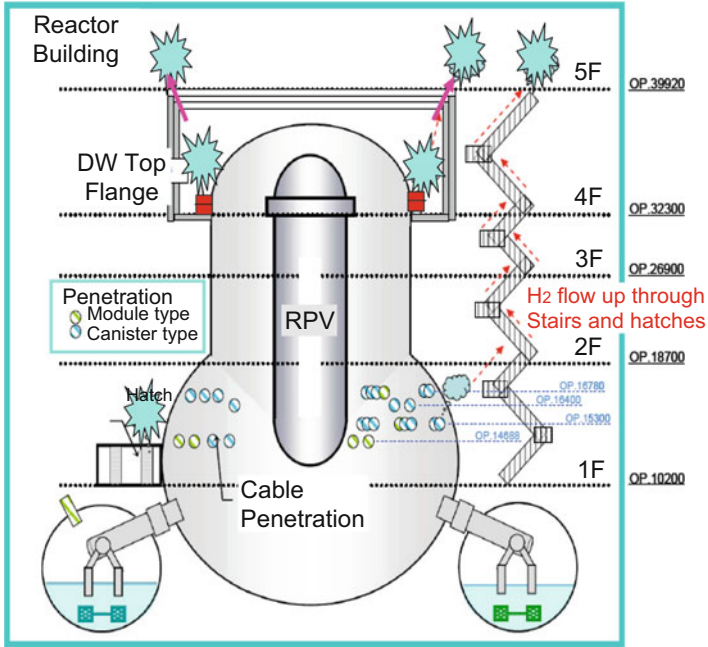
Figure 11 shows that the PCV top flange and hatches can act as leakage pathways. Hydrogen and FP flow upward by way of stairways and hatches. Although there were no nuclear fuels in the reactor core of Unit 4, hydrogen flowed from Unit 3 through the stack line into Unit 4 and underwent reverse flow through the standby gas treatment system (SGTS) filters (Fig. 12) [3, 6].

Fig. 11 Estimated leak path from dry well by overpressure and high temperature [3, 6, 11]

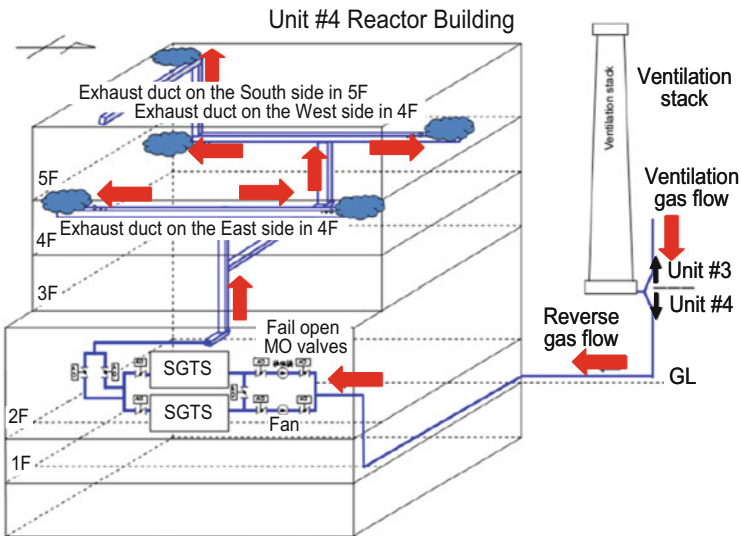
There was a strong hydrogen explosion that occurred in the Unit 4 reactor building on March 14. The author pointed out to NISA that the harden vent line might have acted as a means of hydrogen and fission product (FP) leakage through SGTS and HVAC lines (Fig. 13). As shown in Fig. 14, it was confirmed that the SGTS filters were contaminated and all MO valves were open because of the fail-open design in Units 3 and 4. Seats of the butterfly valves were made of neo-plane rubber and damaged by iodine. This might have caused hydrogen detonation in Unit 4, where there were no nuclear fuels in the reactor core, because hydrogen and FP could have flowed back into each room through the exhaust gas ducts. The vent lines of each NPP should have been independent of the SGTS/HVAC line.

Fig. 12 H₂ gas flow into Unit 4 reactor building from Unit 3 [3, 6, 11]

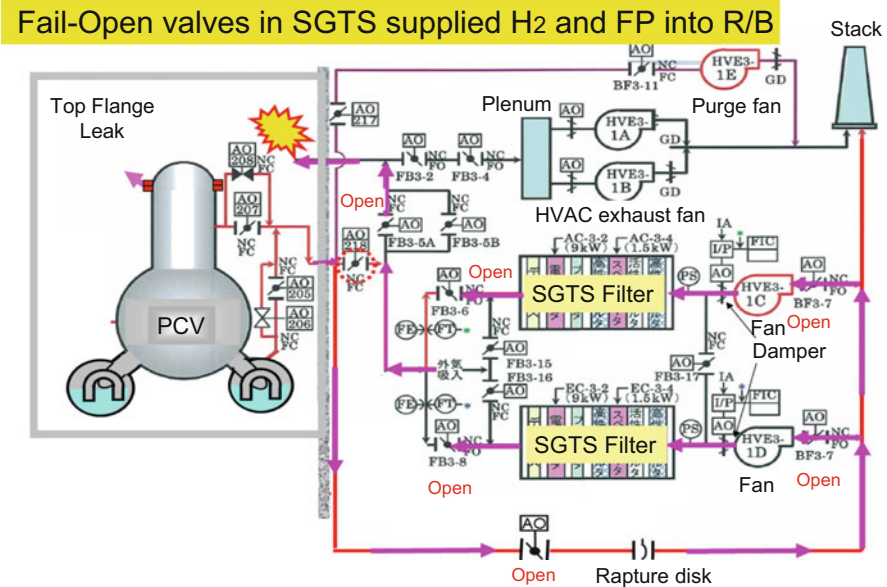
Fig. 13 Flow diagram of SGTS/HVAC and added hard vent system [11]

NISA ordered that the licensees make a new independent vent line for filtered vent system. This is one of the lessons learned. There were no accident reports about Fukushima Daiichi pointing out the vent system fault and potential risks. The causes of severe accidents and countermeasures are shown in Fig. 15, in which (P) means protection and (R) resilience action. Corium cooling was very effective in achieving the cold shutdown cooling, even after the containment failure at the Fukushima Daiichi NPPs.

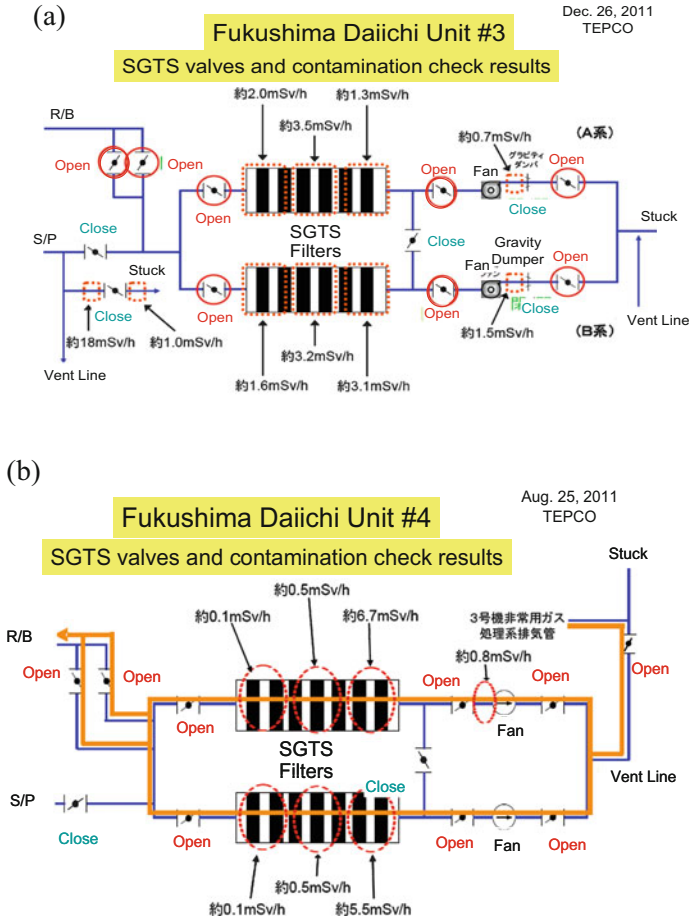
Fig. 14 Results of SGTS valve open/close status and filter contamination [2]. (a) Fukushima Daiichi Unit 3. (b) Fukushima Daiichi Unit 4

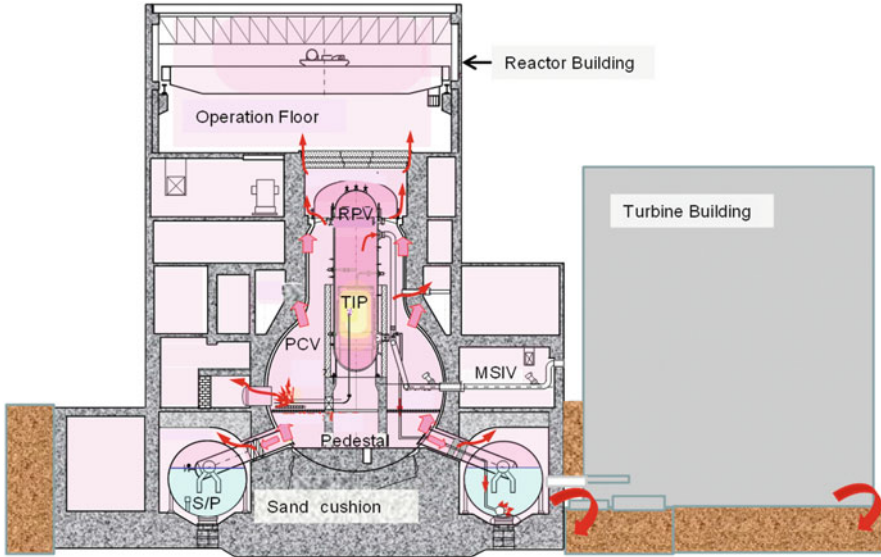
Figure 51 shows the estimated leak path of fission products from the PCV. After recirculating water injection to the core, melted core debris was cooled and reached cold shutdown. However, contaminated water still leaked from the damaged PCV and flowed out of the reactor building.

Fig. 51 Estimated leak path of fission products from primary containment vessel

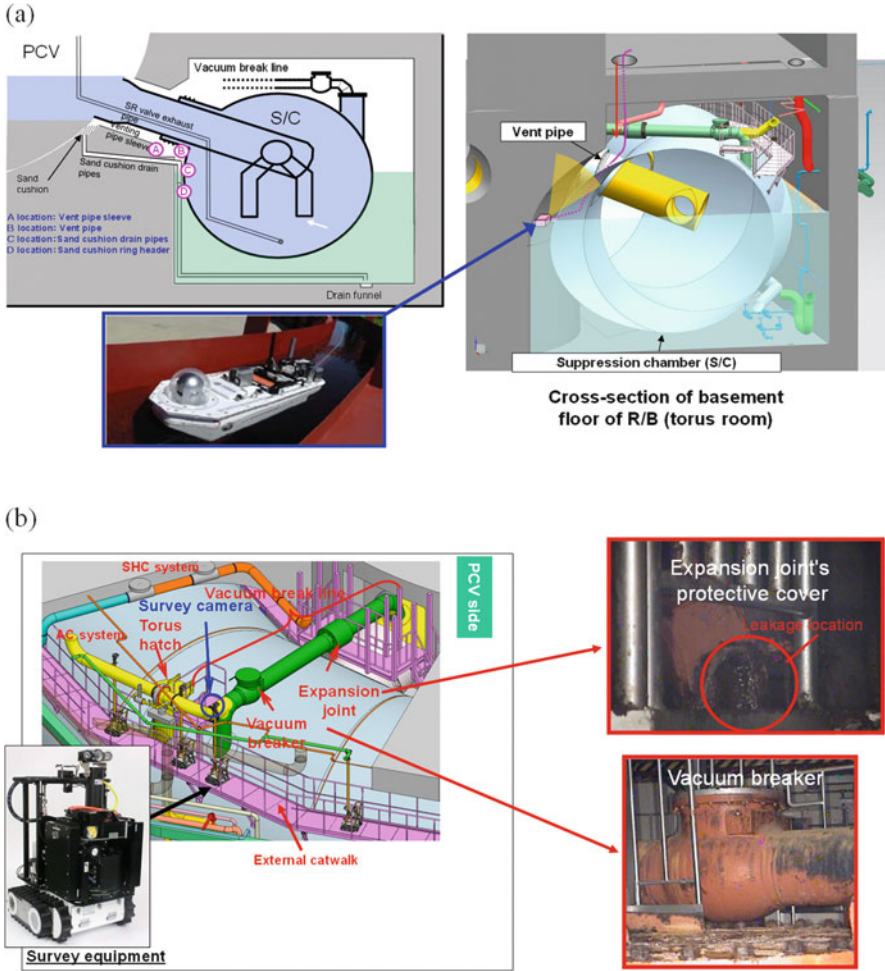
Therefore, the leak location was found by using robots. Figure 52a shows boat-type robots with a camera checking water flow out of the bottom of the PCV area in a torus room on the basement floor of Unit 1. Video from the boat robot discovered water flow from a sand cushion drain pipe [18, 19]. This indicates some failure at the bottom of the PCV wall and that water leaked through the sand cushion drain. Sand cushions are used to mitigate the stress on the bottom flange of the PCV.

Figure 52b shows another type of robot, which can walk on the external catwalk on the torus of the suppression chamber and survey water leakage on the upper side of that chamber and piping. Such robot found leakage from the protection cover of a vacuum breaker expansion joint in Unit 1. This is consonant with the discovery of the water flow on the surface of the suppression chamber torus by the boat-type robot.

Fig. 52 Survey robot to discover contaminated water leakage in Unit 1 [18, 19]. (a) A boat-type robots with a camera checking water flow. (b) Survey robot walking on catwalk outside of SC

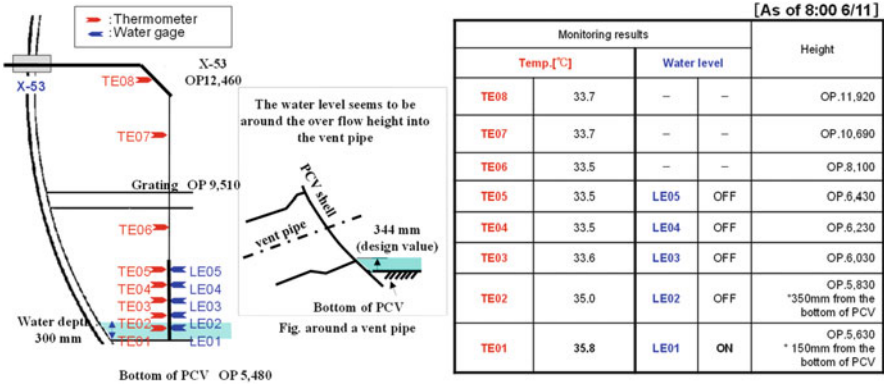
Figure 53 shows the effort in Unit 2 to find the water level in PCV. A water level probe with thermocouple was inserted through X-53 penetration. This found a water depth of 300 mm, which is near the overflow height into vent pipe. This indicates a leakage path at the vent pipe or suppression chamber torus. This leak can be stopped using balloon plugs, which are used for main steam line plugging during the annual maintenance of main steam isolation valve (MSIV) [15].

Fig. 53 Water-level checking at bottom of PCV of Unit 2 [15]

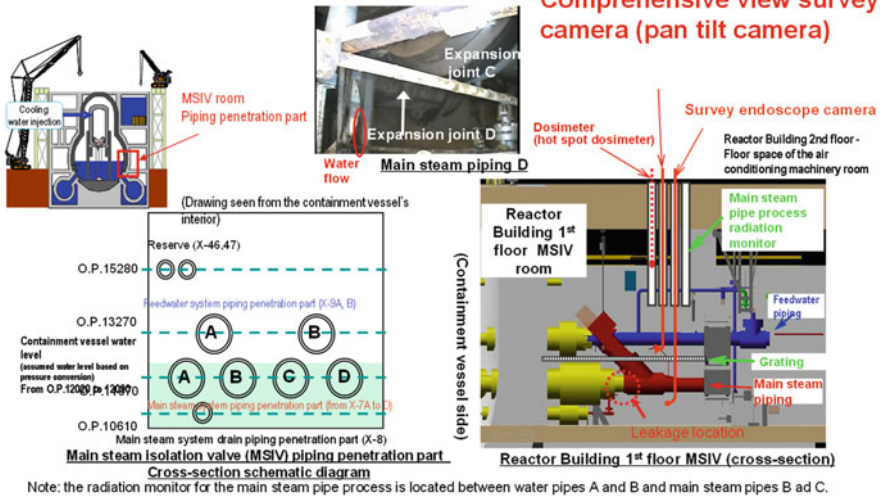
As shown in Fig. 54, a video camera was used to find PCV water leak in the reactor building at Unit 3. The camera was inserted from the second floor and discovered leakage from the expansion joint of main steam line pipe D from the PCV in the MSIV room on the reactor building first floor.

Fig. 54 Investigation to find leakage location in Unit 3 [15]

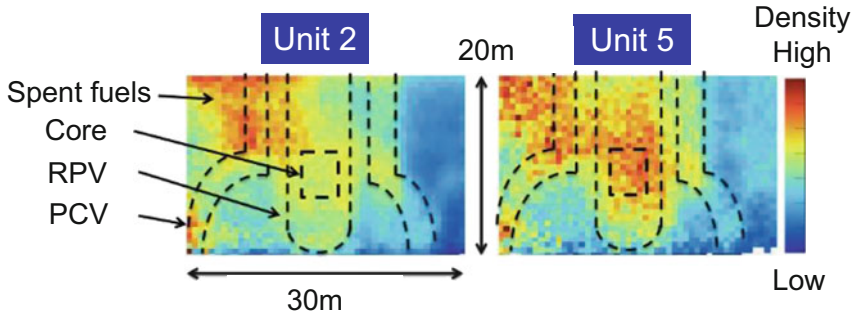
Figure 64 compares muon radiography results between Units 2 and 5. No fuels were found in the core or lower plenum at the RPV bottom. All fuels melted downward through the melted piping of the control rod drive (CRD) mechanism and fell to the pedestal concrete floor.

Fig. 64 Comparison of muon radiography results between Unit 2 and Unit 5 [20]
